Re: 49 CFR Part 573; Recall of Mercedes-Benz Rear Load Leveling

TO: Mercedes-Benz Dealer Principals, General Managers, Sales Managers, Service Managers, Parts Managers	FROM: Thomas Brunner; Department Manager; Vehicle Compliance and Analysis; Engineering Services
RE: : Recall Campaign 2012070006 – Check Level Sensor Linkage at Rear Axle, Replace if Necessary, Model 211 Wagon, Model Years 2007- 2009	DATE: August 31, 2012

Campaign No. 2012070006, August 2012

SUBJECT: **Model 211 Wagon, Model Year 2007 - 2009**
Check Level Sensor Linkage at Rear Axle, Replace if Necessary

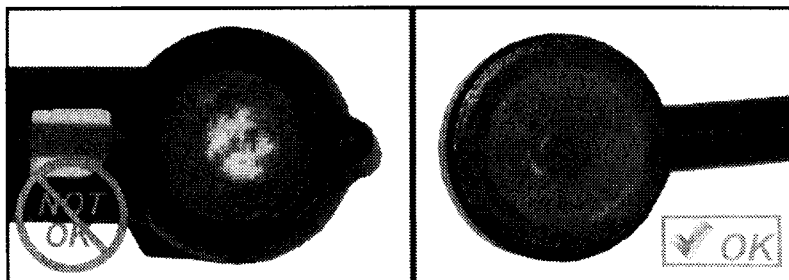
Figure 1 Open ball head

DAG has determined that the load leveling rear air suspension in the subject vehicles may not perform as designed due to a supplier material specification issue that can cause the ball head of a connecting rod in the level control system to seize. The rod is connected to the stabilizer bar and transmits the vertical movement of the suspension system to a sensor. In the case of a seized ball, the rod may break. Should this occur, the possibility exists that the sensor will generate a constant signal indicating that air suspension level is too low. This triggers a continuous attempt to increase the pressure in the air bellows, which can first lead to uncomfortable and stiff suspension characteristics, and in very rare cases could lead to a loss of air pressure in the air bellows. To date, we are not aware of any cases in the U.S. where the air bellows have failed. As a result of a failure of the rear air suspension connecting rod, owners may experience reduced control of the vehicle which could increase the risk of a vehicle crash. Nevertheless has initiated a voluntary recall of all potentially affected vehicles described above. The recall will be conducted to replace the rear air suspension connecting rod in the subject vehicles.

1. If closed ball head **IS** installed (OK, Figure 1): Procedure is complete.
2. If closed ball head is **NOT** installed (NOT OK, Figure 1): Proceed to subject B: **Install New Level Linkage**.
