SERVICE PROCEDURE

G-12517
July 2012

SUBJECT: NON-COMPLIANCE RECALL
Roof-Mounted Emergency Exit on certain BE, CE, and RE bus models built 01 April 2011 thru 31 March 2012 with ProLo roof-mounted emergency exits produced by Specialty Manufacturing Inc. (SMI).

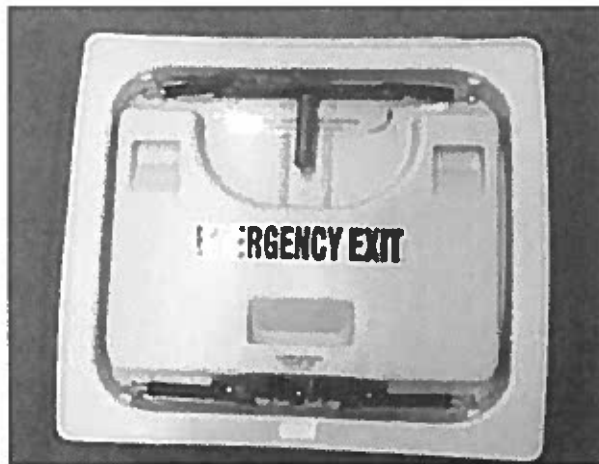
Figure 1

1. Park vehicle on flat surface, shift transmission to park or neutral, set parking brake, and block wheels to prevent vehicle from moving in either direction.
2. Inspect label just to right of handle on latch lid for build date to determine if hatch was manufactured from 01 April 2011 through 25 March 2012. (Figure 1 and Figure 2).

3. If hatch was manufactured between dates listed in step 2, proceed to step 4 and replace hatch rear support receiver. Otherwise, proceed to step 5.
4. Please refer to SMI repair instructions included with this letter for each roof-mounted exit on the bus.
5. Remove wheel blocks.
