# Recall Bulletin

## PRODUCT SAFETY RECALL

**SUBJECT:** Potential Missing Welds in Rear Compartment

**MODELS:** 2011-2012 Chevrolet Cruze

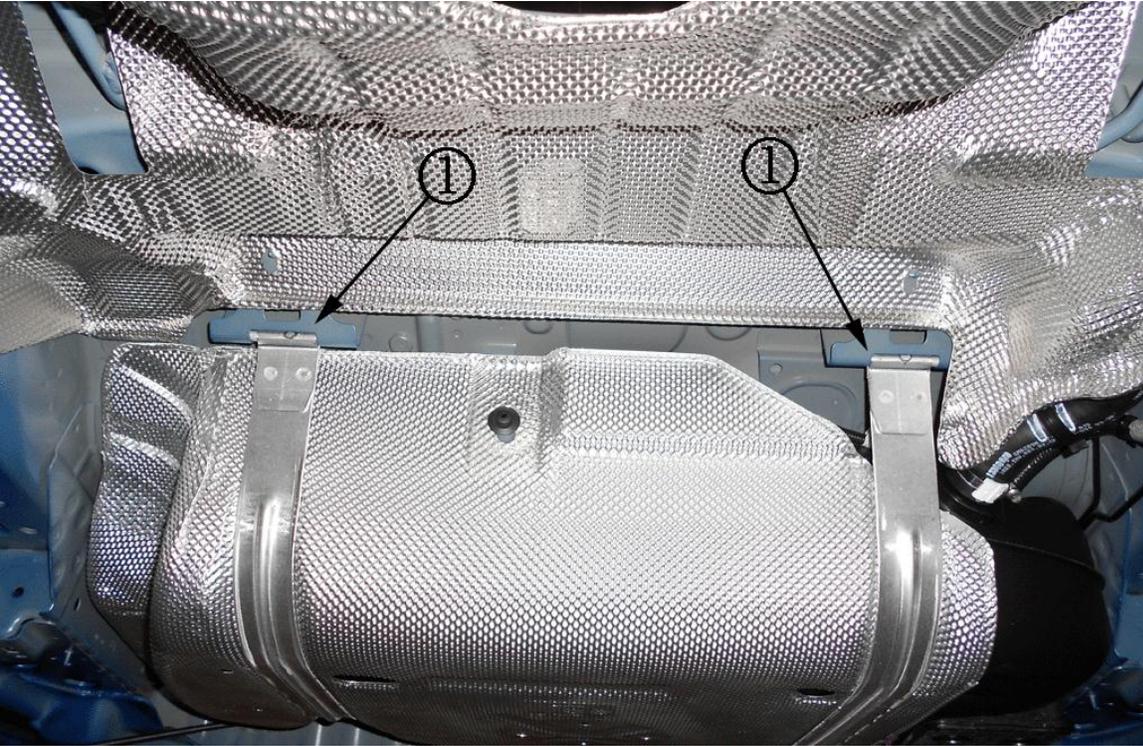
2877182

2. Locate the fuel tank strap brackets (1).

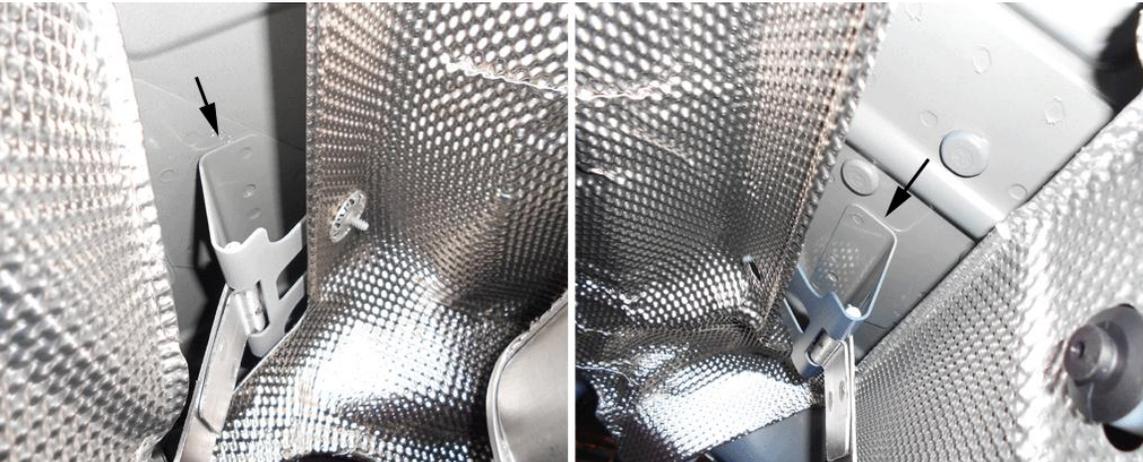
2877158

- If the fuel tank strap brackets are spot welded flush to the floor pan, no further action is required. Lower the vehicle. Refer to illustration. Arrow indicates fuel tank strap bracket to floor pan contact point.

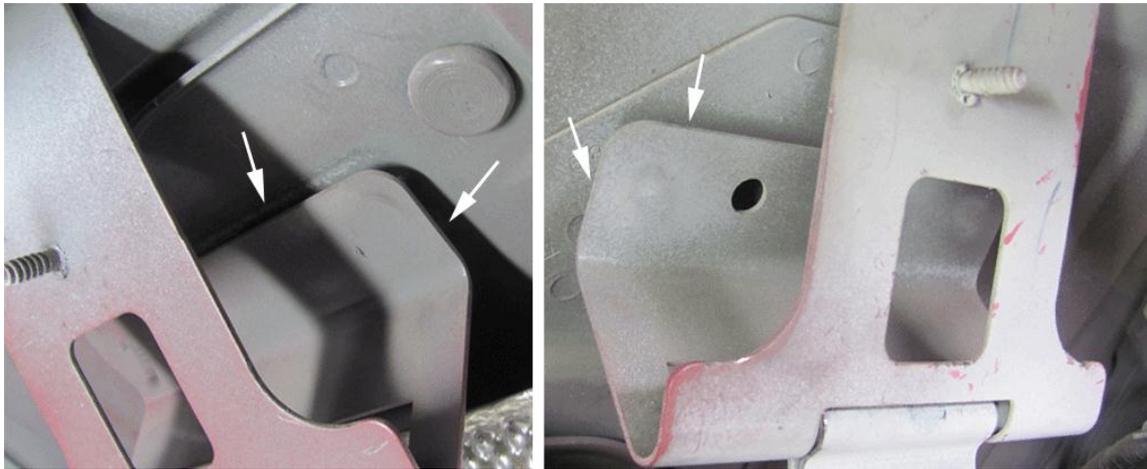
2877112

- If you can see a gap between the fuel tank strap bracket and floor pan, the spot weld is missing, proceed to step 4. Refer to illustration. Arrow indicates fuel tank strap bracket to floor pan contact. Illustration show a gap between the fuel tank strap bracket and floor pan.

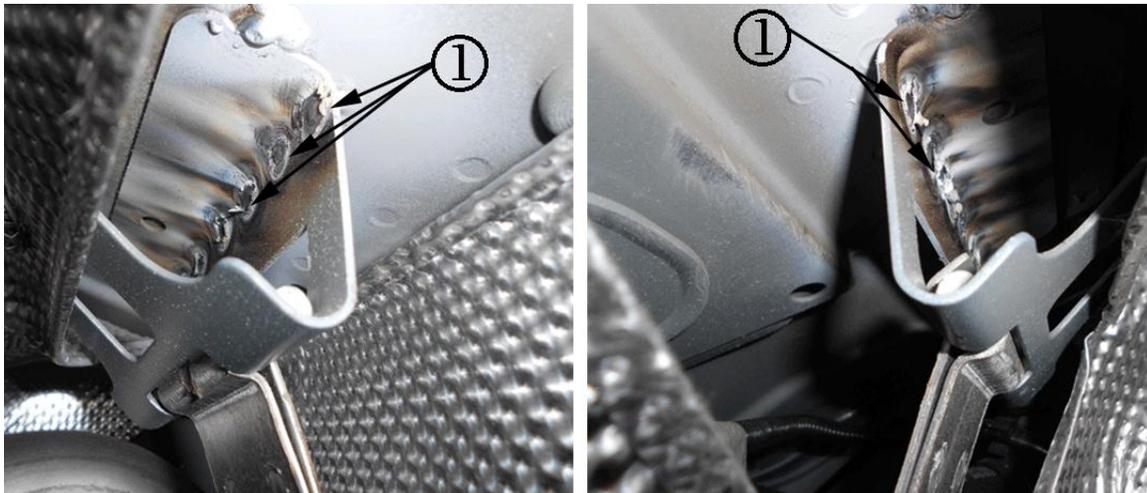
2877132

- If the fuel tank strap bracket is MIG welded (1) to the floor pan, proceed to step 4. Refer to illustration. Arrow indicates MIG welds and fuel tank strap bracket to floor pan contact. MIG welded fuel tank strap brackets require the service repair in this bulletin.
