Audi

# Safety Recall

Code: 60B2

**Subject: 2012 Model Year Audi Q5 with Sunroof Glass Panel  
Front Sunroof Glass Panel**

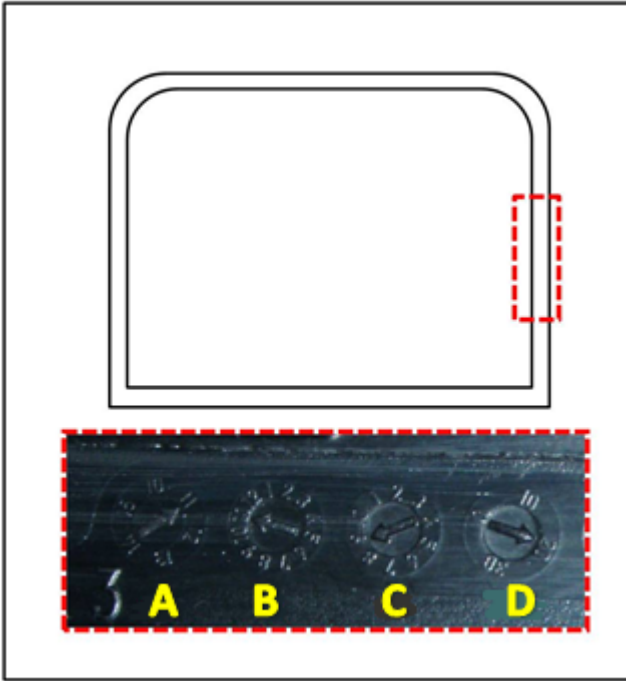
⇐ Check the manufacturing date on the inside of the glass panel:

A = Year (11)

B = Month (11)

C + D = Day (9 + 20 =29)

(example: 11/29/2011)

- If the manufacturing date is **November 28, 2011 (11/28/2011) or later**, the glass panel is ok and can be reinstalled. Continue with procedure using new screws, 4L0 898 057, without installing new glass panel.
- If the manufacturing date is **before November 28, 2011 (11/28/2011)**, the glass panel must be replaced, continue with procedure by installing new glass panel using repair kit, 8R0 898 998.
