BULLETIN NUMBER:
SB12-11-S001

Regional Safety Recall 12V-306

Corrosion Affecting the Forward Mounting Point for Rear Suspension Lower Link Brackets

- 1998-1999 Model Year Isuzu Amigo (UA)
- 2000-2002 Model Year Isuzu Rodeo Sport (UA)

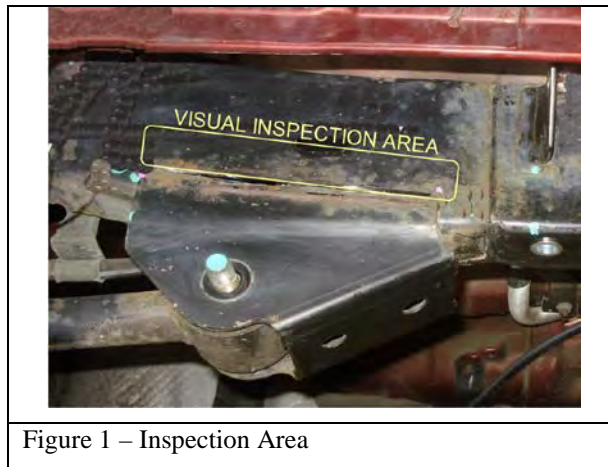
1. Raise the vehicle. When placing the lift points, be sure to keep the rear lifting points at least 300mm (12 inches) ahead of the rear lower trailing link front mounting bracket. This spacing is necessary for inspection and repair accessibility.
2. Visually inspect the Rear Lower Trailing Link Front Mounting Bracket inspection area. Use the Visual Comparison Photo (P/N 2-90SVA-003-0) or Figure 1 for reference. If most of the frame coating is still in place and very little surface rust is present, apply Noxudol 300 (Go to "Condition One: Apply Noxudol 300" in this bulletin). If most frame coating is missing and excessive rust is present go to the next step.

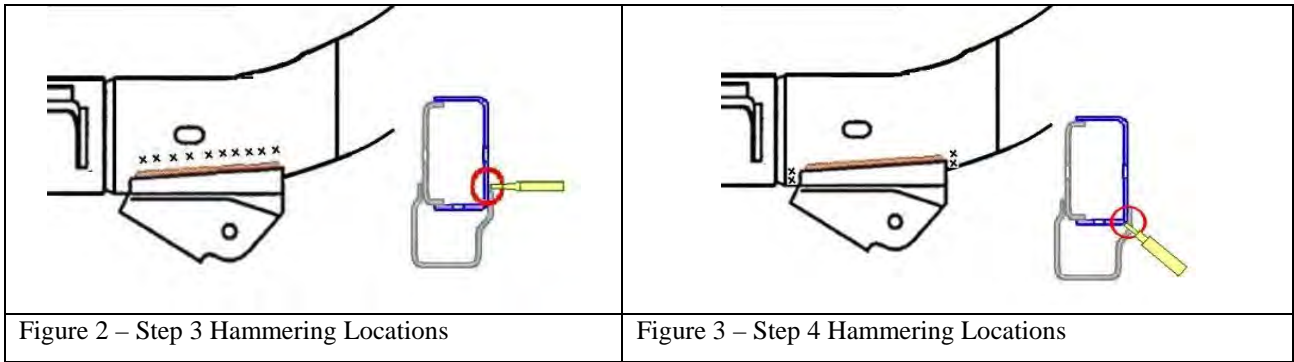
3. Using a 3/16" flat punch and a 12-16 oz. hammer, hammer on the locations identified with an "X" in Figure 2. Swing the hammer 10 to 12 inches to be sure enough force is applied to the punch. If no hole is created, apply Noxudol 700 and Noxudol 300 (Go to "Condition Two: Apply Noxudol 700 and Noxudol 300" in this bulletin). If, however, the flat punch creates a hole in any one location, go to the next step.
4. Using a 3/16" flat punch and a 12-16 oz. hammer, hammer on the locations identified with an "X" in Figure 3.
 - a. If no hole is created, continue to "Condition Three: Reinforcement Bracket Type "C" Installation" in this bulletin.
 - b. If the flat punch creates a hole in any one location, continue to "Condition Four: Reinforcement Bracket Type "D" Installation" in this bulletin.

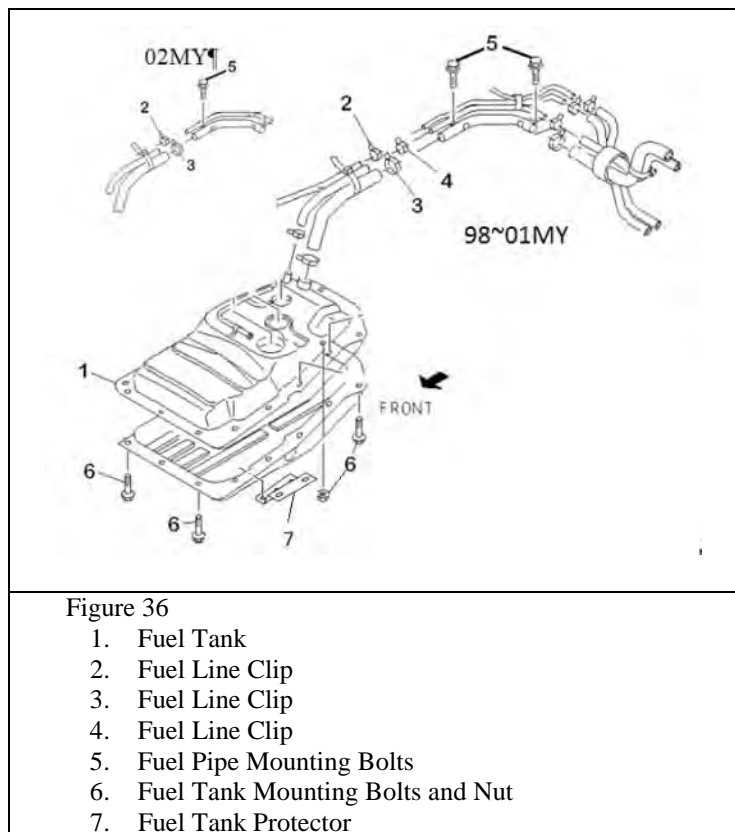
2. Inspect the interior frame rail at the mounting points for the bracket. If perforation is evident at these mounting points, please review immediately with your service manager or contact a National Operations Manager at 1-800-533-0244 (Option 2) prior to attempting the repair.
3. Remove the following components as per the service manual:
 - a. Rear bumper assembly.
 - b. Exhaust silencer – new gaskets provided in kit.
 - c. Linear EGR valve – new gasket provided in kit.

1. Remove the fuel tank assembly as per the service manual. New clamps are provided in kit.
 - a. Disconnect fuel line at fuel filter supply and return hoses.
 - b. Disconnect fuel tank at locations 2, 3 and 4 shown in Figure 36.
