Campaign Service BULLETIN

BULLETIN NUMBER:
SB12-11-S001A

Regional Safety Recall 12V-306

Corrosion Affecting the Forward Mounting Point for Rear Suspension Lower Link Brackets

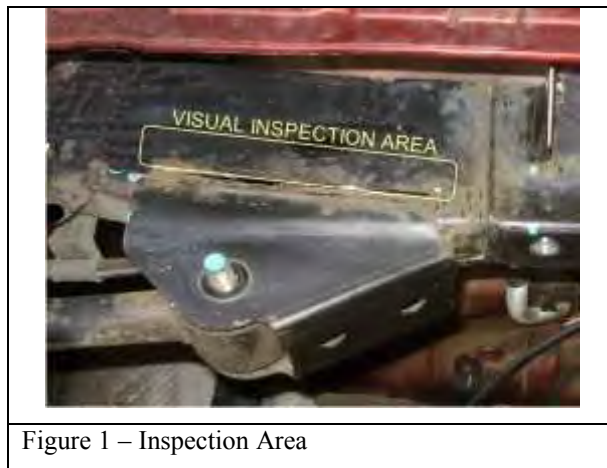
2. Using a 3/16" flat punch and a 12-16 oz. hammer, hammer on the locations identified with an "X" in Figure 2. Swing the hammer 10 to 12 inches to be sure enough force is applied to the punch. If a hole is created go to Step 4. If no hole is created, visually inspect the Rear Lower Trailing Link Front Mounting Bracket inspection area. Use the Visual Comparison Photo (P/N 2-90SVA-003-0) or Figure 1 for reference. If most of the frame coating is still in place and very little surface rust is present, apply Noxudol 300 (Go to "Condition One: Apply Noxudol 300" in this bulletin). If most frame coating is missing and excessive rust is present go to the next step.

3. Apply Noxudol 700 and Noxudol 300 (Go to "Condition Two: Apply Noxudol 700 and Noxudol 300" in this bulletin).
4. Using a 3/16" flat punch and a 12-16 oz. hammer, hammer on the locations identified with an "X" in Figure 3.
 - a. If no hole is created, continue to "Condition Three: Reinforcement Bracket Type "C" Installation" in this bulletin.
 - b. If the flat punch creates a hole in any one location, continue to "Condition Four: Reinforcement Bracket Type "D" Installation" in this bulletin.
