Safety Recall

SR12-61

PASSENGER SEAT TRACK INSPECTION AND REPAIR.

9700 (B13R)

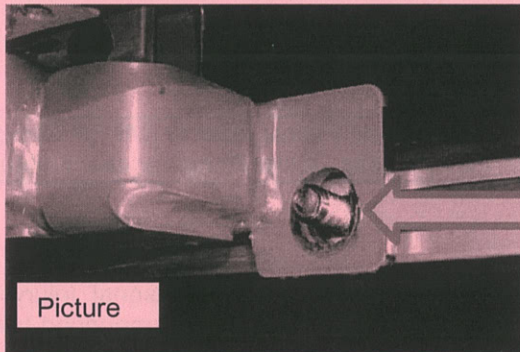
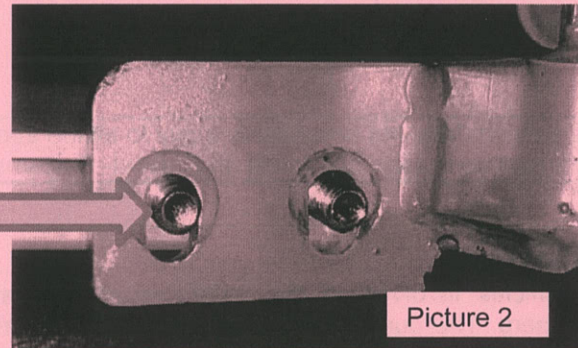
When the first nut is removed (picture 1), you will notice that the holes on the mounting brackets are slotted and they are generally NOT resting all the way down, but the seat has a tendency to “drop” on that side when the last nut is removed. **DO NOT look through the holes on the brackets for inspection.**

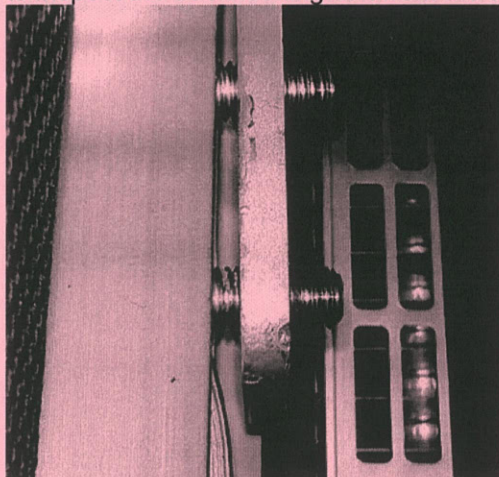
Picture 3

A “good” track (as shown on picture 3 below) will look perfectly flat around the bolt. If there is any deformation of the track surface around the bolt, which would be a sign of over-torqueing, as the track has begun to “pull through” the mounting bracket.

This type of damage can generally NOT be noticed through the mounting holes, this is why it's important to inspect the track looking at it from the top (as shown on picture 3)

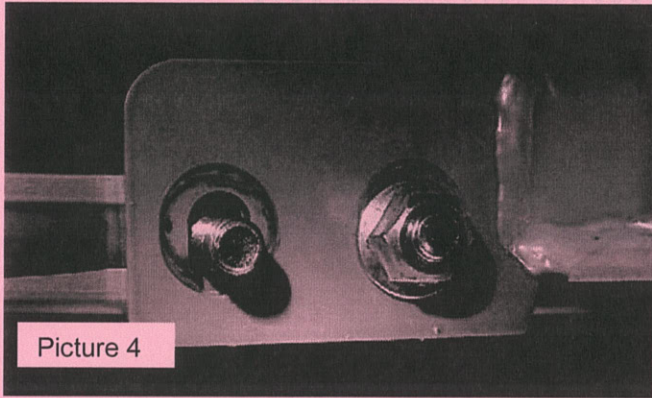
Picture 4

NOTE: you must inspect all seats on the side being worked on BEFORE re-assembling hardware, because if there's any damage found, you will be taking all that hardware back off to perform the necessary repair.
