SUBJECT: **Safety Recall 12S37 - Supplement #2**
Certain 2001-2004 Model Year Escape Vehicles with 3.0L Engine and Speed Control Engine Cover Modification

REF: **Safety Recall 12S37- Supplement #1**
Dated August 22, 2012

CERTAIN 2001-2004 MODEL YEAR ESCAPE VEHICLES EQUIPPED WITH 3.0L ENGINE AND SPEED CONTROL — ENGINE COVER MODIFICATION

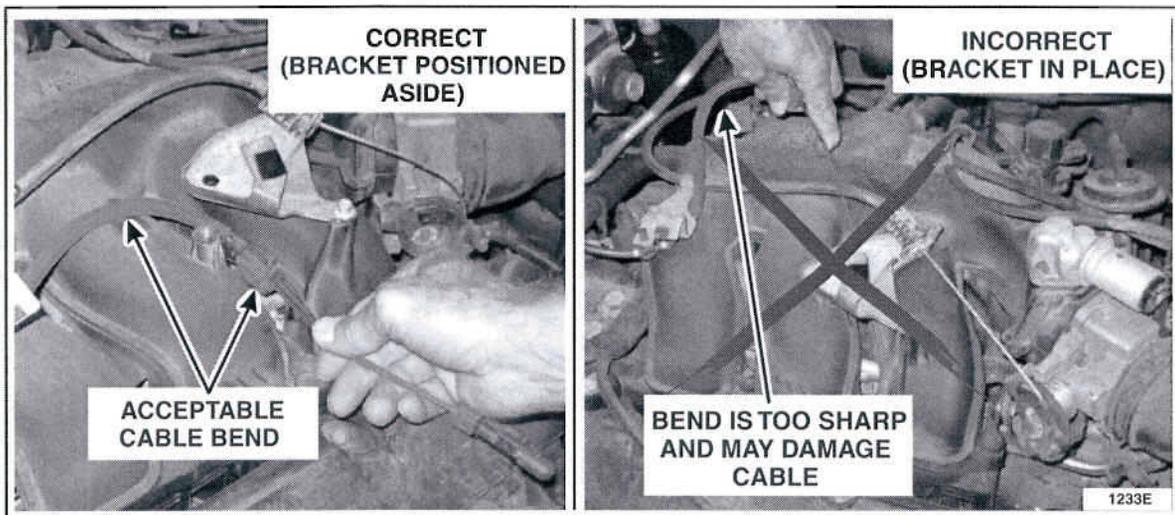
FIGURE 2

Check to see if the speed control cable has been previously disconnected.

2. NOTICE: Do not bend the speed control cable. The throttle cable bracket must be positioned aside or damage to the speed control cable may occur.

- If the speed control cable is connected, proceed to step 3.
- If the cable is disconnected, reconnect the speed control cable to the throttle body before proceeding to step 3. See Figure 2. To reconnect the cable:
 - a. Loosen the RH throttle cable bracket bolt and remove the LH cable bracket bolt.
 - b. Rotate the bracket to allow enough clearance for the speed control cable to be removed.
 - c. Remove the speed control cable from under the bracket and connect the cable to the throttle body.
 - d. Reposition the throttle cable bracket and tighten both bracket bolts to 10 Nm (89 lb-in).

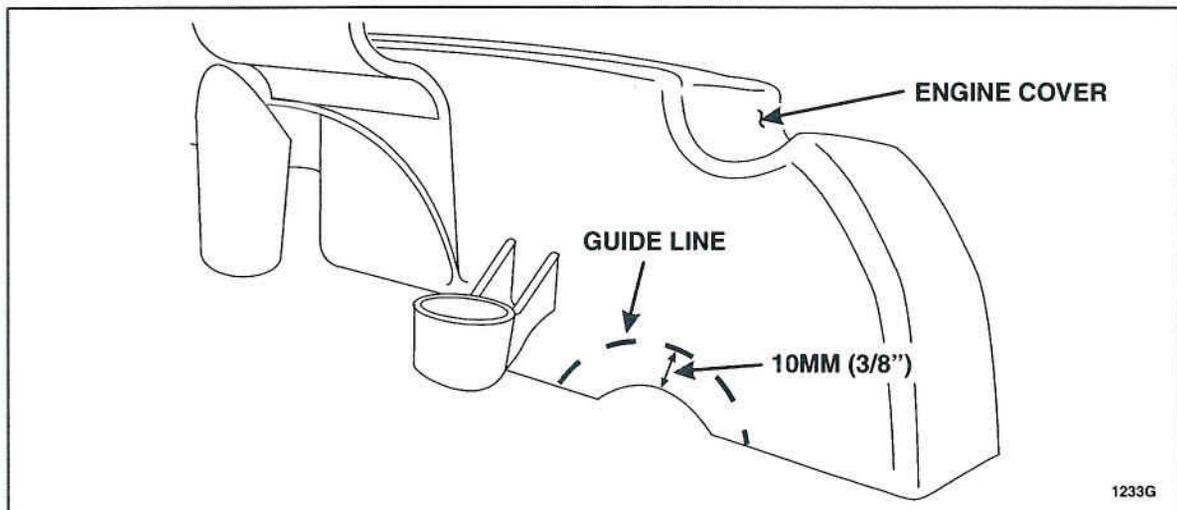
FIGURE 4

NOTE: The engine cover already has a relief to accommodate the drive belt tensioner. This relief needs to be trimmed to provide additional clearance.

4. Mark a guide line on the engine cover that is approximately 10mm (3/8") larger than the original opening. See Figure 4.
