Reference: NHTSA Identification Number 12V-391

Enclosure: Dealer and Owner Letter for Recall M25

# **Safety Recall M25 / NHTSA 12V-391 Occupant Restraint Control Module**

**2013 (WD) Dodge Durango**

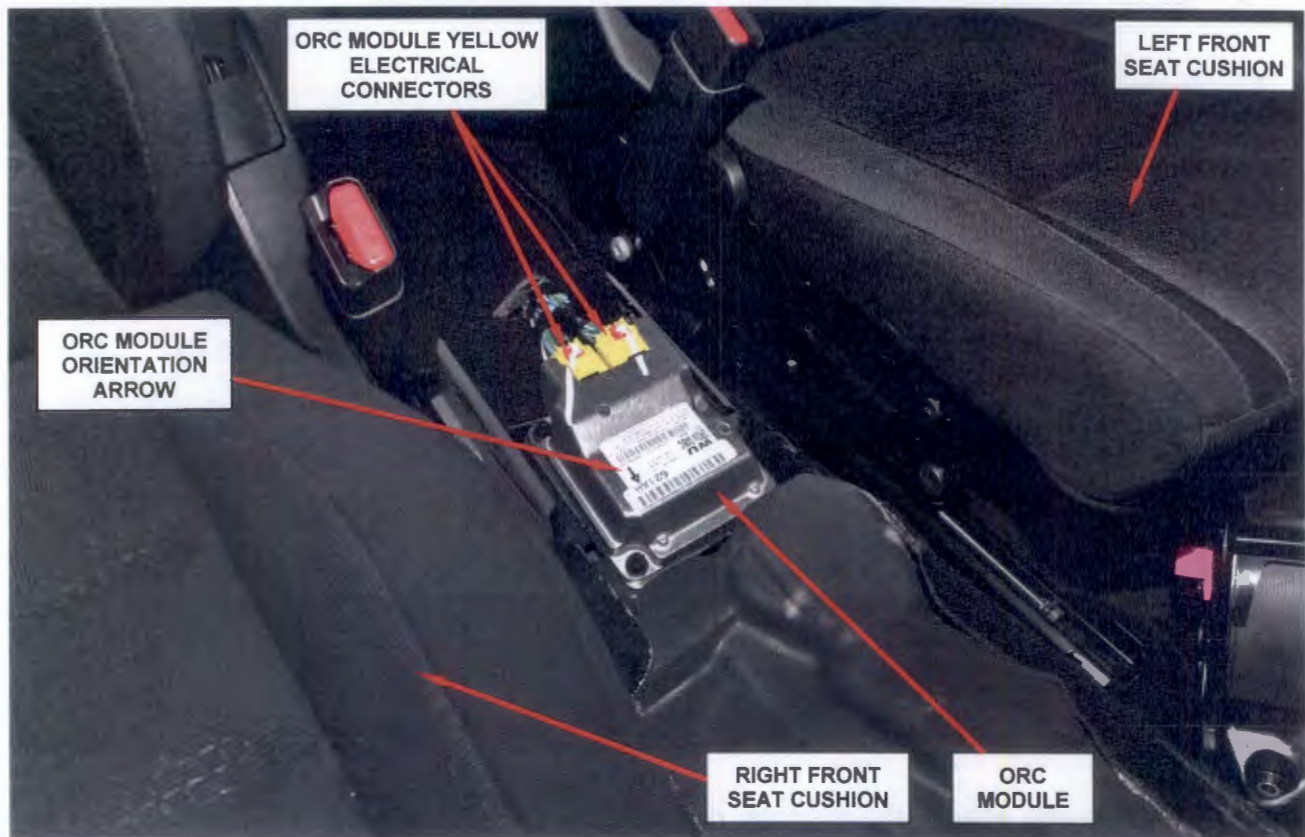
**Figure 9 – Occupant Restraint Control Module Location**

The Occupant Restraint Control (ORC) module on about 1,400 of the above vehicles may have reduced performance in the event of a side impact rearward of the second row seats. This could cause a third row seat passenger to have an increased risk of injury during certain crash conditions.

21. Disconnect the two Occupant Restraint Control (ORC) module yellow electrical connectors (Figure 9).
22. Remove and save the three ORC module retaining nuts (Figure 9).
23. Remove and discard the original ORC module.
24. Install the new ORC module into position. Tighten the three ORC module retaining nuts to 80 in. lbs. (9 N·m).

25. Connect the two yellow ORC module electrical connectors (Figure 9).
