Technical Bulletin

Section Title: Body, Cab and Accessories
 TSB No. TS 13 09212

- SUBJECT:** SAFETY RECALL CAMPAIGN “NU”; INOPERABLE LOW AND HIGH BEAM HEADLIGHT FUNCTION.
- MODEL(S):** FORENZA SEDAN/WAGON, RENO (RQ420)
- YEAR:** ALL 2004~2005 MY, AND CERTAIN 2006 MY THROUGH PRODUCTION DATE OF MARCH 27, 2006
- CONDITION:** Some vehicles may experience an intermittent or total loss of high/low beam headlight function.
- CAUSE:** Affected vehicles were produced with an instrument panel wire harness which included a splice pack (S201) that may have high resistance at the headlamp splice.
- CORRECTION:** Suzuki dealers are requested to remove the S201 splice pack and then re-join related wiring with the special crimp/solder style splice connectors (part # 99963-85ZSC).

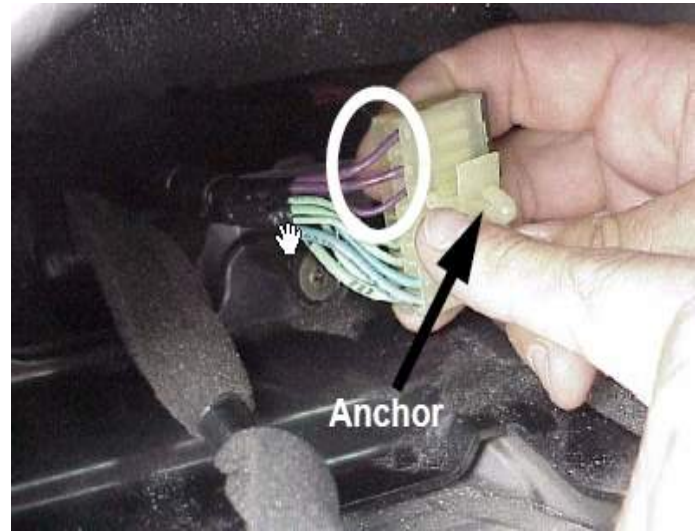
7. Pull the splice pack out from in between the A/C duct and dash support structure. Inspect the splice pack for the three violet wires shown. If they have been cut off, a repair attempt has been made. If the violet wires are showing signs of a poor repair (loose, improperly soldered, poorly crimped, burnt etc...) the violet wires will have to be included in this repair as follows beginning with step 8.

With the splice pack anchor facing you as shown, the three violet wires will be on top.

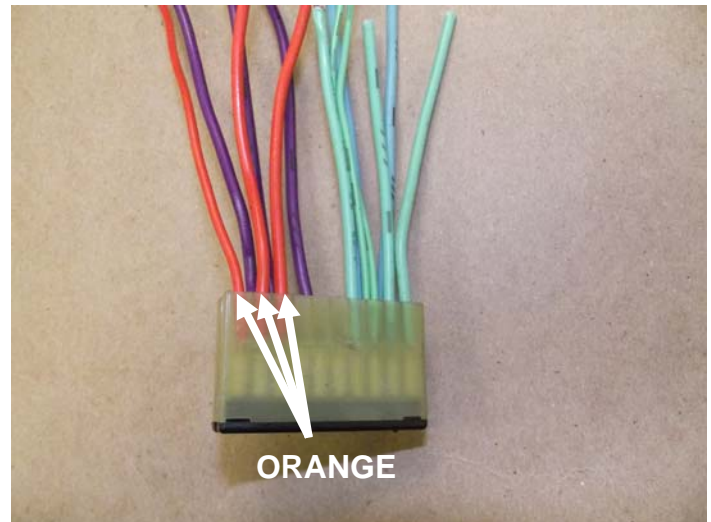
A small number of 2006 model year vehicles may include three (3) orange wires which must be included in the repair.
