1199 Panigale Safety Upgrades
Models: MY 2012 and MY 2013 Panigale (All Versions)
Recall Bulletin RCL-12-006

Date: Tuesday, August 7th, 2012
To: Dealer Principal, Service Manager, North American Dealer Network
From: Austin Gray, Technical Director; Jonathan LaForte, Technical Manager

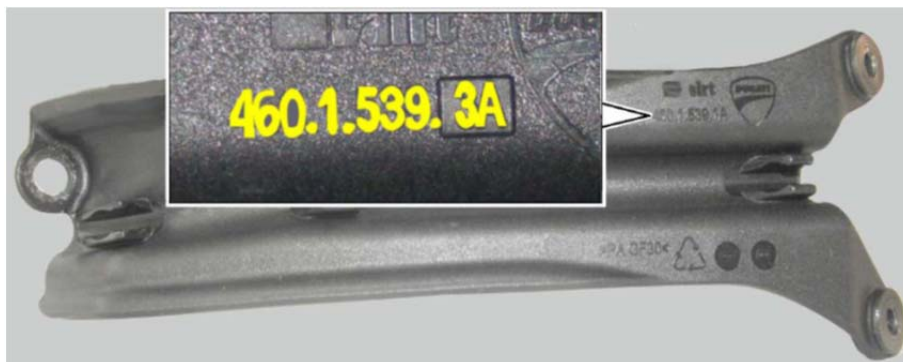
- A) **EXHAUST BUTTERFLY VALVE BOWDEN CABLE SUPPORT** (all versions): In some rare conditions of engine faulty operation (for instance when the bike is operated while running on one cylinder due to a fouled spark plug) it is possible that the excess heat built up in the catalytic converter can overheat the lower engine area. This could cause the exhaust butterfly valve Bowden cable support, installed to the oil sump, to melt or burn. This part must be replaced with the new one having a higher heat rating. During this procedure it is also required that the technician re-tighten the screws retaining the silencer central brackets. (Even if this has previously been performed during the OIL SERVICE 1000 pursuant to Tips&Tricks no. 54).

Instructions for replacing part no. 46015393A (All versions) Ref. no. 1 Page 4.

7) Remove the *exhaust butterfly valve Bowden cable support (A)*, by loosening the *bottom screw (7)* and the *two top nuts (8)*, keeping the four *spacers (9)*.

- 9) Install the new *exhaust butterfly valve Bowden cable support (B)* part no. 46015393A and engage the cable inside the *three clips (C)*.

- 10) Fit the new exhaust butterfly valve Bowden cable support (B) part no.46015393A and tighten the **bottom screw (7)** to **$5\text{ Nm} \pm 10\%$** after applying **LOCTITE 222**, then tighten the **two top nuts (8)** to **$6\text{ Nm} \pm 10\%$** .

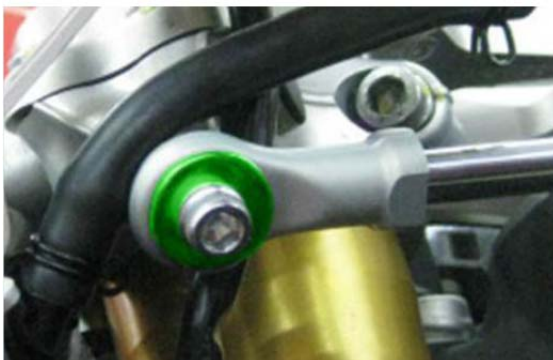
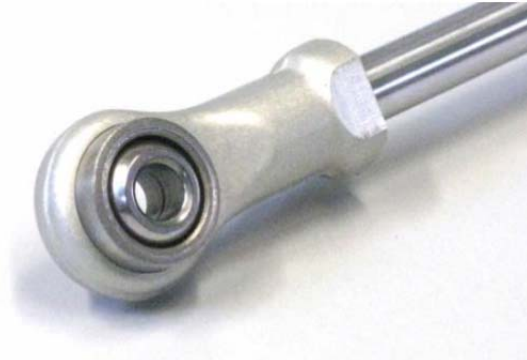
- B) **OHLINS STEERING DAMPER HEAD UNIBALL BEARING** ("S" and "S Tricolore" versions only): It is possible that due to incorrect assembly tolerance, the mentioned uniball bearing could slip out of its seat on the Ohlins steering damper. It is necessary to install a special washer on its mounting point to prevent this problem.

Instructions in Section C for installing the washer P.6.4X18X1.6 ISO7093 ("S" and "S Tricolore" versions only) Ref. no. 2 Page 4.

Washer (20) must be installed only on S versions, i.e., where an Ohlins steering damper is fitted. The washer must NOT be installed on BASE versions equipped with SACHS steering damper.

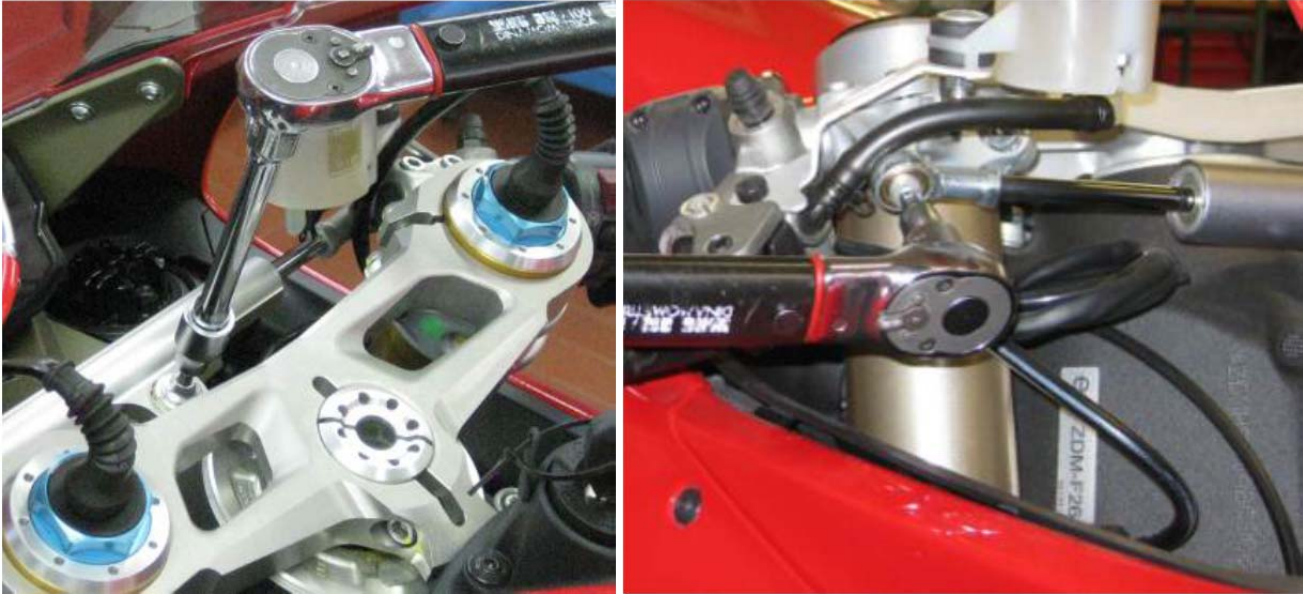
- C) **STEERING DAMPER RETAINING SCREWS** (all versions): The two steering damper retaining screws might loosen from their original tightening torque. It is necessary to re-tighten the screws and properly apply the specified threadlocker.

- 1) Remove the **central screw (17)** retaining the steering damper to the frame, remove any trace of threadlocker and thoroughly degrease the surface.
- 2) Tighten the **screw (17)** with **LOCTITE 222** to **10 Nm \pm 10%**.

- 3) Remove the **screw (18)** retaining the **steering damper (19)** to the right-hand handlebar, remove any trace of threadlocker and thoroughly degrease the surface.
- 4) Start the **screw (18)** with **washer (20)** in-between.

5) Tighten the **screw (18)** with **LOCTITE 222** to **10 Nm \pm 10%**.

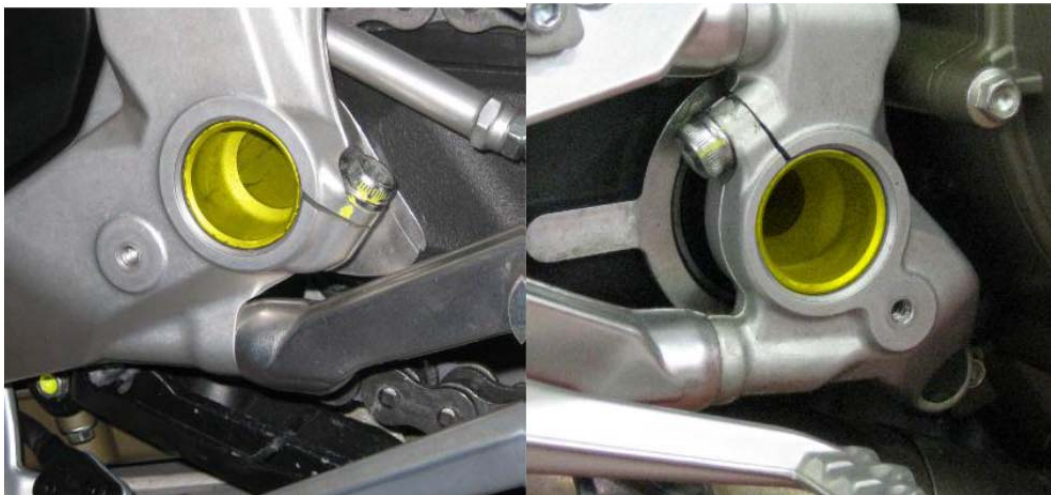
- D) **SWING-ARM SHAFTS** (all versions): It is necessary to re-tighten again the right-hand and left-hand shafts fastening the swinging arm to the engine since they might not be tightened correctly.

- 1) Loosen the **screw (21)** from clamp on RIGHT-hand swinging arm shaft.
- 2) Loosen the **RIGHT-hand swinging arm shaft (22)** by 180° without removing it.
- 3) Tighten **RIGHT-hand swinging arm shaft (22)** to **100 Nm ± 10%**.
- 4) Tighten clamp **screw (21)** to **8 Nm ± 5%**.

- 5) Slacken the **screw (23)** from clamp on LEFT-hand swinging arm shaft.
- 6) Loosen the **LEFT-hand swinging arm shaft (24)** by 180° without removing it.
- 7) Tighten **LEFT-hand swinging arm shaft (24)** to **100 Nm ± 10%**.
- 8) Tighten clamp **screw (23)** to **8 Nm ± 5%**.

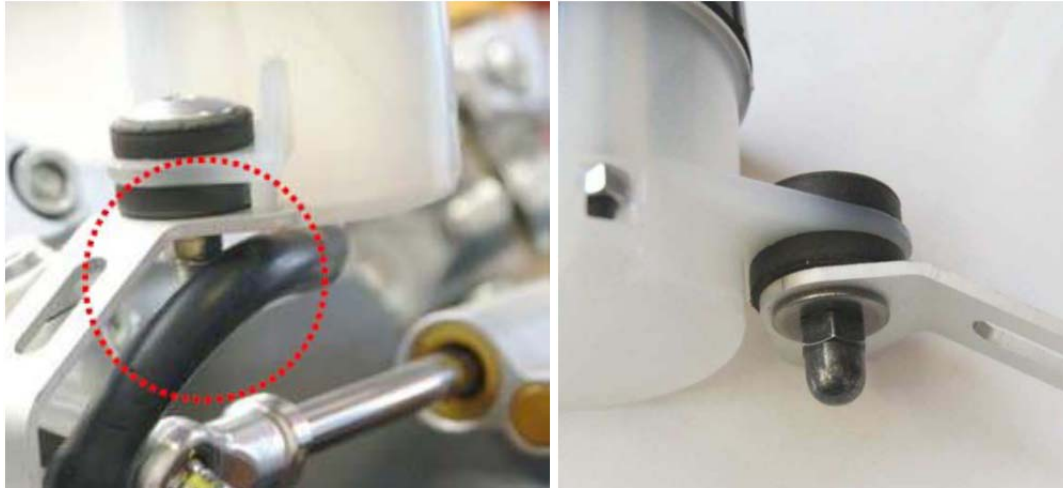
- E) ***FRONT BRAKE MASTER CYLINDER FLUID RESERVOIR CONNECTION TUBE*** (all versions): The front brake master cylinder fluid reservoir connection tube might interfere with the threading end of the reservoir retaining screw. In order to avoid this potential damage it is necessary to install a nut and washer.

Instructions for replacing *Cap nut M5 DIN1587-KL6 Galvanized black (Ref. no. 3 Page 4)* and add a *washer P.5X15X1.5 UNI6593SS (All versions) Ref. no. 4 Page 4.*

- 2) Start the new **cap nut (27)** and add the **washer (28)**. Tighten the **cap nut (27)** with **LOCTITE 222** to **5 Nm \pm 10%**.
