Recall Bulletin

F/CMVSS NONCOMPLIANCE RECALL

SUBJECT: Windshield Washer Hose May Separate

MODELS: 2012 Chevrolet Sonic

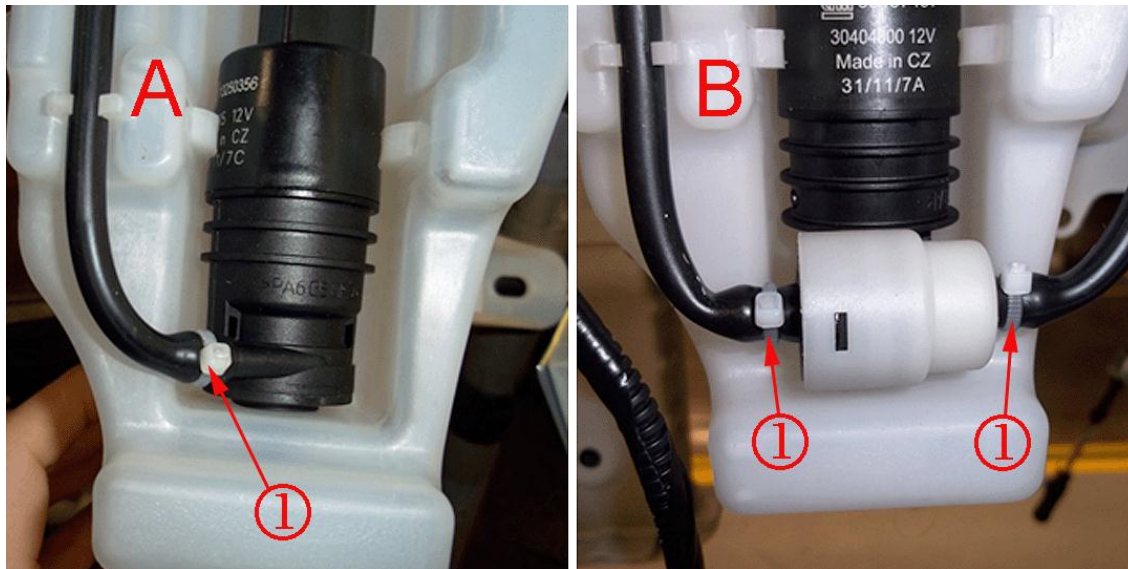
2896898

(A) Windshield Washer Bottle with One Front Hose. (B) Windshield Washer Bottle with Front and Rear Hoses.

There are two different windshield washer bottle designs. Sedan vehicles (A) have a windshield washer bottle pump with one front hose. Hatchback vehicles (B) have a windshield washer bottle pump with a front and rear hose. The procedure in this bulletin includes instructions on where to install three (3) band ties on the one front hose design windshield washer bottle. In addition, the procedure in this bulletin provides instructions on where to install six (6) band ties on the front and rear hose design windshield washer bottle.

4. **“A” Sedan Vehicles:** Inspect the windshield washer bottle at the pump to determine if a band tie (1) is installed on the front hose of the pump. If a band tie (1) is not installed, install one as shown in the “A” portion of the illustration.

“B” Hatchback Vehicles: Inspect the windshield washer bottle at the pump to determine if two band ties (1) are installed on the front and rear hoses of the pump. If band ties (1) are not installed, install two band ties (1) as shown in the “B” portion of the illustration.

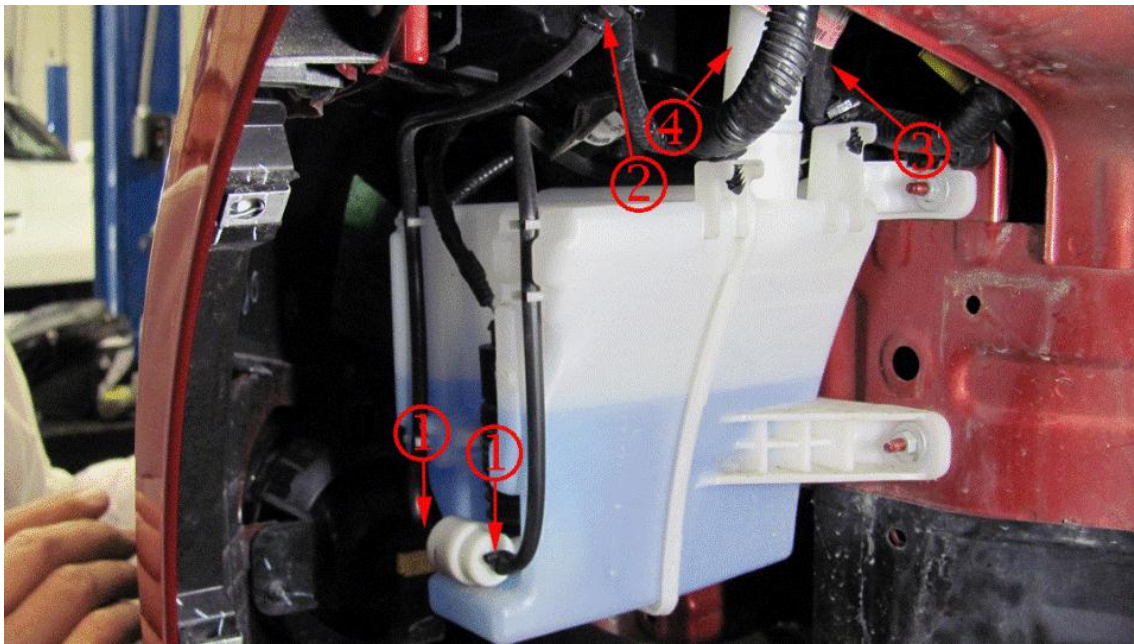
2896902

Front and rear hose windshield washer bottle design shown, front hose windshield washer bottle design is similar. (1) Pump Location (2) Front Hose Connection (3) Rear Hose Connection.

5. Install band ties at the following locations of the windshield washer bottle hoses:
 - **Sedan Vehicles:** Install 1 band tie at the pump location (1), if required, and 2 band ties at the front hose connection (2).
 - **Hatchback Vehicles:** Install 2 band ties at the pump location (1), if required, 2 band ties at the front hose connection (2) and 2 band ties at the rear hose connection (3). The windshield washer bottle neck (4) will have to be removed to gain access to the rear hose connection. Re-install the windshield washer bottle neck after installing the band ties at the rear hose connection.
6. Install the front wheelhouse liner inner front extension. Refer to *Front Wheelhouse Liner Inner Front Extension Replacement* in SI.
7. Install the front driver side (left) tire and wheel assembly. Refer to *Tire and Wheel Removal and Installation* in SI.
8. Lower the vehicle.
