Bulletin No. R84001

**To:** CODA Service and Warranty**Subject:** CODA Model Year 2012  
Verification and Correction of Roof Mounted Side Curtain Airbag Installation**Revision:** Initial Release**Summary:** This Recall Campaign Bulletin describes the necessary steps for verification of proper installation of the side curtain airbags.**Purpose:** Inspect vehicles to confirm proper installation of both side curtain airbags and perform repair if inspection results reveal improper installation.

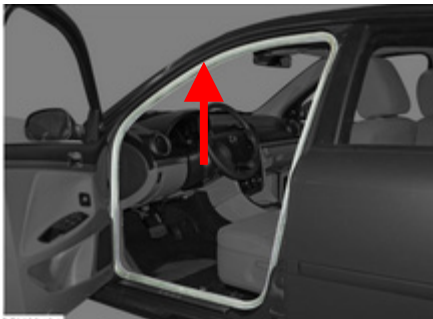
- Verify correct installation at both front doors at foremost point of header, near the A-pillar as indicated by arrow.

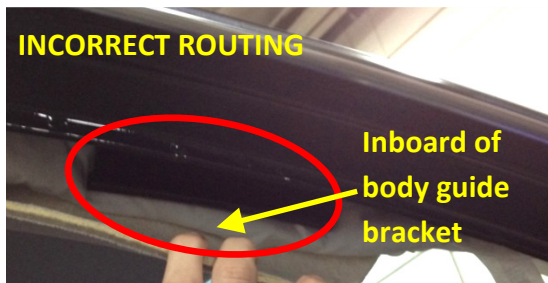
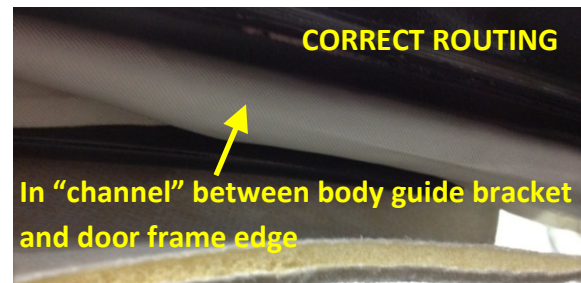
Curtain airbag must be situated in the "channel" between the door frame edge and the body guide bracket.

- If found to be installed inboard of the bracket, photograph the area and contact CODA TAC prior to continuing with repair. ***CODA TAC can be reached at 888-718-5046.***

8. For a side curtain airbag that is found to be installed inboard of the body guide bracket, detach the tether at bottom of A-pillar and gently route the curtain airbag between the guide and the door frame edge and then re-attach the tether (torque 9 Nm / 7 lb-ft).
9. Obtain a clear view of the side curtain airbag and confirm proper installation along the entire length of the curtain airbag.

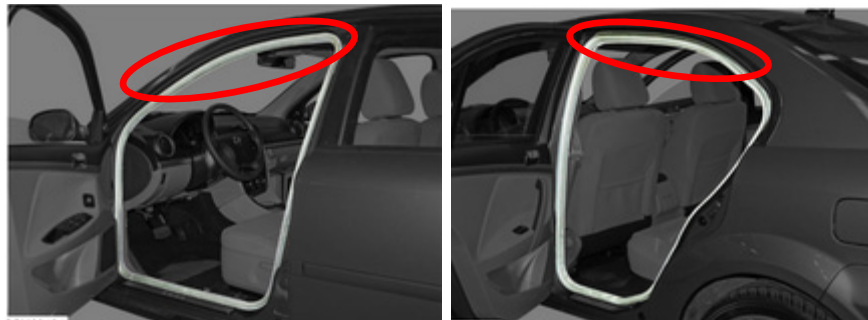
10. Inspect areas indicated below by following the seam to make sure that it runs continuously along the bottom edge of the airbag assembly.

11. If the installation is confirmed to be OK by verifying side curtain airbag seam, reassemble the vehicle and ensure proper fit of all panels and seals.
12. If the side curtain airbag seam is found to be improperly installed, proceed to remove headliner by following service manual section 82 and 84 (FTR No. 82501002).
  - a. Removal of B-pillar lower and upper trim
  - b. Removal of upper and lower seat belt mounting
  - c. Removal of C-pillar trim
  - d. Removal of inner rocker trim
  - e. Removal of rear center high mounted stop lamp
  - f. Removal of sunglasses holder assembly
  - g. Removal of rear parcel shelf
  - h. Removal of side rear seat bolsters
  - i. Removal of rear seat bottom cushion
