# Recall Bulletin 120813FRV

**PRODUCT(S) AFFECTED:**  
Excursion

**MODEL(S) AFFECTED:**  
33 A

**SUBJECT:**  
Diesel Fuel Intake Line Clearance

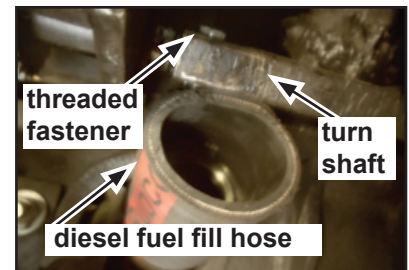
On motor homes affected by this recall, a threaded fastener installed on the turn shaft of the slide-out mechanism may come into contact with a portion of the diesel fuel fill hose while the turn shaft is rotating. If the fastener makes contact with the fuel fill hose, there is a possibility that it will abrade the fuel fill hose and cause a leak. Leaking fuel, in the presence of an ignition source, may lead to a fire.

Follow the steps below to inspect the diesel fuel fill hose, and if necessary, make modifications to eliminate interference between the shaft's threaded fastener and the diesel fuel intake line. Refer to Figure 1 for an example of a fuel line requiring correction.

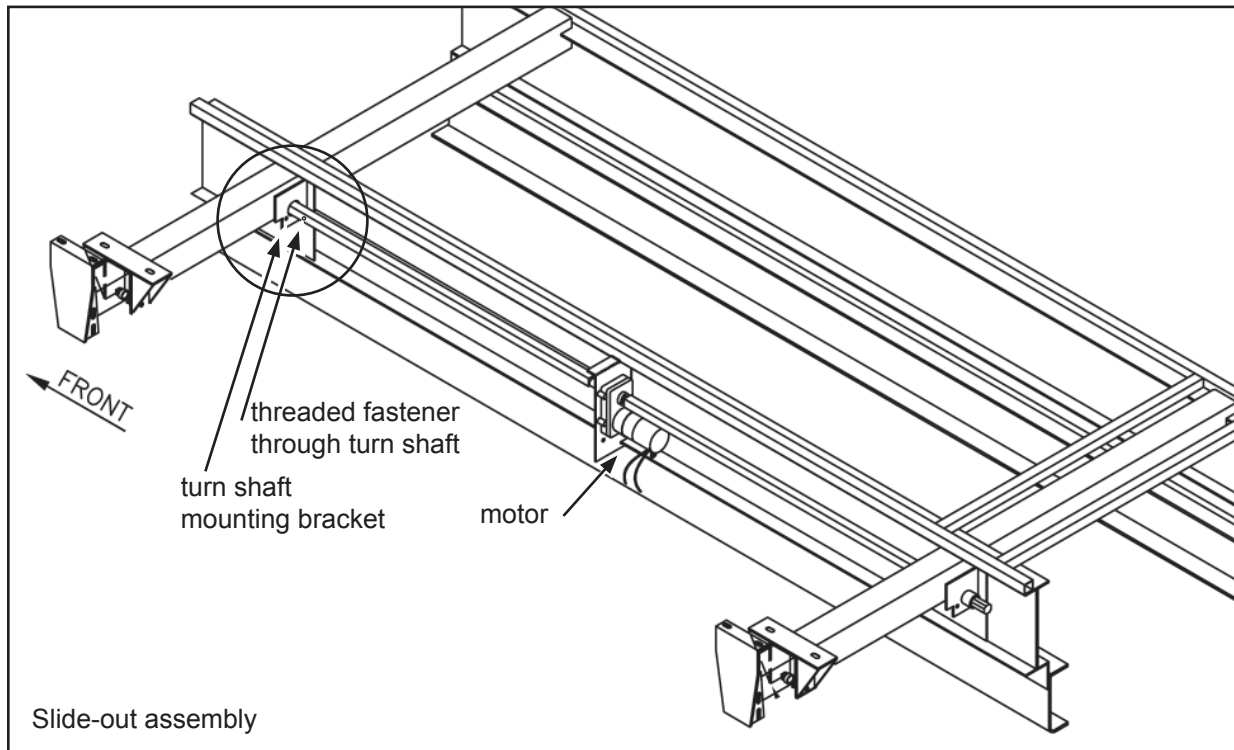
3. Have an assistant bump the control for the slide-out room, extending it just enough that the turn shaft rotates a full 360°. From under the motor home, observe the turn shaft as it rotates, inspecting for any interference between the shaft's threaded fastener and the diesel fuel intake line. Refer to the circled area in the diagram in Figure 2 for the approximate location of the fastener.

- If the threaded fastener does not make any contact with the diesel fuel intake line, no further action is required.
  - If the threaded fastener contacts any portion of the diesel fuel intake line, determine whether or not the threaded end of the fastener can be shortened to eliminate contact with the fuel line.

- Proceed to Step 4 if the threaded fastener can be shortened to eliminate contact with the fuel fill line.
    - If damage to the diesel fuel intake line is found, or if shortening the fastener will not eliminate contact with the fuel line, contact Fleetwood RV Dealer Technical Support for further instructions and Prior Authorization to perform additional or alternate repairs.

4. Use a cut-off wheel or Dremel tool to cut off the threads of the fastener that extend past the nut. **Do not cut or damage the nut.**
5. Inspect the shaft again as the assistant operates the room.
