# SAFETY RECALL

**NUMBER: 520120016.01**

**MODEL: Karma**

**TITLE: Low Temperature Cooling Fan Voluntary Safety Recall**

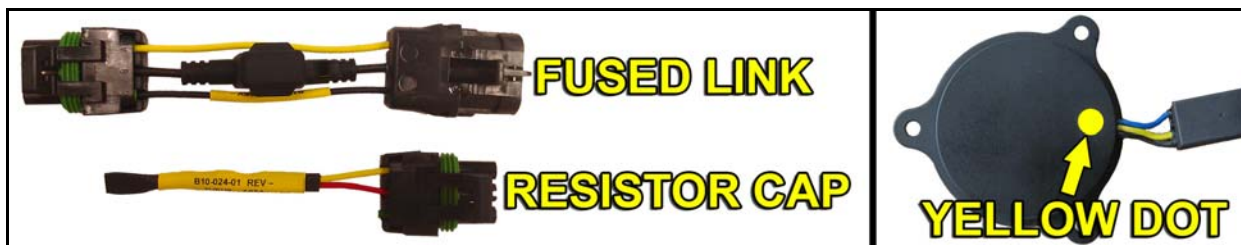
Figure 0B.

Any LT cooling fan motor in retailer inventory without a yellow dot (Figure 0B) cannot be sold or installed.

– If yellow dot exists on right-hand low temperature cooling fan motor (shown in Figure 0B), leave fan in place and continue on to step 3.6.
