Safety Recall Trucks

Date	Group.	No.	Page
11.12	SC0365		1(9)

Forward Lighting Operation
CHU, CXU

SAFETY RECALL INFORMATION:

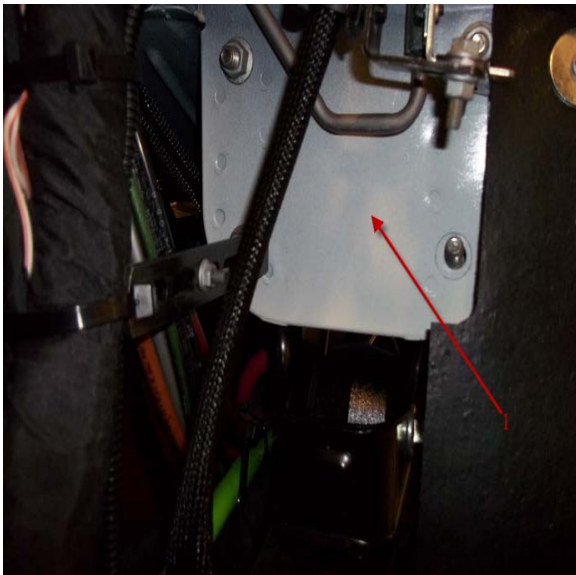
(1) Bulkhead location for bracket.

1. Remove the grill from the hood.
2. Install the relay mounting bracket at the location shown in the following illustrations; bulkhead location for bracket (1). Torque the M8 fasteners to 30 +/- 5 Nm (22 +/- 3.7 ft-lb). Torque Cab knee nut to 68 +/- 6 Nm (50 +/- 0.5 ft-lb).

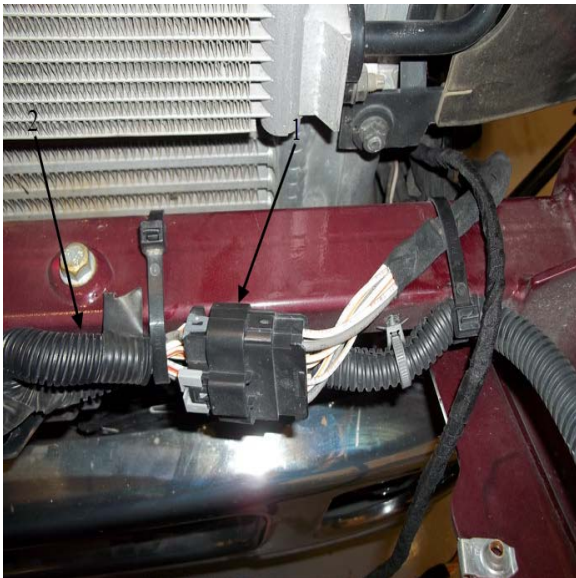
Original Harness Connection

1. Front Chassis Harness Connection
2. Hood Harness Connection

6. *** This step applies to MACK CXU vehicles only.
 - A. On the horizontal crossbar, connect the overlay harness to the head light harness connector. Secure the connector and harness with cable ties.
 - B. Remove the p-clip and bolt securing the hood harness from the vertical portion of the hood (stand-off bracket).
 - C. Route the hood harness under the stand-off bracket, overlay harness and connector above the stand-off bracket. Secure the connector and harness with cable ties.

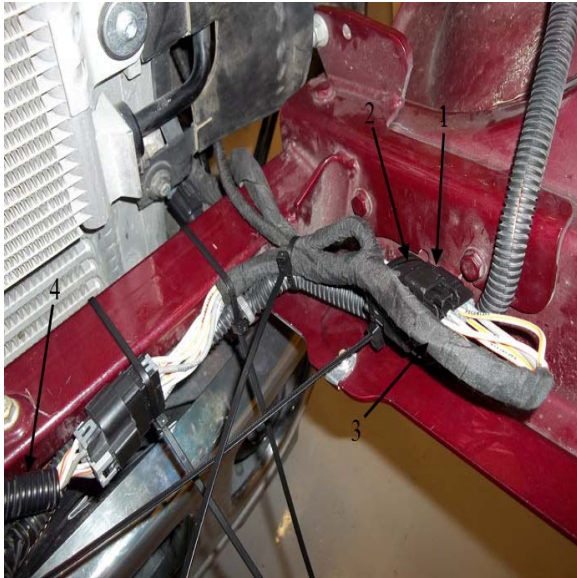
Retrofitted Harness Connection

- 1. P-Clip Removed
- 2. Front Chassis Harness Connection
- 3. Overlay Harness (Part Number 22012391)
- 4. Hood Harness Connection
