PREVOST

**SAFETY
RECALL**

Sr12-29

DATE : SEPTEMBER 2012	SECTION : 23-ACCESSORIES
SUBJECT : AUTOMATIC FIRE DETECTION AND SUPPRESSION SYSTEM (AFSS) – PROTECTION OF LINEAR THERMAL DETECTOR (LTD)

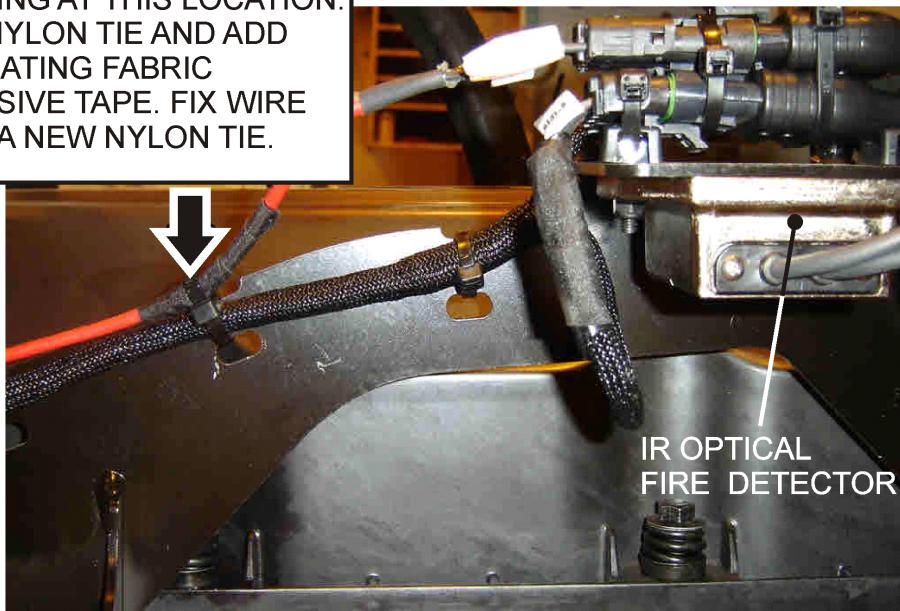
At only one location, the protective insulating fabric tape might be too short or improperly placed on the LTD (red cable) to prevent rubbing against the nylon tie.

PROTECT LINEAR THERMAL DETECTOR SHEATH FROM RUBBING AT THIS LOCATION. CUT NYLON TIE AND ADD INSULATING FABRIC ADHESIVE TAPE. FIX WIRE WITH A NEW NYLON TIE.

2. Cut and remove the existing nylon tie. Add enough fabric tape to protect LTD (red cable) from rubbing against the nylon tie. Fix LTD cable at the same location using included nylon tie.

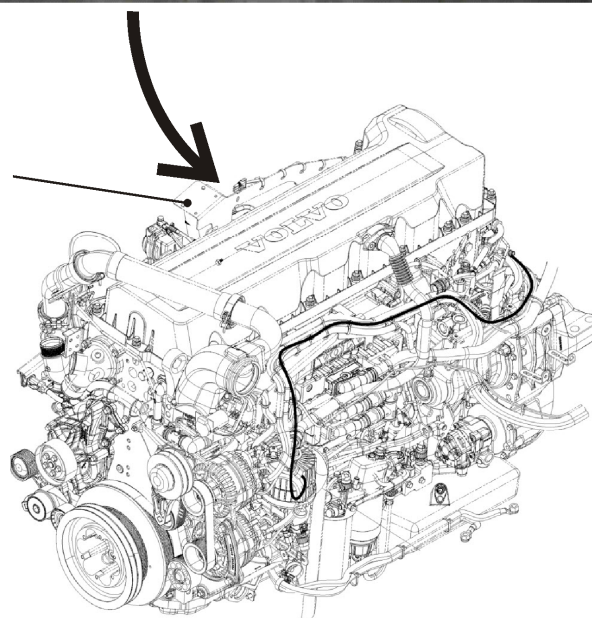
IR OPTICAL
FIRE DETECTOR
LOCATION

1. There is only one location where the protective fabric tape might be too short or improperly located. Check the engine turbocompressor side near the optical infrared (IR) fire detector (see image above).
