Recall Bulletin

PRODUCT SAFETY RECALL

SUBJECT: Shift Lever Indicator May Not Display Correct Gear

MODELS: 2008-2010 Chevrolet Malibu
2008-2010 Pontiac G6
2007-2010 Saturn AURA
Equipped with 4-Speed Automatic Transmission (ME7/MN5)

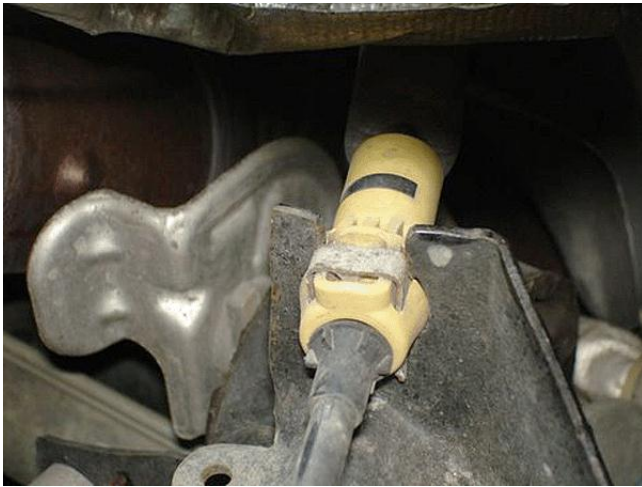
3256032

Note: Perform the service repair procedure in this bulletin on second design transmission shift cables only. First design transmission shift cables do NOT require a repair. Refer to the illustration to view a first design shift cable. Refer to *Transmission Shift Cable Kit Installation Procedure* in this bulletin to view the second design transmission shift cable.

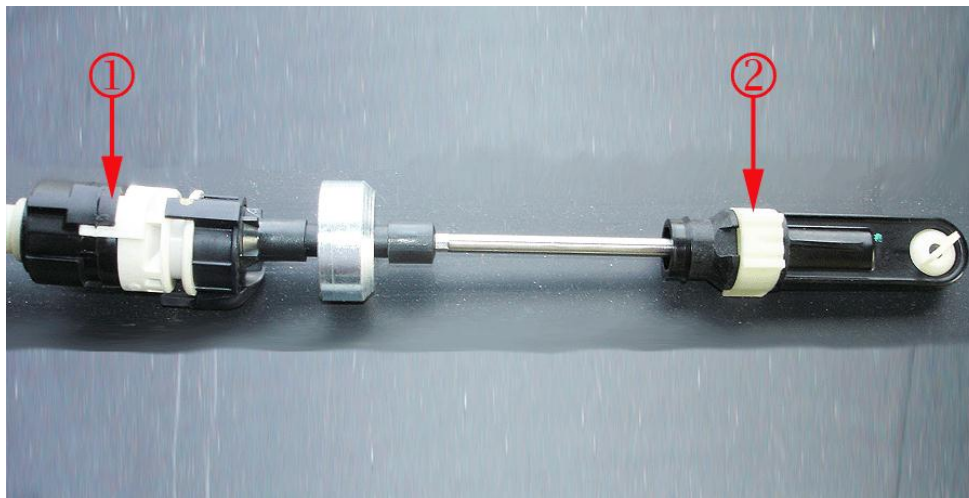
2269489

- (1) Shift Cable Locking Tabs
- (2) Shift Cable Adjuster Locking Clip

1. Open the hood and locate the transmission shift cable.
2. Determine if the transmission shift cable locking tabs are fractured and separated.

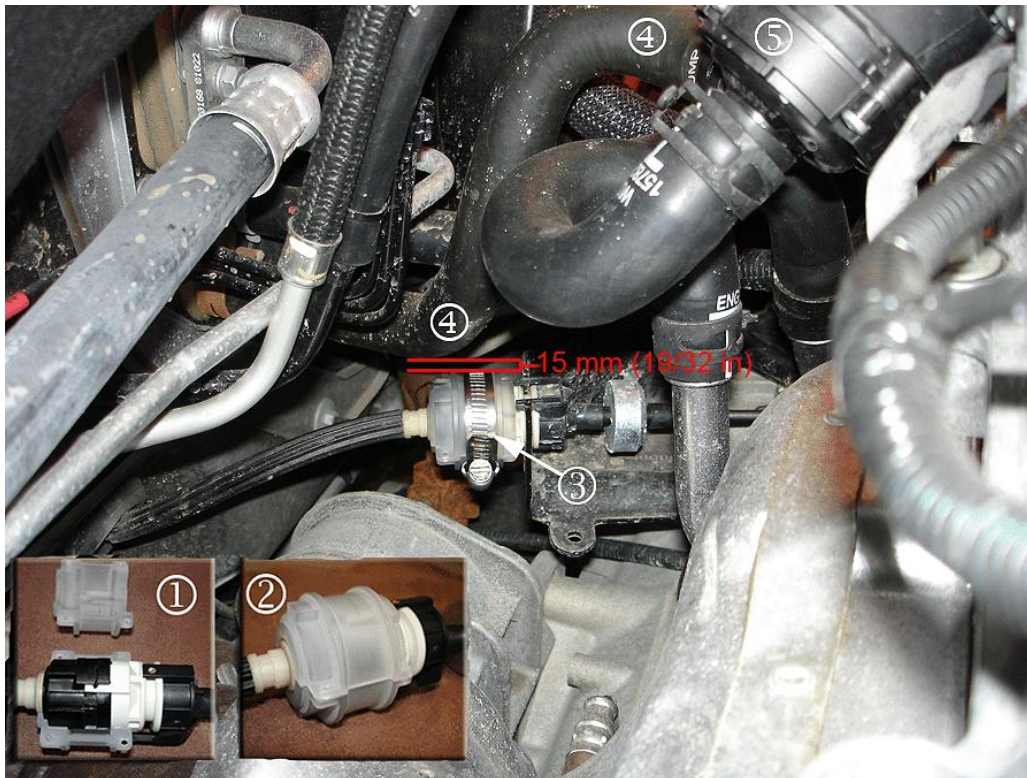
2269484

- (1) Clam Shell in Two Pieces
- (2) Clam Shell Around Shift Cable Locking Tabs
- (3) Clamp on Clam Shell
- (4) Inlet Coolant Hose and
- (5) Heater Cooler Pump.

3. Install the clam shell (1) (2) over the shifter cable locking tabs.

4. Install the service clamp over the clam shell (3). Position the clamp fastener head away from the inlet coolant hose (4). **Tighten the clamp to 4 N·m (35 lb-in).**
5. Ensure that there is 15 mm (19/32 in) of clearance between the inlet coolant hose (4) and the clam shell (3). On hybrid equipped vehicles, it may be necessary to reposition the inlet coolant hose (4) to achieve the required 15 mm (19/32 in) of clearance. **To reposition the inlet coolant hose (4) on hybrid equipped vehicles, locate the heater cooler pump (5) and perform Steps 5.1-5.4.**

Caution: Do not kink or damage the inlet coolant hose (4) when repositioning the hose to obtain the 15 mm (19/32 in) clearance. To avoid damaging the hose clamp, use J-38185 or equivalent hose clamp pliers to loosen the hose clamp.

- 5.1. Using J-38185 or equivalent hose clamp pliers, loosen the inlet coolant hose (4) connected to the heater cooler pump (5). Note the location of the clamp on the inlet coolant hose (4).
 - 5.2. Rotate the inlet coolant hose (4) clockwise until 15 mm (19/32 in) of clearance between the inlet coolant hose (4) and clam shell (3) is achieved.
 - 5.3. Ensure that the inlet coolant hose clamp is secure on the inlet coolant hose (4) in the production location.
 - 5.4. Install the generator control module cover. Refer to *Generator Control Module Cover Replacement* in SI.
6. Close the hood.
