# Recall Bulletin

## PRODUCT SAFETY RECALL

**SUBJECT:** Shift Lever Indicator May Not Display Correct Gear

**MODELS:** 2008-2010 Chevrolet Malibu  
2008-2010 Pontiac G6  
2007-2010 Saturn AURA  
Equipped with 4-Speed Automatic Transmission (ME7/MN5)

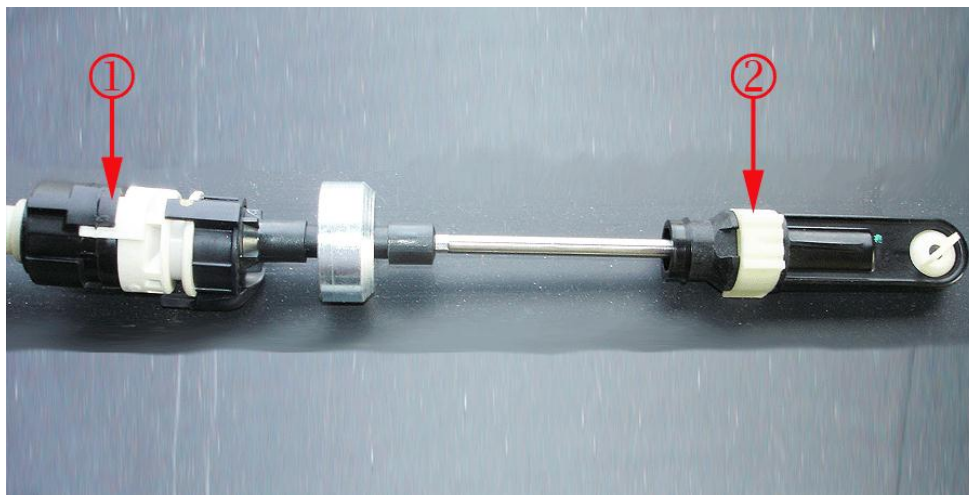
2269489

- (1) Shift Cable Locking Tabs
- (2) Shift Cable Adjuster Locking Clip

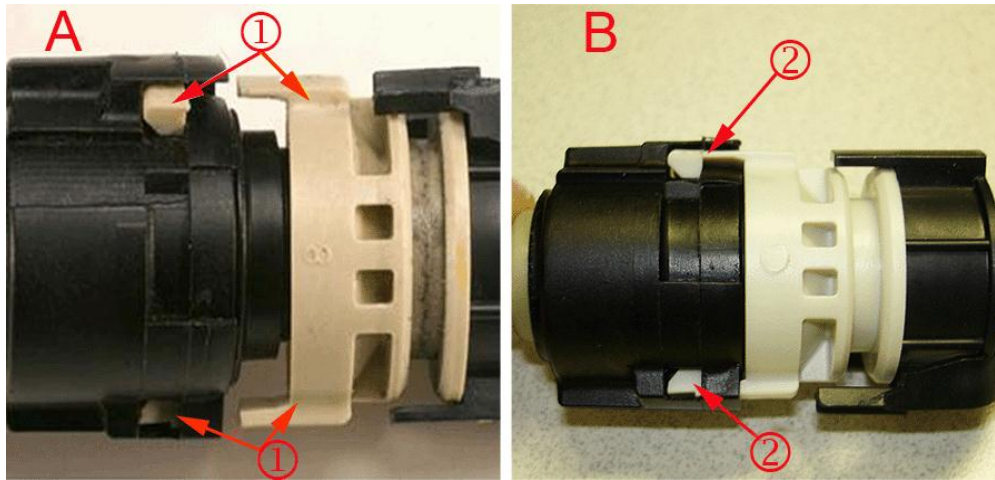
2269486

2. Determine if the transmission shift cable locking tabs are fractured and separated.

- If the transmission shift cable locking tabs (1) are fractured and separated (A), remove the transmission shift cable and replace it with a new one. Refer to *Floor Shift Control Cable Replacement or Range Selector Lever Cable Replacement* in SI. **Also install a transmission shift cable kit with the new shift cable.**
- If the transmission shift cable locking tabs (2) are NOT fractured and separated (B), install the transmission shift cable kit. Proceed to Step 3.

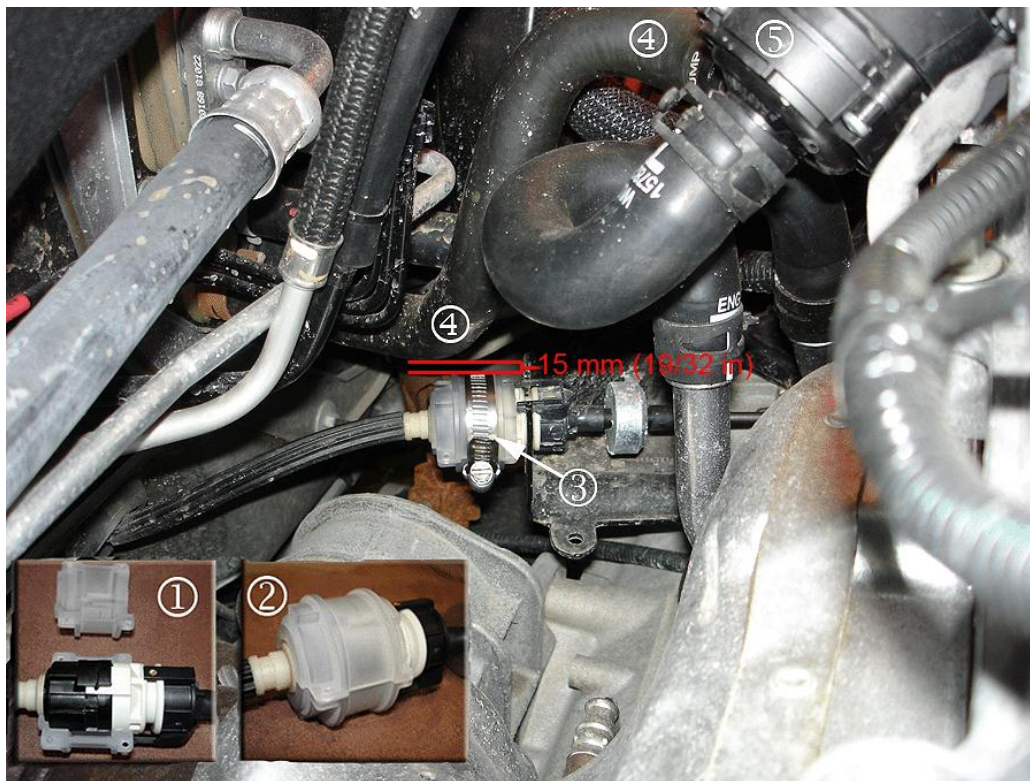
2269484

- (1) Clam Shell in Two Pieces
- (2) Clam Shell Around Shift Cable Locking Tabs
- (3) Clamp on Clam Shell
- (4) Inlet Coolant Hose and
- (5) Heater Cooler Pump.

3. Install the clam shell (1) (2) over the shifter cable locking tabs.
4. Install the service clamp over the clam shell (3). Position the clamp fastener head away from the inlet coolant hose (4). **Tighten the clamp to 4 N·m (35 lb-in).**
5. Ensure that there is 15 mm (19/32 in) of clearance between the inlet coolant hose (4) and the clam shell (3). On hybrid equipped vehicles, it may be necessary to reposition the inlet coolant hose (4) to achieve the required 15 mm (19/32 in) of clearance. **To reposition the inlet coolant hose (4) on hybrid equipped vehicles, locate the heater cooler pump (5) and perform Steps 5.1-5.4.**

**Caution: Do not kink or damage the inlet coolant hose (4) when repositioning the hose to obtain the 15 mm (19/32 in) clearance. To avoid damaging the hose clamp, use J-38185 or equivalent hose clamp pliers to loosen the hose clamp.**

- 5.1. Using J-38185 or equivalent hose clamp pliers, loosen the inlet coolant hose (4) connected to the heater cooler pump (5). Note the location of the clamp on the inlet coolant hose (4).
  - 5.2. Rotate the inlet coolant hose (4) clockwise until 15 mm (19/32 in) of clearance between the inlet coolant hose (4) and clam shell (3) is achieved.
  - 5.3. Ensure that the inlet coolant hose clamp is secure on the inlet coolant hose (4) in the production location.
  - 5.4. Install the generator control module cover. Refer to *Generator Control Module Cover Replacement* in SI.
6. Close the hood.
