Campaign No. 2012100001, November 2014

SUBJECT: **Model 231, Model Year 2013**
Replace Refrigerant R1234yf with Refrigerant R134a

Urgent Safety Recall # 2012100001
Replace Climate Control System Refrigerant
NHTSA Recall # 12V-478

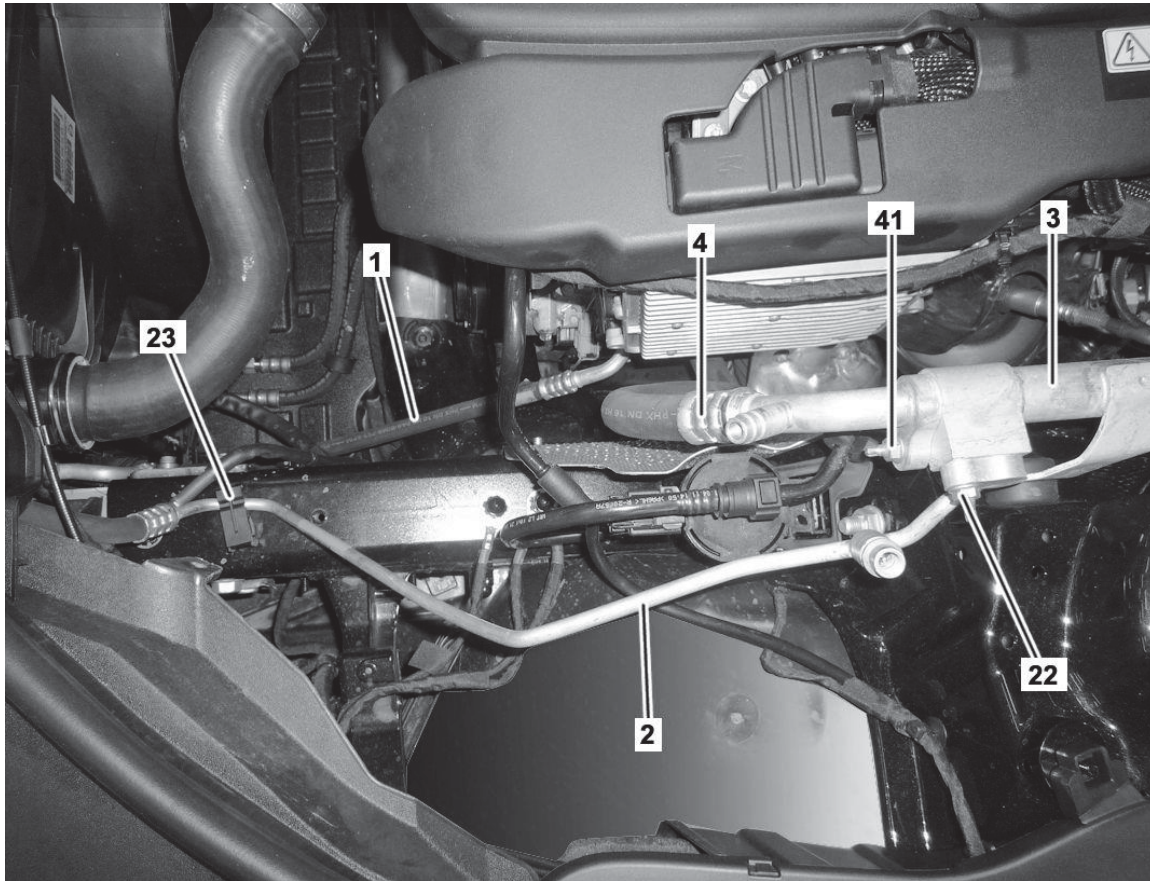
Figure 1

1	High pressure refrigerant line	22	Nut
2	Condenser refrigerant line	23	Condenser refrigerant line mounting clip
3	Low pressure refrigerant line (to evaporator).	41	Nut
4	Low pressure refrigerant line (to compressor).

- Remove nut (41, Figure 1).
 - Torque nut (41) to 8 Nm when installing.
- Disconnect refrigerant line (4, Figure 1) from refrigerant line (3).
- Remove nut (22, Figure 1).
 - Torque nut (22) to 8 Nm when installing
- Disconnect condenser refrigerant line (2, Figure 1) from mounting clip (23).
- Disconnect condenser refrigerant line (2, Figure 1) from refrigerant line (3).

17. Assemble in reverse order.
18. Recharge air conditioning **with R134a** refrigerant **ONLY** and include 40 cc of refrigerant oil. Refer to WIS: AR83.30-P-1760NKB.
19. Replace information label for R-1234yf air conditioning filling capacity on radiator cross-member with **new R-134a** label (H, Figure 3).
20. Install new caps on A/C service valves of new refrigerant lines (2, 4, Figure 1).

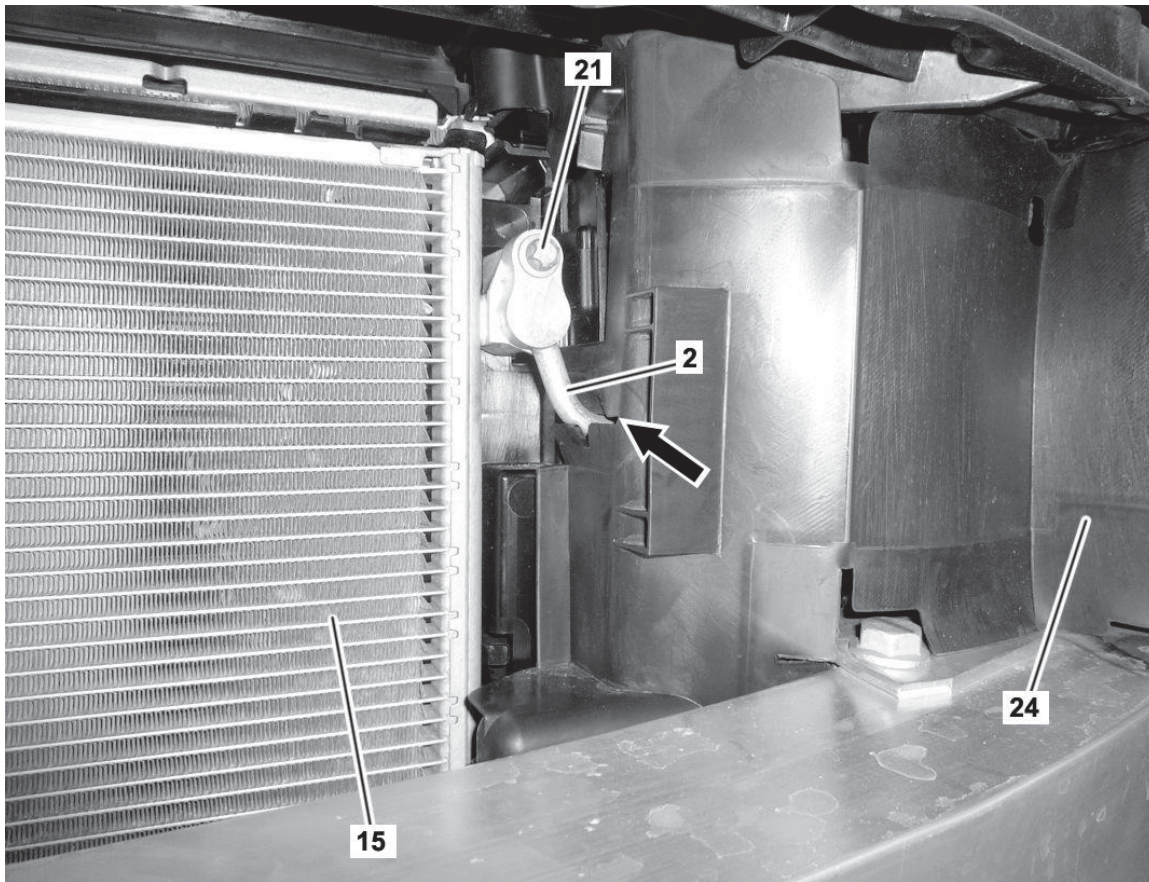
Figure 7 (shown from front of vehicle, behind radiator grill)

- 2 Condenser refrigerant line
 - 15 Condenser
 - 21 Condenser refrigerant line bolt
 - 24 Radiator side shroud
- Arrow: Opening for refrigerant line

14. Carefully pull radiator assembly (A, Figure 6) in direction of arrows (Figure 6) then remove condenser refrigerant line bolt (B)
15. Route condenser refrigerant line (C, Figure 6) out through opening (arrow, Figure 7) in radiator side shroud (24, Figure 7) and remove from engine compartment.
