**Re: 49 CFR Part 573; Recall of Mercedes-Benz CLS**

TO: Mercedes-Benz Dealer Principals, General Managers, Sales Managers, Service Managers, Parts Managers	FROM: Thomas Brunner, Department Manager, Vehicle Compliance and Analysis, Engineering Services
RE: : Recall Campaign 2012110003 – <b>Retorque the Engine Hood Latch Striker, Model 218 (CLS), Model Year 2012</b>	DATE: November 21, 2012

Campaign No. 2012110003, November 2012

SUBJECT: **Model 218**  
**Model Year 2012**  
**Retorque the Engine Hood Latch Striker**

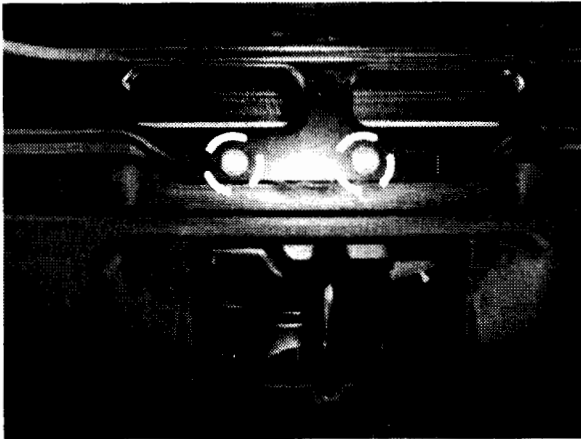
**Figure 3**

This Recall Campaign has been initiated because Daimler AG (DAG), the manufacturer of Mercedes-Benz vehicles, has determined that due to incorrect technical documentation, the bolts securing the striker for the engine hood latch might have been tightened with reduced torque in the subject vehicles. The engine hood is secured with one lock on the left side and one lock on the right side. If only one of these locks is engaged, the engine hood will remain safely secured. If the engine hood is not properly closed and both locks are not engaged, an additional securing mechanism is provided by the engine hood latch. The driver is made aware of this condition by a warning message in the instrument cluster indicating the engine hood is not properly closed. If the driver were to disregard this warning message and if at least two bolts of the striker for the engine hood latch are loose, the engine hood has no securing mechanism and could open while driving, thus increasing the risk of a crash.

3. Retorque 4 bolts (Circled, Figures 3 and 4) of engine hood striker to: 10 Nm.

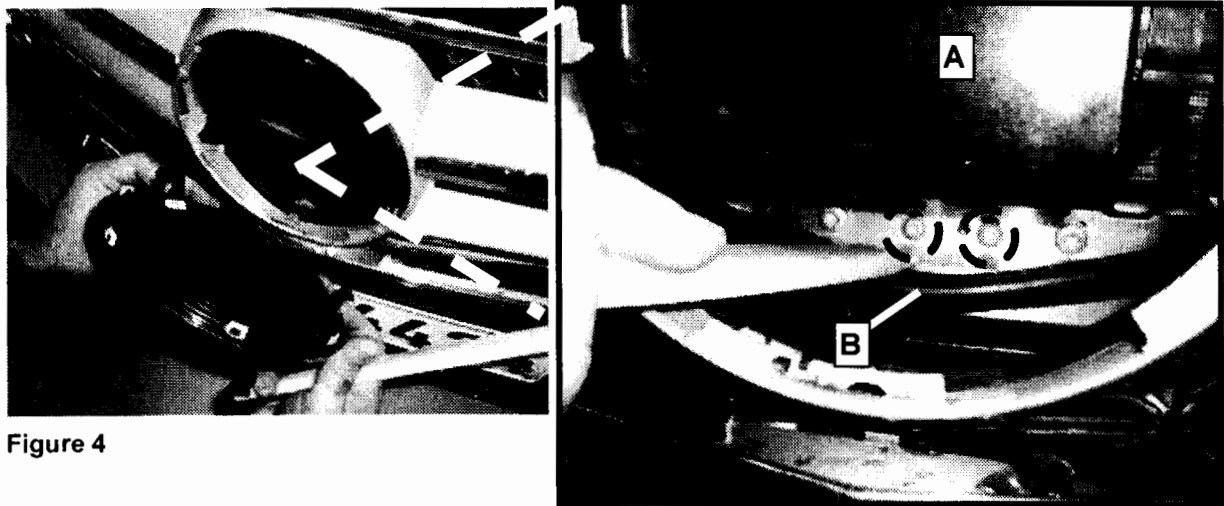
**Figure 4**

Lower striker bolts (circled, Figure 4) are located below Distronic sensor (A) behind rubber hose (B).
