Re: Toyota Safety Recall 12V-537 – Dealer Notification Remedy Phase 2

Subject: **Safety Recall - C0T Remedy Notification**
2004 to certain 2009 Model Year Prius Vehicles
Steering Intermediate Extension Shaft

TECHNICAL INSTRUCTIONS
FOR
SAFETY RECALL C0T
STEERING INTERMEDIATE EXTENSION SHAFT
2004 – CERTAIN 2009 MODEL YEAR PRIUS

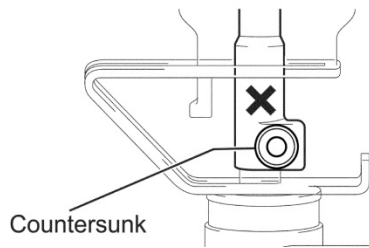
4. MARK THE NG EXTENSION SHAFT

Mark the NG extension shaft

NOTE: The new shaft in the kit (04001-41212) is manufactured with a countersink, mark the NG shaft to confirm it is not reused.
