Recall Information Bulletin

No: C1006110 **Issued:** 1/7/2013

Re: 4M50 Fuel Pipes

Safety Recall C1006110 – 4M50 Fuel Pipes

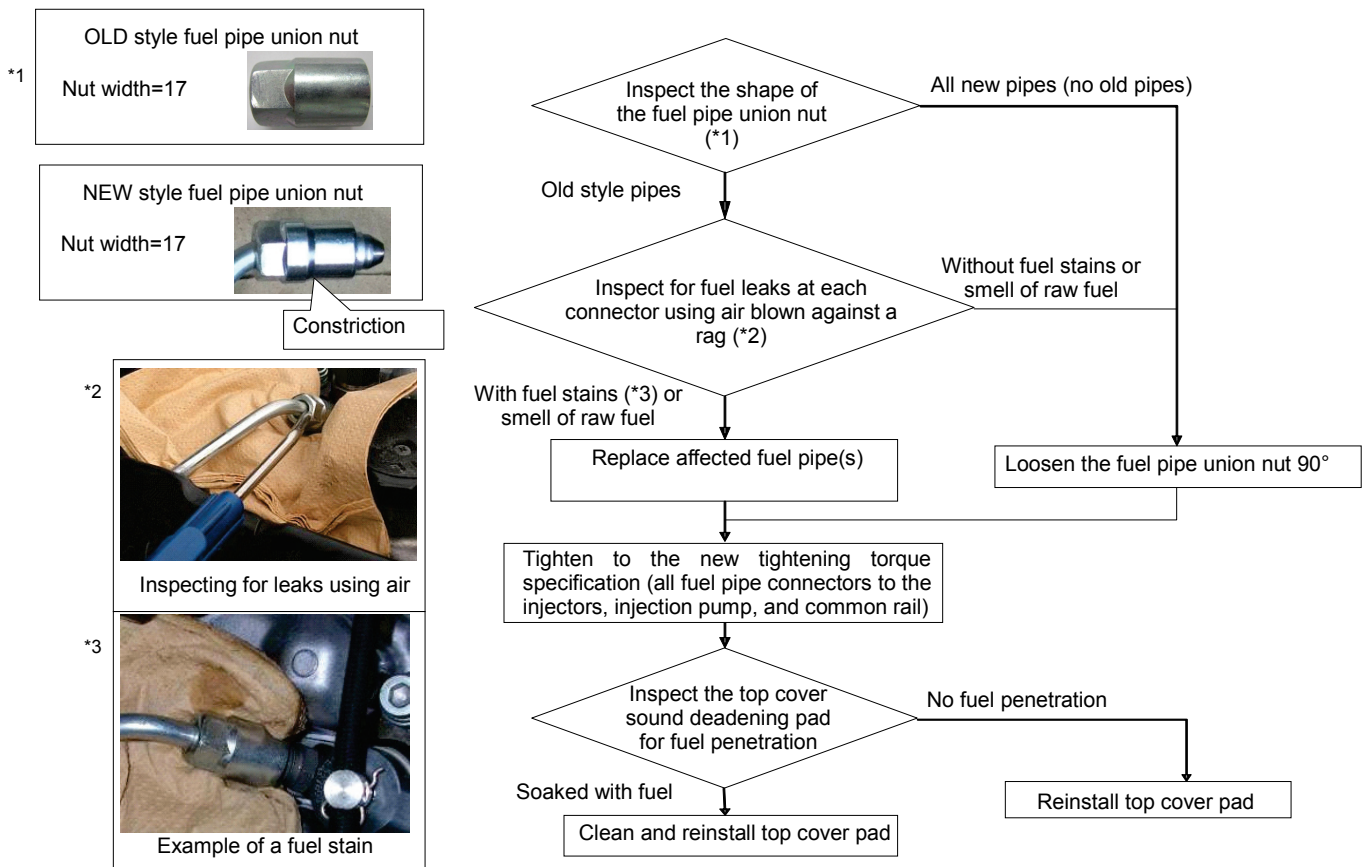
Figure 3 Repair Process Flow chart

If a fuel leak is confirmed, replace only the leaking fuel pipe(s).

If liquid stains the rag when air is blown at the connection, clean the connection and surrounding area, start the truck and allow it to idle for 1-2 minutes, then check for leaks again to ensure that the initial liquid stain was actually caused by a fuel leak, and not residual engine oil or other fluids.

(4) If **NO** fuel leaks are found, loosen all fuel pipe connectors 90°, then tighten the connectors to 28 - 31 ft.lbs.

If a fuel leak is confirmed, replace the affected fuel pipe(s) and tighten the connector(s) to 28 - 31 ft.lbs.

[38 - 43 Nm]. Then, loosen the remaining connectors 90° (¼ turn only!), and tighten the connectors to 28 - 31 ft.lbs.
