SI B11 11 12
Engine

July 2013
Technical Service

Recall Campaign 12V-550:: Replace Hex Bolt with Internal Thread for Deflection Pulley

E70 with M57Y engine

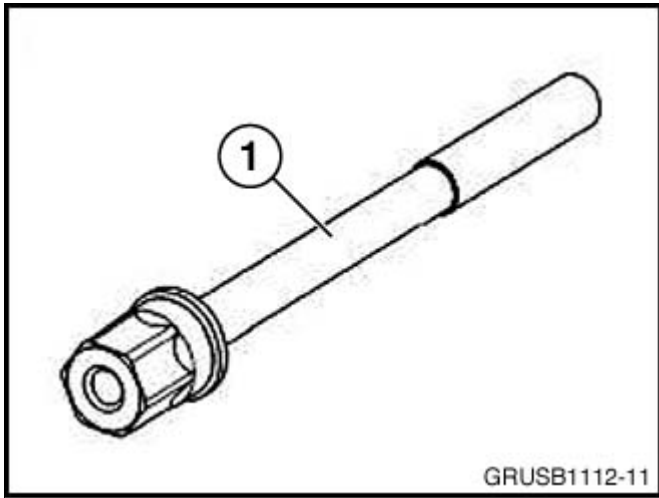
One of the alternator attaching bolts may fail. Subsequently the vehicle may lose power steering assist while driving. If power steering assistance is lost, the vehicle will remain controllable through the mechanical steering system, but with increased steering effort.

5. **NEW** Remove and replace the alternator bolt with P/N 12 31 8 574 809 (M10x125). Do not remove the alternator.

Torque the new bolt to 38 Nm initial torque, and then angle torque the bolt to an additional 180°.
