Re: 49 CFR Part 573; Recall of Mercedes-Benz Fuel Filter Flange

Recall Campaign Bulletin

Campaign No. 2013020002, April 2013

Replace Fuel Filter

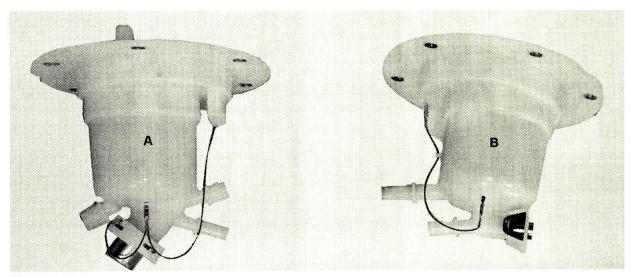
Figure 4

- Fuel filter (A, Figures 3, 4) for models 204.0/9, 212, 207, 216.376, 221.171/186/ 176/195/179 is equipped with 3 fuel line fittings.
- Fuel filter (B, Figure 4) for models: 216.374/394, 221.173/194/174 is equipped with 2 fuel line fittings.

4. Disconnect fuel line connector (arrow, Figure 3) from fuel filter (A).

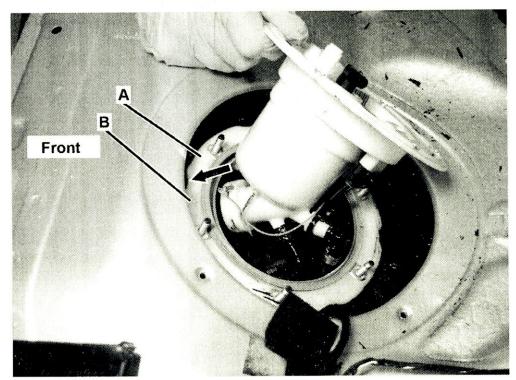
Figure 8

A: Spacer ring
B: Location of
"Top" marking on
spacer ring
Arrow: Location of
top notch on spacer

- Spacer ring (A, Figure 8) is installed with side marked "Top" (B) facing up.
- Tabs on spacer (A) are facing up.
- Torque sequence is observed (Figure 9) do NOT over-torque.
- 10. Start vehicle and check fuel system for leaks.
