**Subject: Land Rover Recall P029 – Rear Brake Caliper Bolts - Dealer Communication**

# TECHNICAL BULLETIN

P029NAS1  
20-DEC-12

### Safety Recall: Rear Brake Caliper Bolt Torque

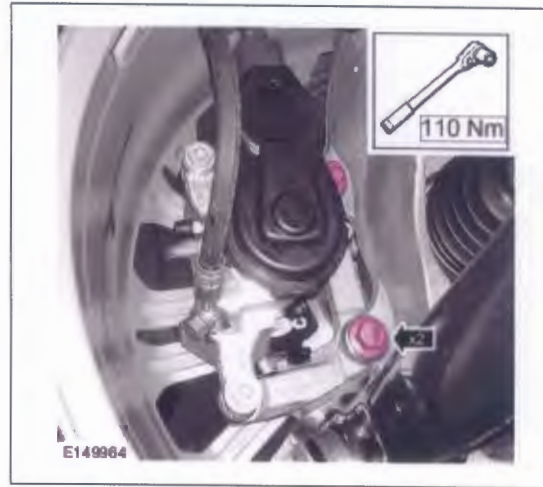
**Situation:** A limited number of vehicles within the listed VIN range have been manufactured out of process and it is possible that the rear brake caliper bolts may not have been torqued to their intended design levels.

1. **△ NOTE: Steps 1-2 -- Range Rover Evoque only.**  
Check that both left-rear brake caliper retaining bolts are present.
  - If missing, replace bolt(s).
  - Tighten both caliper retaining bolts to 110 Nm (81 lbf ft).
