Recall Bulletin

F/CMVSS NONCOMPLIANCE RECALL

SUBJECT: Possible Missing Secondary Hood Latch

MODELS: 2010-2012 Chevrolet Colorado
2010-2012 GMC Canyon

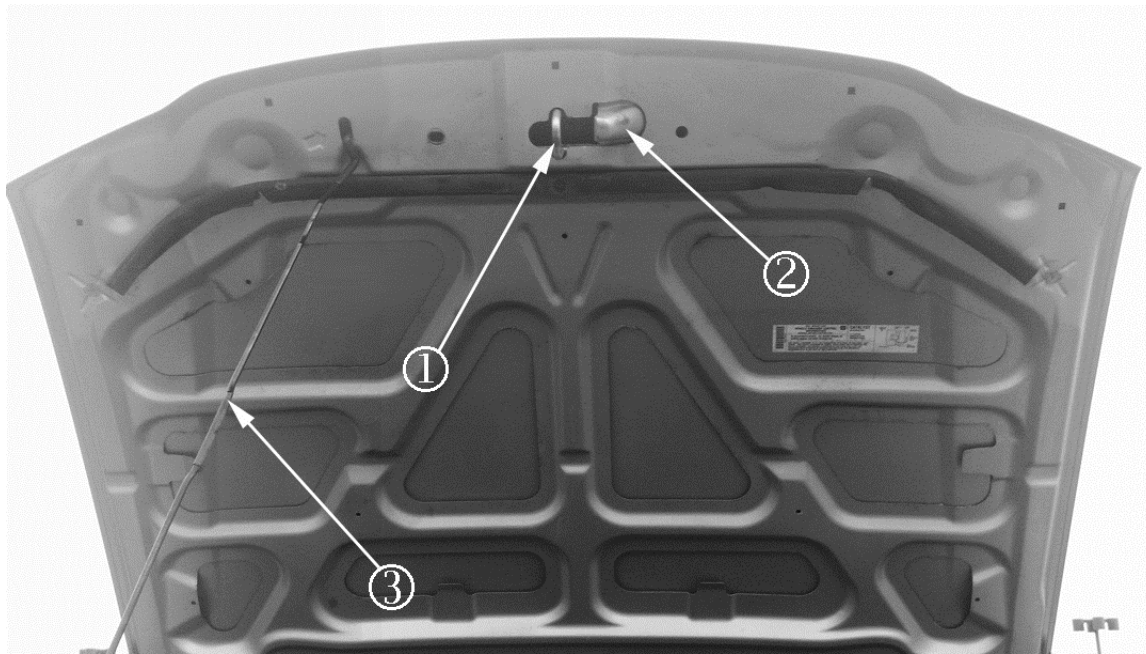
3228827

2. Release the hood prop from its retainer and put the hood prop into the slot in the hood (3).
3. Locate the primary (1) and secondary (2) hood latches. Refer to the illustration.

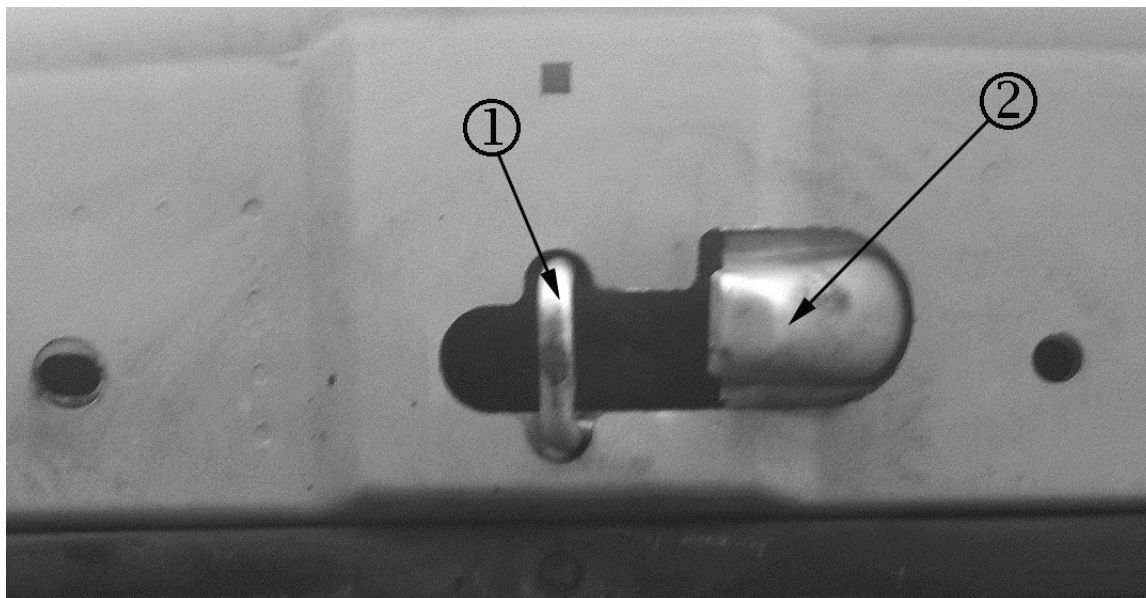
3228830

4. Determine if the hood is assembled with a secondary latch (2).
 - If the vehicle hood is assembled with a secondary latch, no further action is required. Lift the hood to relieve pressure on the hood prop. Remove the hood prop from the slot in the hood and return the prop to its retainer. Lower the hood 25 to 30 cm (10 to 12 in) above the vehicle and release it to latch fully. Check to make sure the hood is closed and repeat the procedure if necessary.
 - If the vehicle hood is NOT assembled with a secondary latch, remove and replace the hood. Refer to *Hood Replacement* in SI for hood removal and installation instructions.

Dealers are to inspect for the presence of the secondary hood latch. If the latch is missing, dealers are to replace the hood.
