WQE-41

February 2013

PRODUCT CAMPAIGN BULLETIN

SUBJECT: Optional Genuine Subaru Puddle Lights

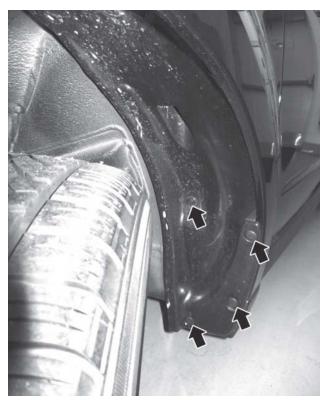
- 1. Raise the vehicle as necessary to access the inner fender splash shields. Wheel removal is generally not required.
- 2. Remove the accessory splash guard (if equipped) and the retaining clips at the rear portion of the front wheel opening. Move just enough of the splash shield to expose the puddle light wiring and body harness connectors

- A Forester is shown in the photo on pg. 4 for illustration only.
- Splash guard removal may also be required for access to the splash shield retaining clips.
- Retaining clip locations will vary by model.
- See **Appendix B** for samples of retaining clip locations by model.
- The photos below show a puddle light harness **without** the in-line fuse on the left and the current replacement harness **with** the in-line fuse on the right.

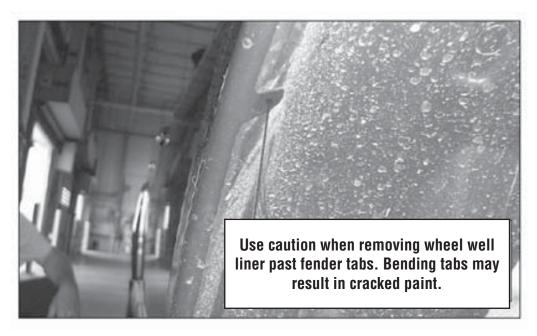
On Legacy, Outback and Forester models, locate the two metal tabs along the inside edge of the front fender. Use caution and support these small painted fender tabs inside the wheel arch when removing the splash shield. These tabs are painted body color and cracking of the paint is likely if the tabs are bent. Place one hand on the tab to secure it while pushing the splash shield up and over the tab with your other hand. Use the same method when you reinstall the splash shield. Touch-up any damaged tabs to minimize any future possibility of rust.

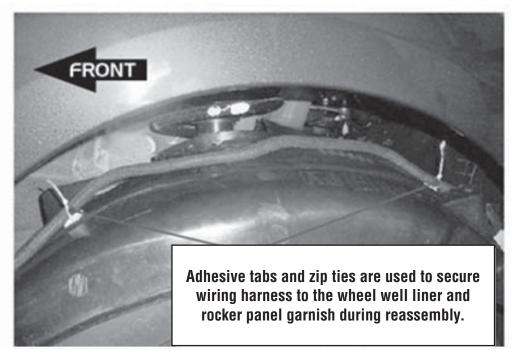
• On Legacy and Outback models, use caution when moving the splash shield as the body harness for the puddle lights is secured to it at two points as shown below. It is not required to drop the entire splash shield. Simply move enough of the shield to gain access to the connection which is located at the rear of the wheel opening. This information and photo are provided as a reference only.

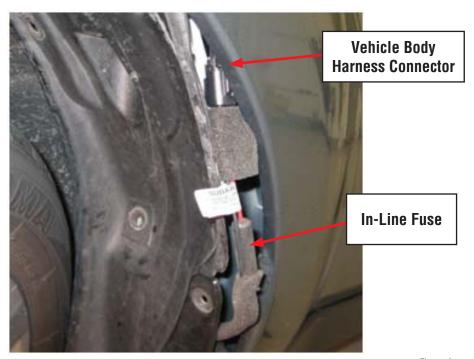
- 3. Once the splash shield has been moved enough for access, inspect the puddle light harnesses.
 - a. If the vehicle already has an in-line fuse in the red power wire within a few inches of the vehicle connector as shown in the photo below or a Fused Mini-Harness as shown in the photo on pg. 7 and both lights (all 4 LED bulbs) operate, no further action is required on that side.
