Re: Toyota Safety Recall 12V-373 – Dealer Re-Notification

Subject: Safety Recall CSE - *(Supplement to CLE) - Interim Notice (C3E)*  
2010 Model HS 250h Vehicles  
**REINSPECTOR REQUIRED** - Rear Lower Suspension Arm No. 1

**INTERIM TECHNICAL INSTRUCTIONS**  
**FOR**  
**SAFETY RECALL CLE INTERIM C3E**  
**REAR LOWER SUSPENSION ARM No.1**  
**CERTAIN 2010 MODEL YEAR HS250h**

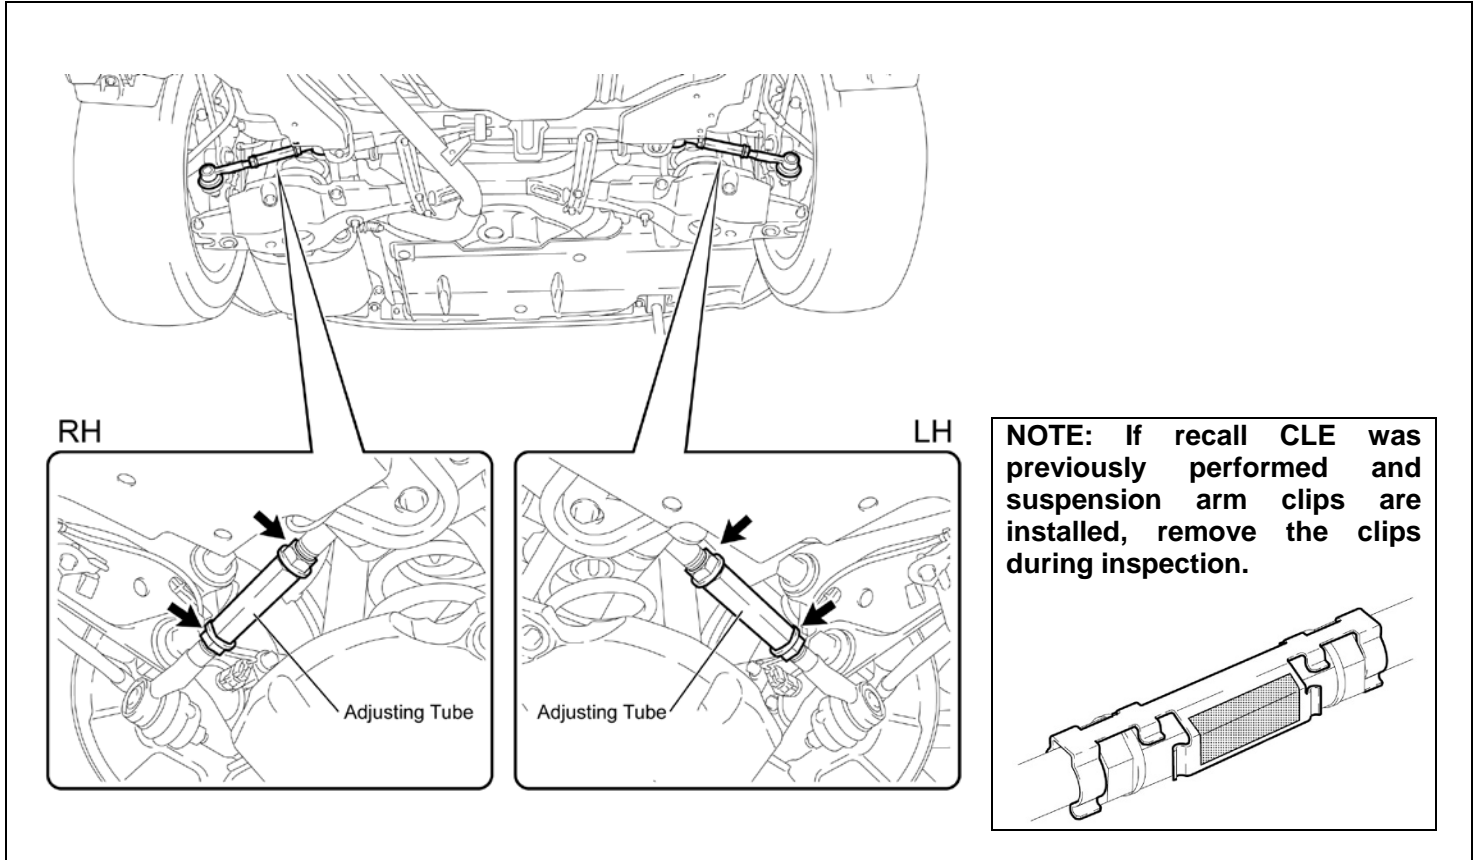
### 1. CHECK FOR LOOSENESS VISUALLY AND BY HAND

- a) Check visually and by hand to determine if any looseness is seen or felt in the suspension arm lock nuts or adjusting tube. Check the LH and RH arms.

- Replace the suspension arm(s) if:
  - Looseness is found.
  - A gap is visible between the lock nut(s) and adjusting tube.

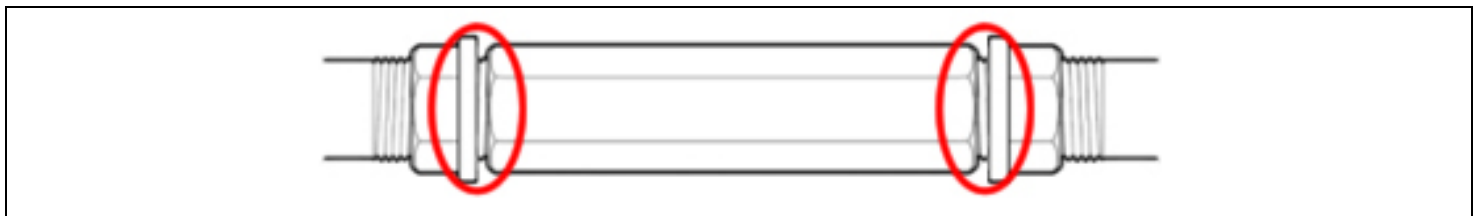
- b) Inspect for a gap between the lock nuts and the adjusting tube.

CONDITION	ACTION REQUIRED
Loose <b>OR</b> Gap	Replace the suspension arm(s) with looseness <b>OR</b> if a gap is found between the lock nut(s) and adjusting tube. Refer to <a href="#">TIS</a> for instructions on suspension arm replacement. <b>NOTE:</b> <ul style="list-style-type: none"> <li>• To prevent stress on the new suspension arm bushing, apply a load to the suspension system to confirm the suspension arm bushing is aligned correctly when tightening by confirming that rear suspension arm No.1 is level with the ground.</li> <li>• Suspension arm adjustment and tightening procedure is critical. After replacing the arm, refer to SECTION VII. in these instructions for this procedure.</li> </ul>
<b>NOT</b> Loose <b>AND</b> <b>NO</b> Gap	The interim portion of this campaign is complete. Return the vehicle to the customer.

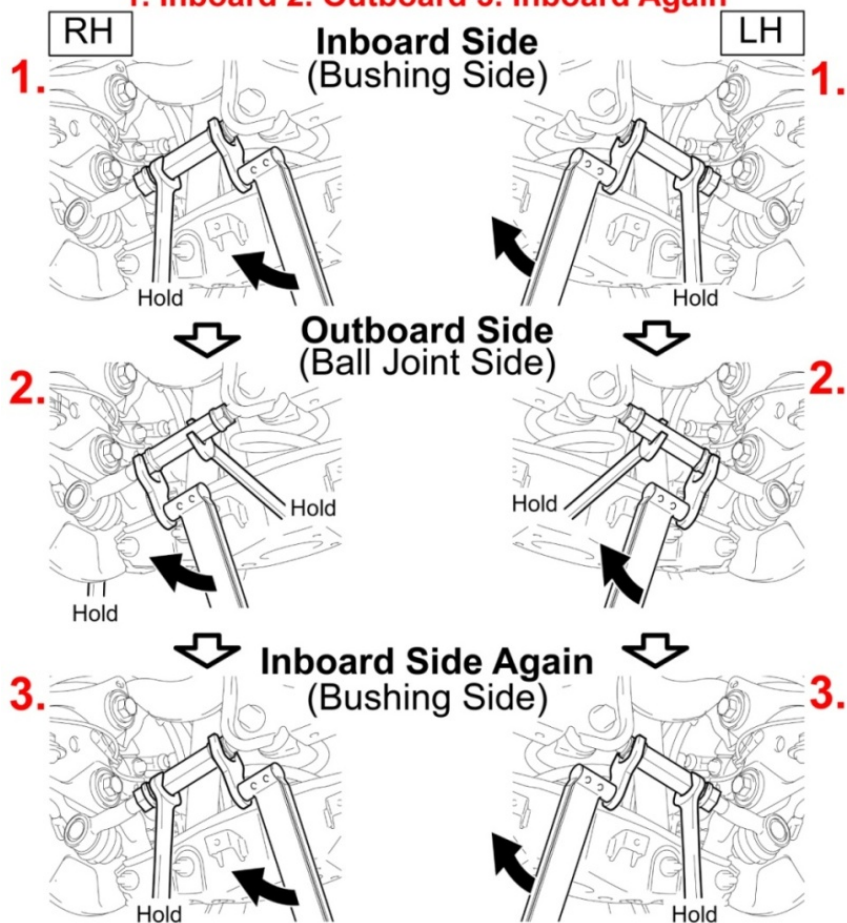
#### 2. TIGHTEN THE LOCK NUTS EXACTLY AS DESCRIBED BELOW

- Holding the adjusting steady tube is **CRITICAL** when tightening the lock nuts, if the adjusting tube is not held steady the lock nuts may become loose.
- The alignment **MUST** be performed by the same technician performing the recall. Only one person should perform the entire recall on each vehicle.
- The tightening procedure for these lock nuts is critical, failure to tighten them in the correct order could cause them to become loose.

Use a 22mm combination wrench and a 22mm crowfoot attached to a torque wrench

Tightening Sequence: 1. Inboard 2. Outboard 3. Inboard Again

Torque: 41ft. lbf (56N·m)

- Tighten the inboard lock nut. **Hold the adjusting tube steady** and tighten the **inboard lock nut** to the specified torque.
- Tighten the outboard lock nut. **Hold the adjusting tube steady** and tighten the **outboard lock nut** to the specified torque.
- Tighten the inboard lock nut again. **Hold the adjusting tube steady** and tighten the **inboard lock nut** to the specified torque.
