The following information is submitted in accordance with the National Highway Traffic Safety Administration's defect reporting regulations, 49 CFR § 573.6. This report relates to certain replacement fuel pumps.

Airtex Products, LP

This report applies to certain aftermarket replacement fuel pump modules with model numbers E8598M; E8518M; E8600M; E8596M and E8597M that were manufactured on two days, July 26, 2013 and July 29, 2013. These model pumps are replacement equipment for certain Subaru vehicles as shown in the table below:

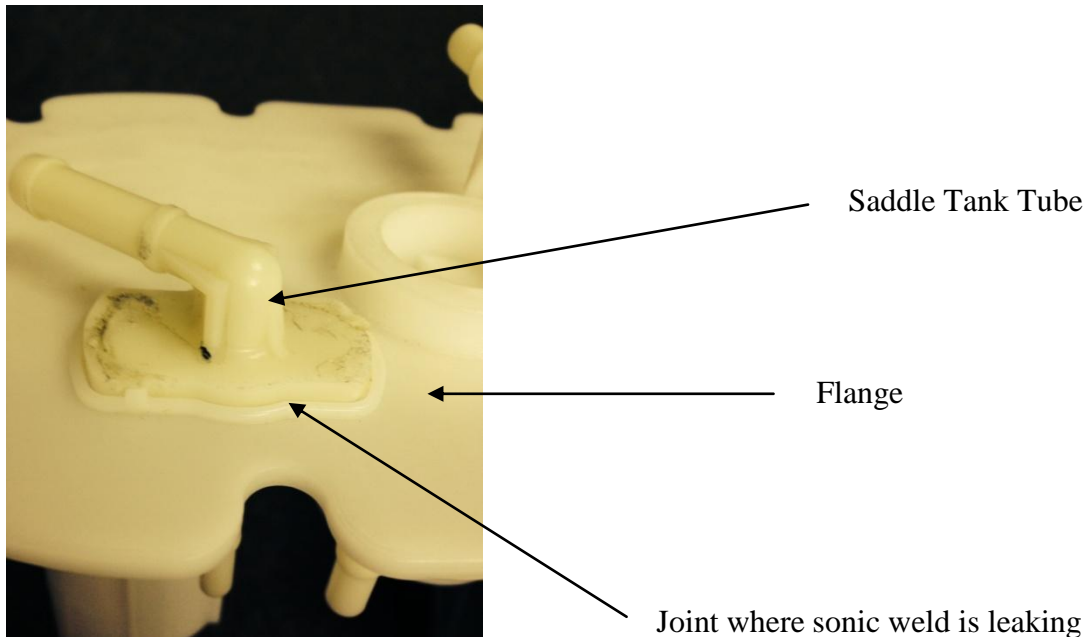
Figure 1

Airtex has identified the following root cause of the non conformity. Airtex makes use of sonic welding to fashion certain plastic component parts. Airtex has determined that a poor sonic weld technique can cause fuel to leak from joint where a saddle tube joins the pump flange. See Figure 1. This non conformity was not detected during manufacturing because improper procedures were utilized during final product testing.

The defective joint may allow fuel to escape when the tank is full. To date, Airtex has received two field reports involving three modules from the field of leaks in installed pumps. Based on its investigation, Airtex believes that a non conforming pump could leak if installed.

The remedy program will consist of no cost replacement of the non conforming pumps. Airtex will take all of the following steps to identify products in the field:

A. On November 22, 2013, Airtex began providing notice to its customers to quarantine pumps manufactured on July 26, 2013 and July 29, 2013 (with package date codes 303 and 313) that were in these customers' inventory. Airtex will replace potentially defective pumps with conforming pumps at no charge.
