March 4, 2013 Ref. No.: GR13-017

# RE: Part 573 Defect Information Report – Moonroof Glass Coming-off on 2012 Subaru Legacy & Outback Vehicles

# **Defect Information Report (49 CFR Part 573.6)**

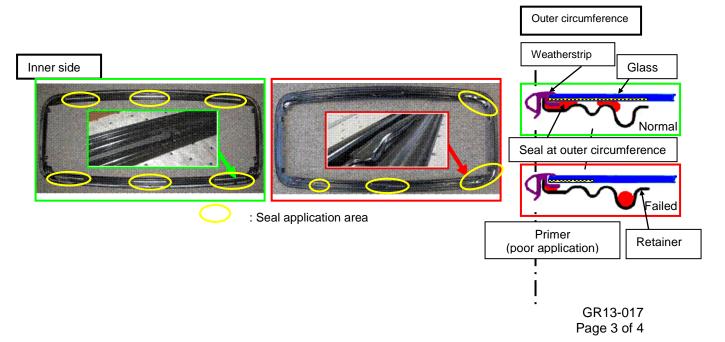
Moonroof glass comes loose or off. Adhesion area between glass and retainer is small.

- a) Width of primer application was found less than the amount specified in the design drawing in certain areas.
- b) Amount and positions of seal (adhesive) application was inappropriate at both of outer and inner circumferences of certain areas.

Assembly process of glass and retainer was changed at supplier from another vendor during summer shut-down in 2010. Application management of primer and seal was inappropriate.

- a) Specification (40 +/- 10mm) of primer application width was not specified in work procedure.
- b) Poor management of seal application amount.

The moonroof glass can loosen and detach from the vehicle during driving, resulting in a potential road hazard for other vehicles that may lead to a collision.

- (i) The remedy plan calls for dealers to inspect glass adhesion condition and dealers will either apply additional seal or replace the moonroof glass with a new one according to the inspection result.
- (ii) Subaru of America, Inc. notified customers on February 22, 2013. Remedy parts are available now for all of the affected units. There is no need to notify dealers since the cars have already been sold.
