13V-078
(5 pages)

RE: Part 573 Defect Information Report – Wiper Motor Bottom Cover Melting on 2012 Subaru Legacy and Outback Vehicles

In accordance with 49 CFR Part 573, "Defect and Noncompliance Responsibility and Reports," Fuji Heavy Industries USA, Inc. on behalf of Subaru of America, Inc. and Fuji Heavy Industries, Ltd., submits the enclosed notification and report concerning a defect in the Front Wiper Motor Bottom Cover on certain 2012 model year Subaru Legacy and Outback vehicles sold in the United States. Our internal designation for this recall campaign is: WVV-32.

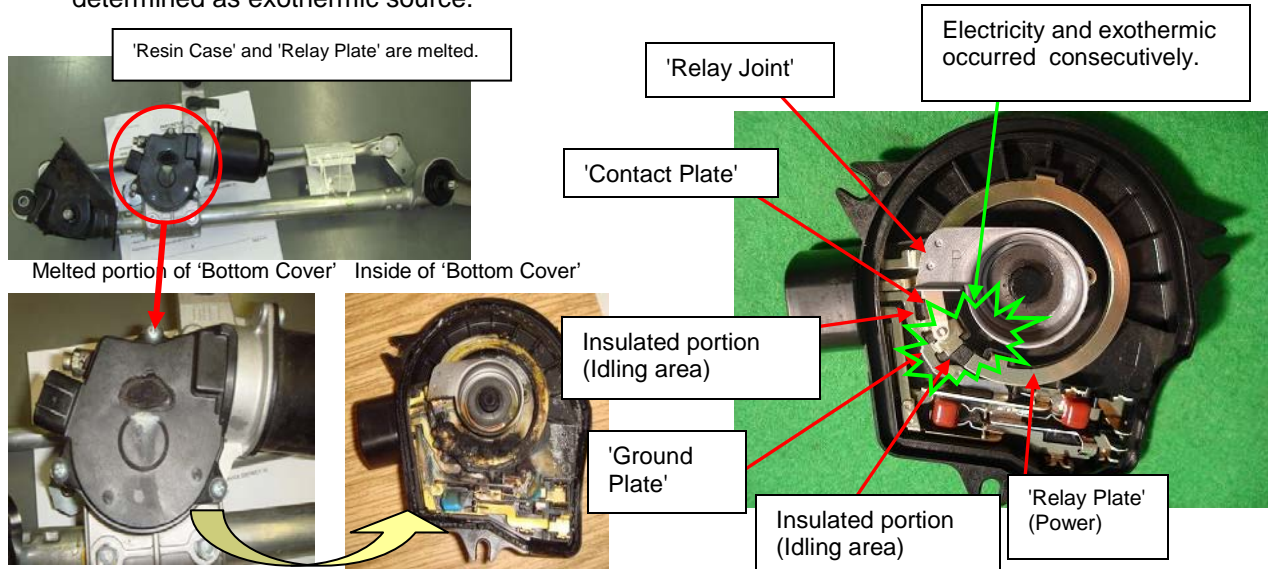
(1) Evaluation result of returned parts

Melting damage was confirmed on resin case of "bottom cover" and internal "relay plate". "Relay plate" was most severely damaged before the insulated portion (idling area), which was determined as exothermic source.

- Carbonization of "insulating portion" will start and progress due to occurrence of electric sparks.
- As carbides form a path to allow electricity current flow, it will flow in "relay plate" and "ground plate," generating heat, which will lead to melting of the "bottom cover" assembly.

- Interference occurs between "relay joint brim" and "worm wheel" due to improper clearance dimension.
- Continuous chatter occurred while drawing "contact point" current when movement of wiper arms was restricted due to a certain external source.
- In case the wipers were used continuously under the condition, the insulating portion will be carbonized to allow electricity current flow, which may lead to heat and melting of "bottom cover" assembly.

The windshield wiper motor bottom cover can internally catch fire in the worst case.

(i) The remedy plan calls for dealers to replace the front wiper motor bottom cover assembly with a new one.
