**Re: PART 573 NOTICE RE BELLOWS PIPE ON 2012 - 2013 MCI D SERIES**  
**COACHES WITH CUMMINS 2010 ISX ENGINE**

Safety Defect and Noncompliance Report Guide for Vehicles  
**PART 573 Defect and Noncompliance Report**

**MCI Service Bulletin 397**

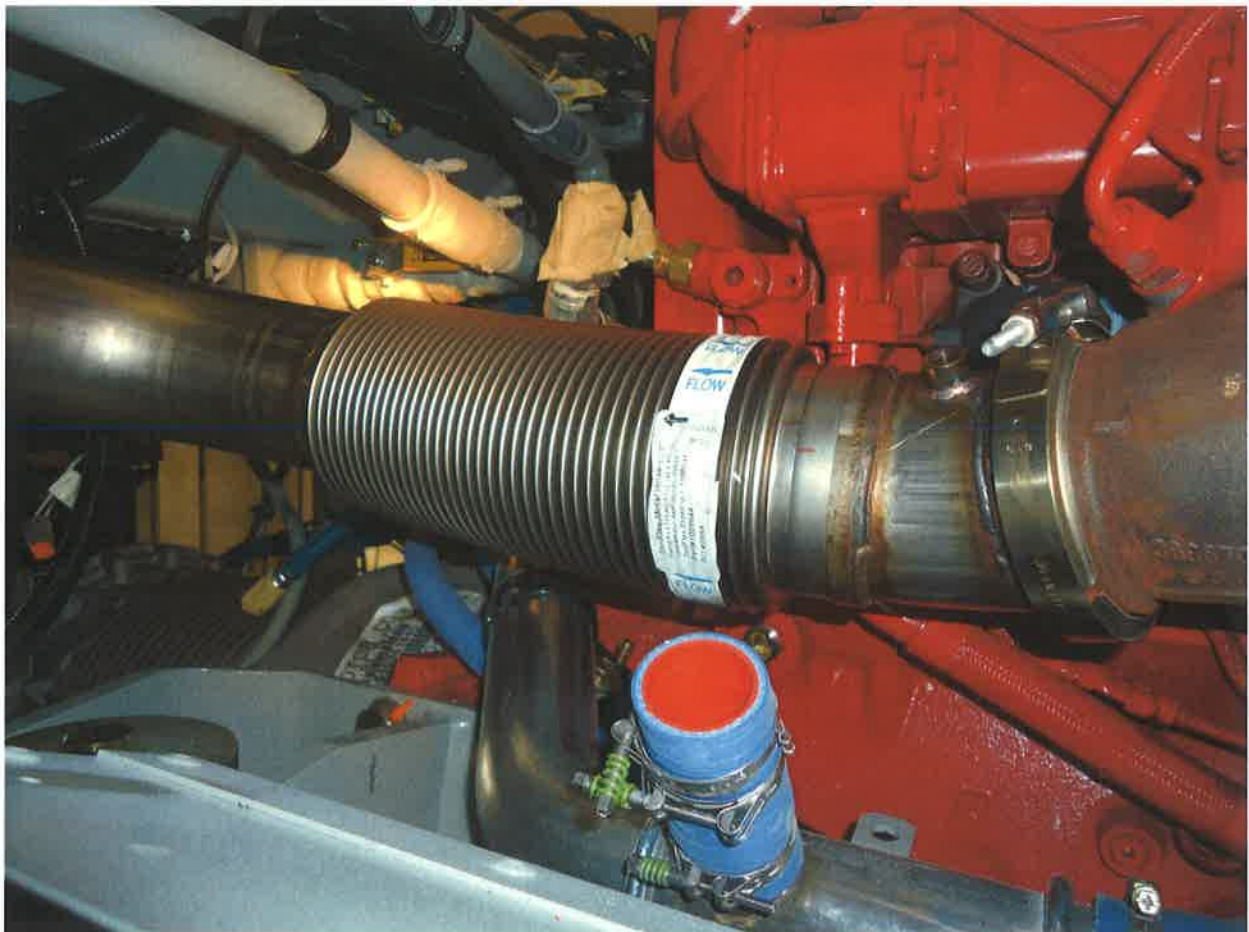
The bellows pipe is shown in the picture below:

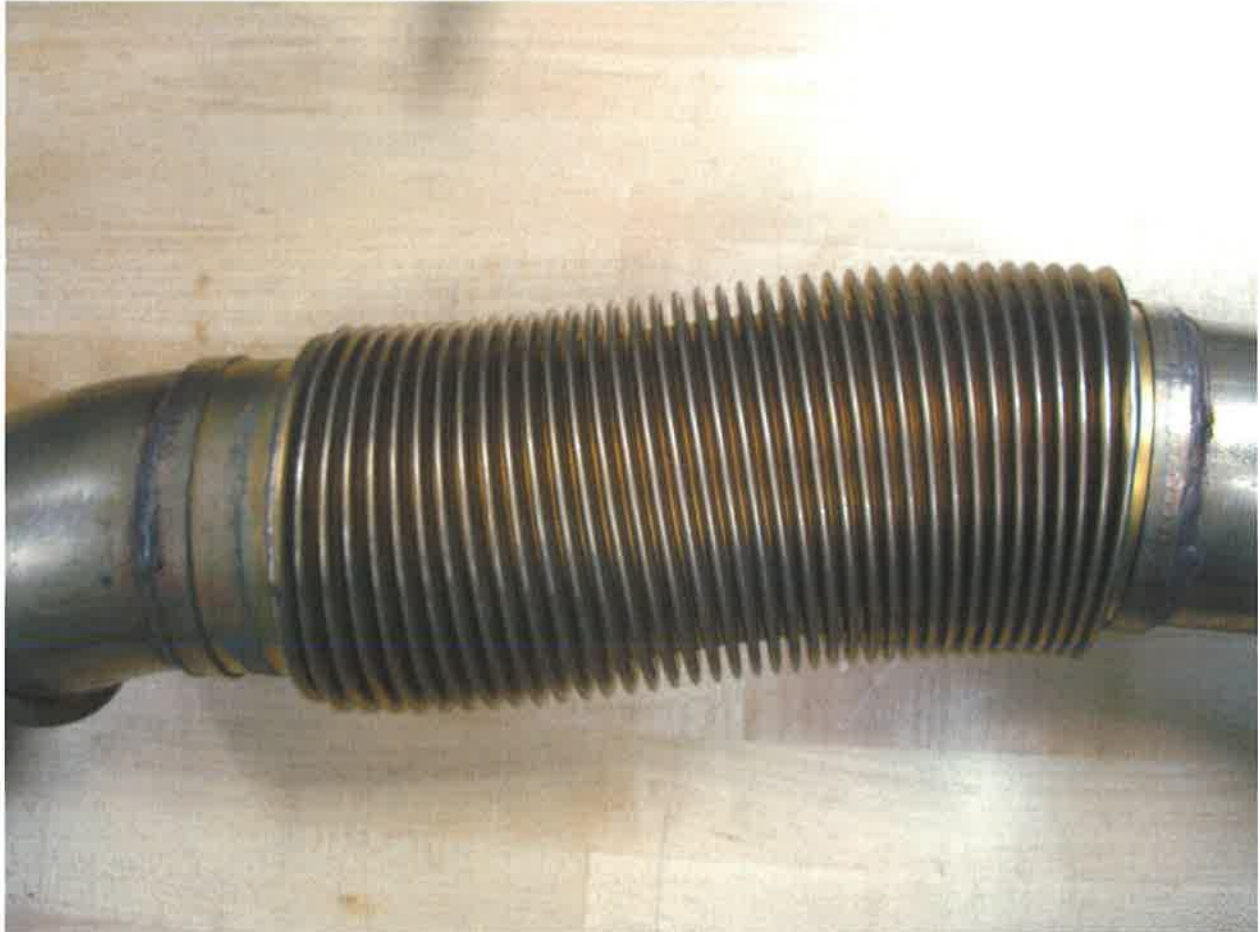
MCI identified an incorrect assembly process related to the installation of the bellows pipe, which is a component of the exhaust system. The incorrect assembly process may cause deformation of the bellows pipe that could potentially result in a failure of this pipe during operation. The exhaust system of the Cummins EPA 2010 engine automatically undergoes a regeneration process that clears soot from the Diesel Particulate Filter ("DPF", which is another component of the engine exhaust system). The regeneration process involves the injection of diesel fuel into the DPF and the subsequent combustion of this fuel clears the soot from the DPF. This process is intended to be completely contained within the exhaust system. However, if the bellows pipe fails and a regeneration event occurs, the combustion may not be completely contained within the exhaust system and could potentially exit the

**bellows pipe. If this occurs, the hot combustion gases could cause a fire, potentially resulting in personal injury and/or property damage.  
When the bellows pipe is incorrectly assembled it can be deformed as shown in the following picture:**

**The thermal blanket covering the bellows pipe may show signs of combustion.**

In March and April 2013, MCI became aware that two MCI D coaches had sustained fire damage. MCI's investigation revealed that the damage had resulted from an active regeneration event and the presence of a cracked bellows pipe. The cracked bellows pipe allowed combustion products to escape the exhaust system, causing damage to surrounding material.

As a result of its investigation, MCI decided to recall the affected vehicle population to inspect and replace as necessary bellows pipes that may have been deformed during the incorrect assembly process.

**MCI will provide, at no cost to customers, the parts and labor to inspect and replace as necessary any failed or deformed bellows pipes. The procedure will be further described in MCI Service Bulletin 397, to be sent under separate cover.**

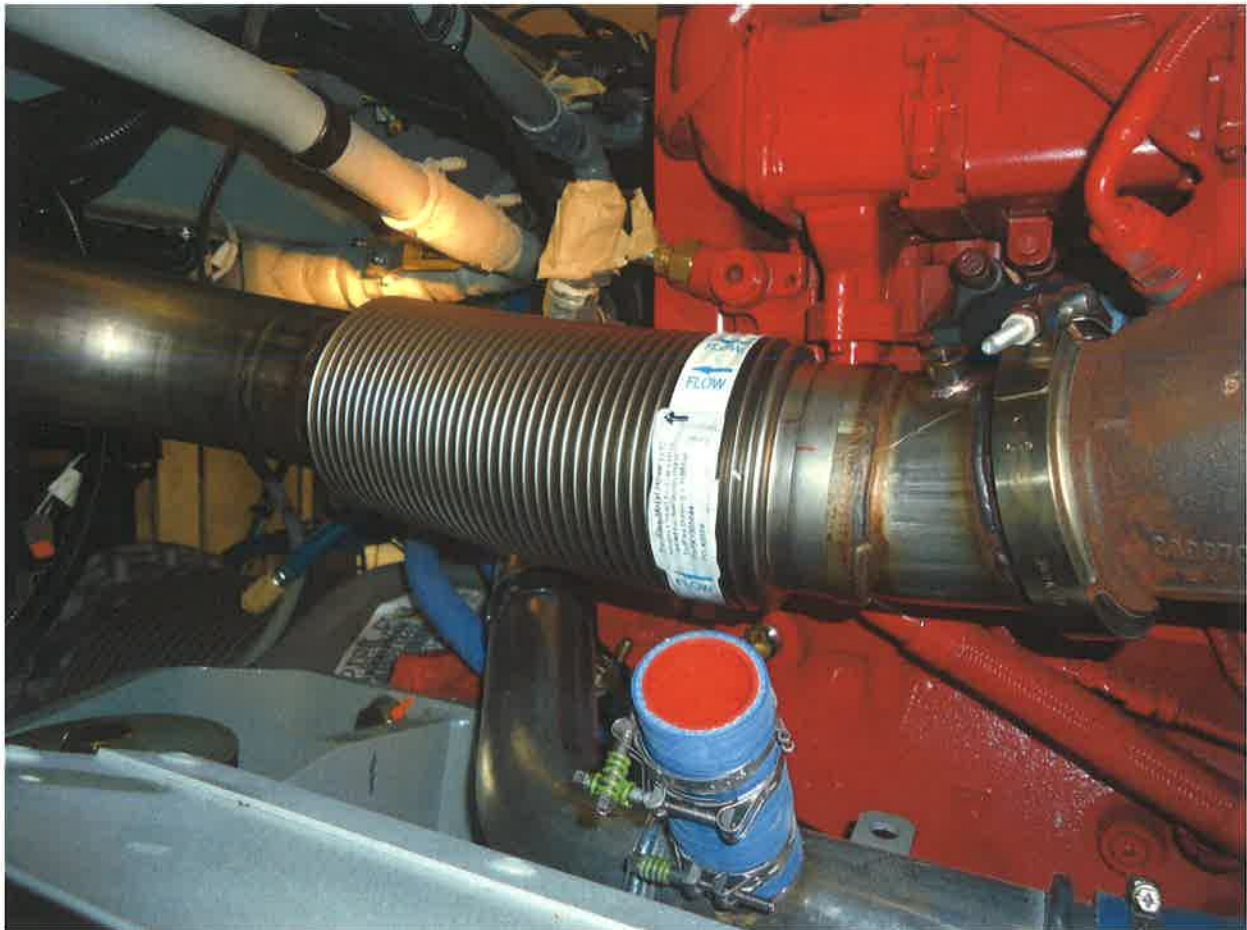
**The rework will result in the proper assembly and alignment of the bellows pipe, which will avoid or reduce the likelihood of a thermal event. The picture below depicts the correct installation:**

Coaches built after unit 12847 are not included in the recall because MCI changed the assembly process for installation of the bellows pipe.
