**Fuji Heavy Industries U.S.A., Inc.**c/o Subaru of America  
Subaru Plaza  
PO Box 6000  
Cherry Hill, NJ 08034-6000  
856-488-8500  
856-488-8669 faxAugust 1, 2013  
Ref. No.: GR13-053Ms. Nancy Lummen Lewis  
Associate Administrator for Enforcement,  
National Highway Traffic Safety Administration  
Attention: Recall Management Division (NVS-215)  
1200 New Jersey Ave. SE  
Washington, DC 20590**RE: Part 573 Defect Information Report –5-Speed Automatic Transmission (AT) Parking Rod on 2014MY Subaru Legacy, 2014MY Subaru Outback and 2013MY Subaru Tribeca Vehicles**

**Defect Information Report (49 CFR Part 573.6)**

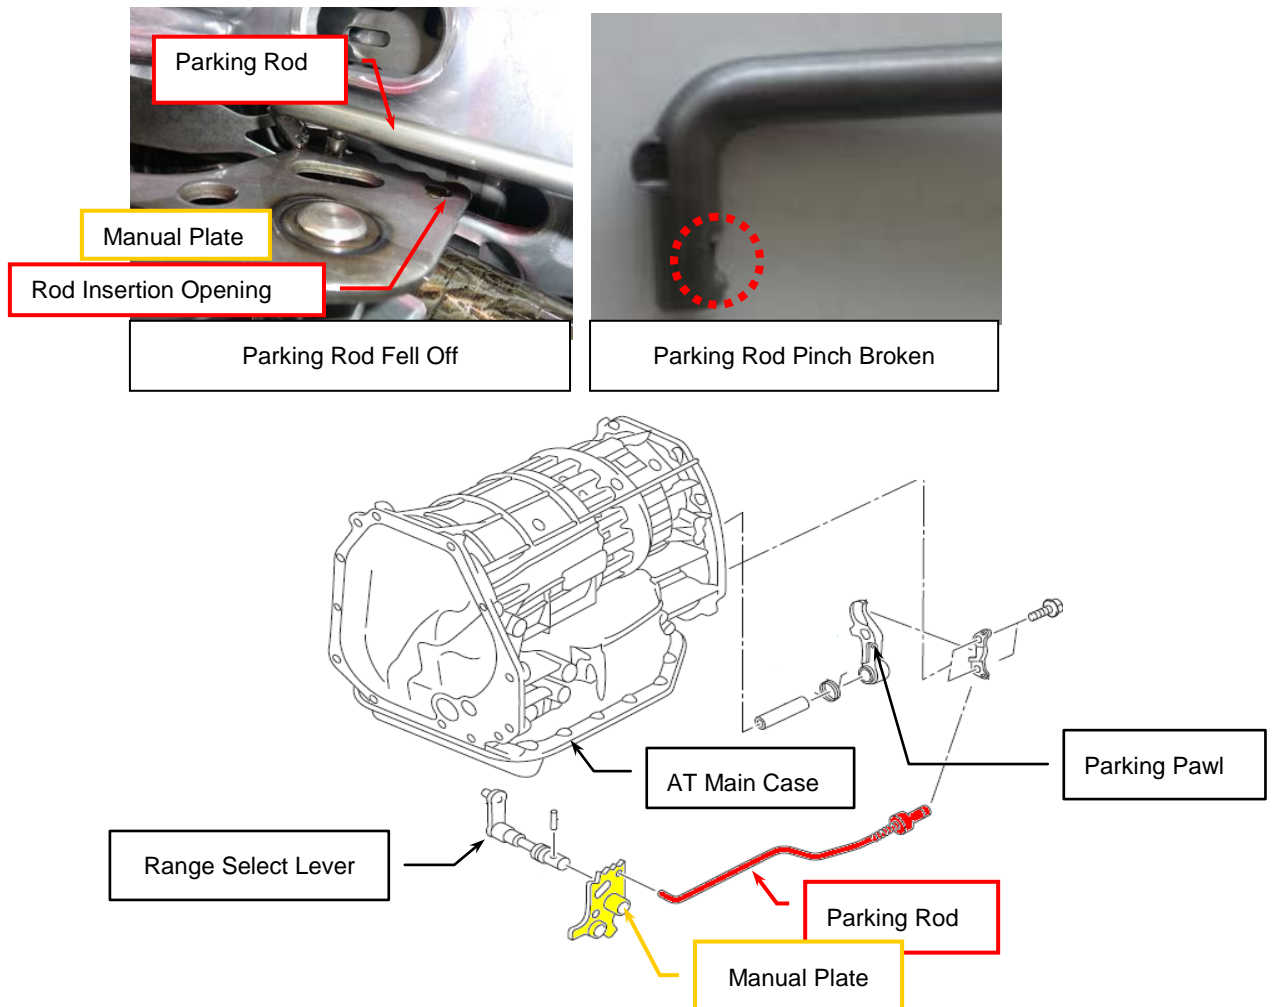
The parking rod of the 5-speed automatic transmission was not assembled correctly. The parking rod pinch was broken upon installation, which may cause disengagement of the parking rod from the manual plate (please refer to the illustrations below). Potential issues caused by this condition are described below:

- 1) Even with the transmission shifted into the “park” position, the parking pawl will not be engaged in the parking gear and therefore, the parking mechanism may not operate properly to prevent vehicle movement. If the parking brake is not used when parking the vehicle, it may move unexpectedly.
- 2) If the parking rod detaches during engagement into the “park” position, disengagement of the parking gears, when moving the gear selector from the “park” position, may not be possible, which would prevent the vehicle from being moved or driven.

- The Parking rod was broken at the pinch point and the rod was disengaged from the manual plate.
  - Since the pinch point showed material shear failure and an impression was seen at the rod insertion opening of the manual plate, the rod pinch point was determined to have been damaged during the automatic transmission assembly process.

- (i) The remedy plan calls for dealers to replace the original 5-speed automatic transmission (AT) assembly with a new one.
- (ii) Subaru of America, Inc. expects to notify U.S. dealers on or around August 2, 2013. It is expected that owner notification will begin within 30 days. The owner letter will not contain a reimbursement statement since all of the vehicles are/were covered under warranty for the necessary repair and vehicle owners would not have incurred any out of pocket expenses. Subaru will update NHTSA if the situation changes significantly.
