**SUZUKI MOTOR OF AMERICA, INC.**

13V-449  
(8 pages)

Affected vehicles are all 2004-2013 Suzuki GSX-R600, 2004-2013 Suzuki GSX-R750, and 2005-2013 Suzuki GSX-R1000 motorcycles. Refer to Attachment 1 for details.

5. Description of Defect

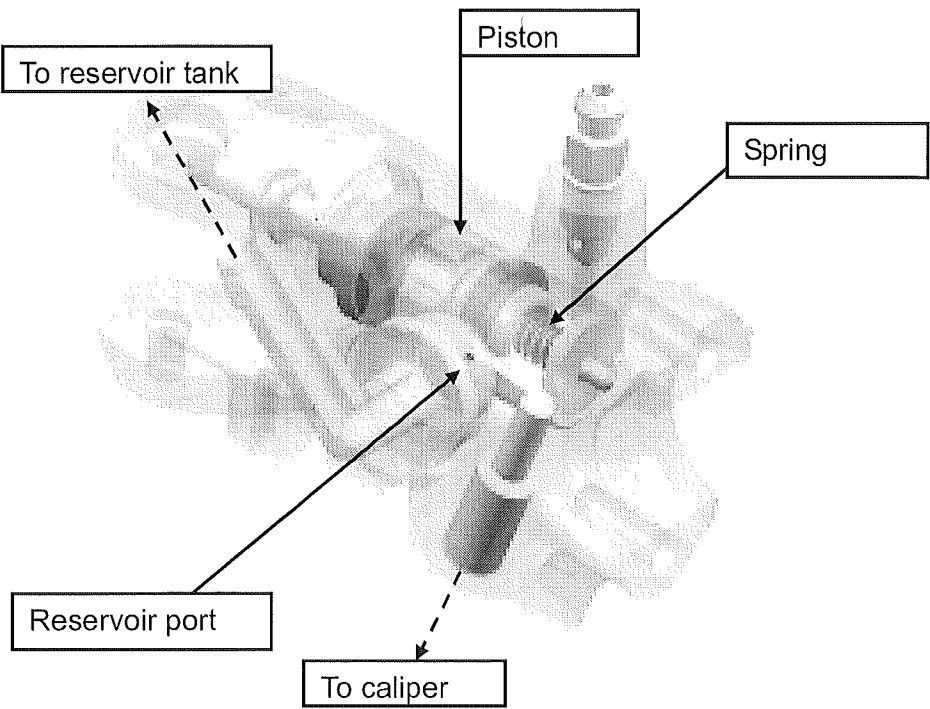
Front Brake Master Cylinder

After a long-term service life of the motorcycle without changing the brake fluid, the brake fluid can deteriorate and absorb moisture. The brake piston inside the front brake master cylinder of some motorcycles may not have uniform surface treatment. This combination of conditions can lead to corrosion of the brake piston. Corrosion of the brake piston generates gas, which may not be adequately purged from the master cylinder due to the side position location of the reservoir port. Gas remaining in the master cylinder can affect braking power by reducing proper fluid pressure transmission to the front brake. Over time, as gas continues to slowly accumulate above the reservoir port, the front brake lever may develop a “spongy” feel and stopping distances may be extended, increasing the risk of a crash.

Suzuki distributors will conduct a safety-related recall campaign to replace the front brake master cylinder on affected motorcycles with a redesigned part that has the reservoir port at the top location of the master cylinder to allow better purging of gas, and has improved surface treatment for the brake piston. Several associated parts will also be replaced. SMAI currently anticipates that it will notify dealers about the details of the recall during the week of October 28, 2013, and will notify owners about the recall during the week of November 4, 2013. We expect that the Suzuki distributors in Hawaii and Puerto Rico will follow a similar schedule.

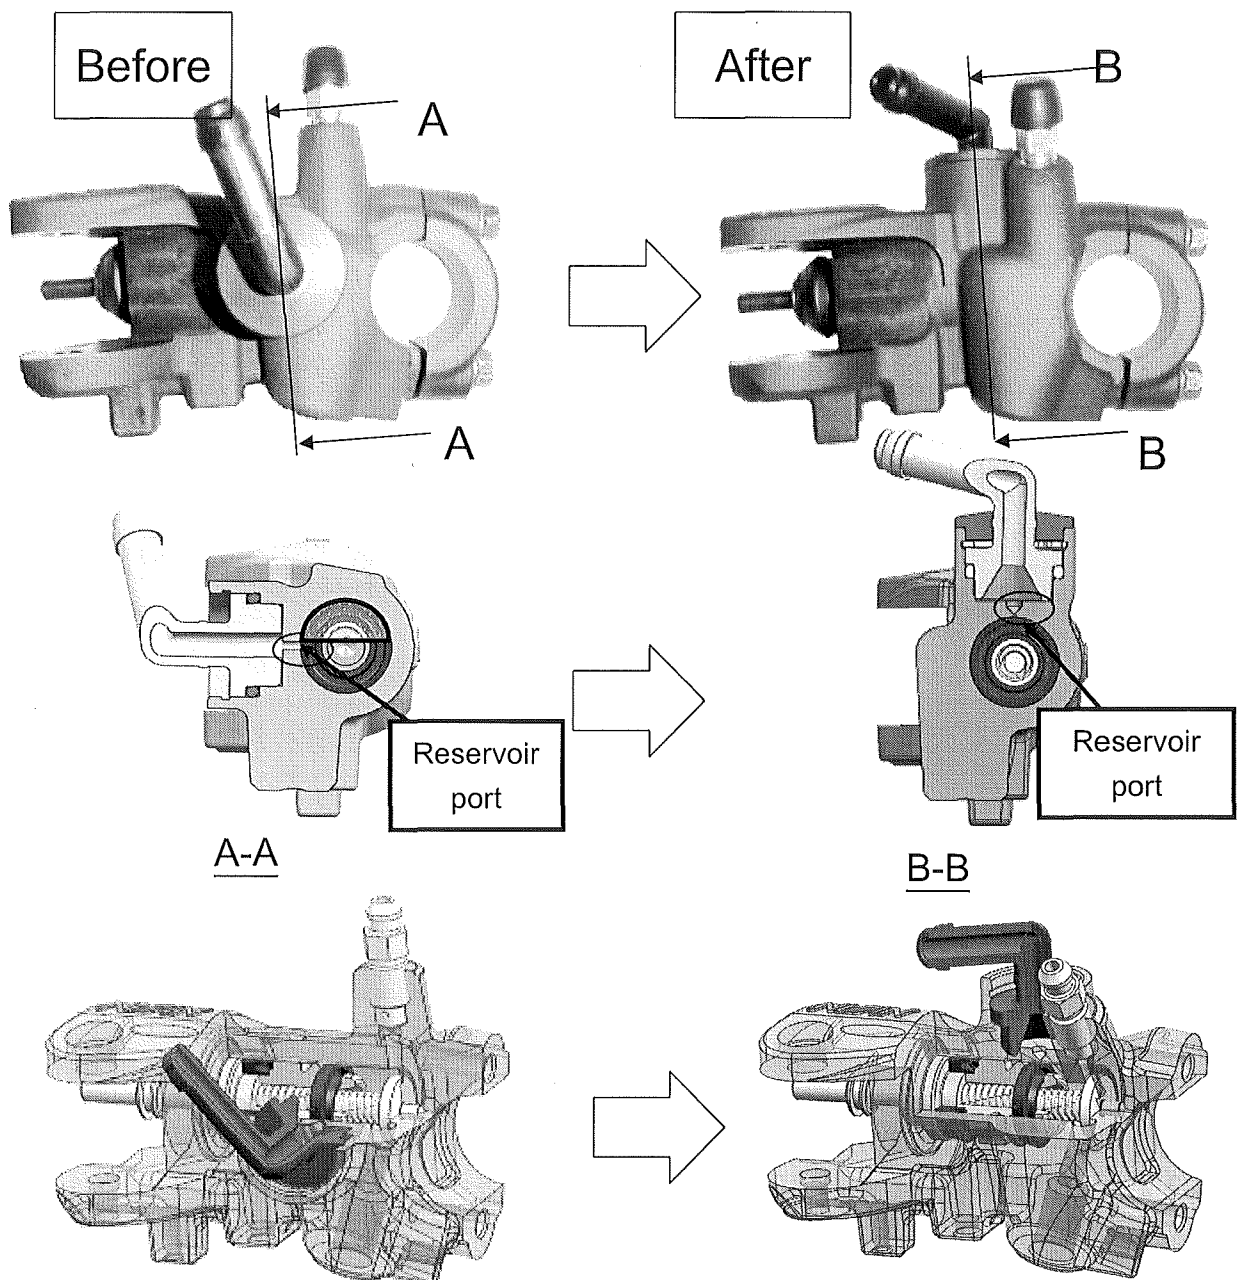
### Countermeasure

The reservoir port is located at the side position of the master cylinder. Gases are not purged sufficiently.

The reservoir port is located at the top position of the master cylinder to allow better purging of gases.
