This Service Information bulletin supersedes SI B27 01 13 dated February 2013.

Recall Campaign 13V-017: ActiveE Drivetrain - Transmission Shaft Sealing

E82E

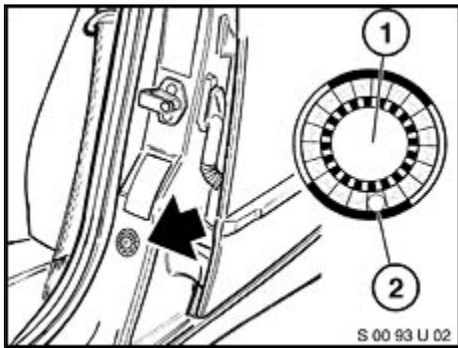
This Recall Campaign has been assigned code number **639**. After the vehicle has been checked and/or corrected, obtain a label (SD 92-417) and:

- A. Emboss your BMW center warranty number in the middle of the label (1);
- B. Punch out code number **639** (2), printed on the label; and
- C. Affix the label to the **B**-pillar as shown.
