Recall Bulletin

PRODUCT SAFETY RECALL

SUBJECT: Supplemental Restraint System (SRS) Electronic Control Module (ECM)

MODELS: 2003-2004 Pontiac Vibe

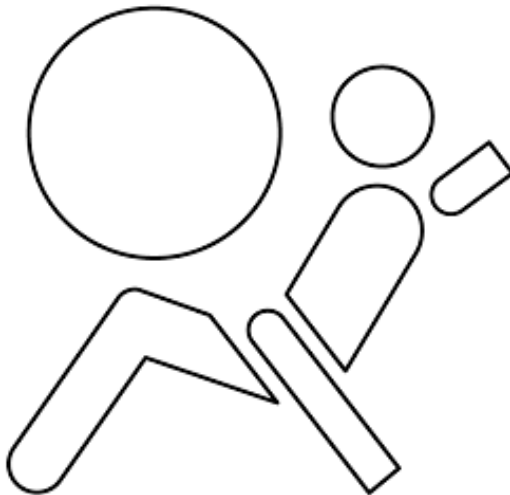
3352671

Condition #1: Light Remains On, **OR** Light Blinking, **OR** Light Does Not Come On.

Condition #2: Light Goes Off.

Corrective Action: Replace the Sensing and Diagnostic Module (SDM) and install the sub harness. Proceed to **STEP 2. CHECK FOR DTCs.**

Corrective Action: Install the sub harness. Proceed to **STEP 2. CHECK FOR DTCs**
