Recall Bulletin

PRODUCT SAFETY RECALL

SUBJECT: Supplemental Restraint System (SRS) Electronic Control Module (ECM)

MODELS: 2003-2004 Pontiac Vibe

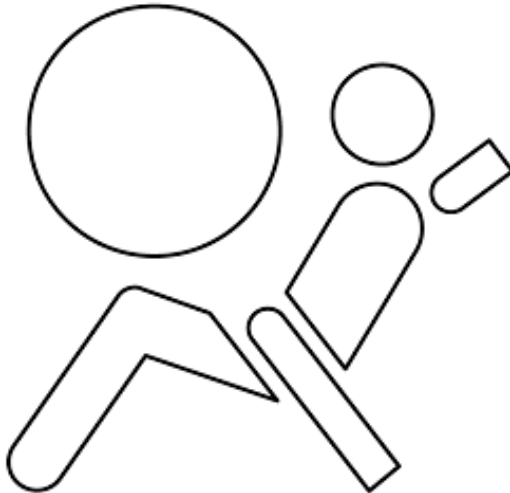
3352671

- a) Verify that the warning indicator comes on when the ignition switch is turned on.

- b) After the ignition has been on for approximately 6 seconds check the behavior of the warning indicator.

Condition #1: Light Remains On, **OR** Light Blinking, **OR** Light Does Not Come On.

Condition #2: Light Goes Off.

Corrective Action: Replace the Sensing and Diagnostic Module (SDM) and install the sub harness. Proceed to **STEP 2. CHECK FOR DTCs**.

Corrective Action: Install the sub harness. Proceed to **STEP 2. CHECK FOR DTCs**

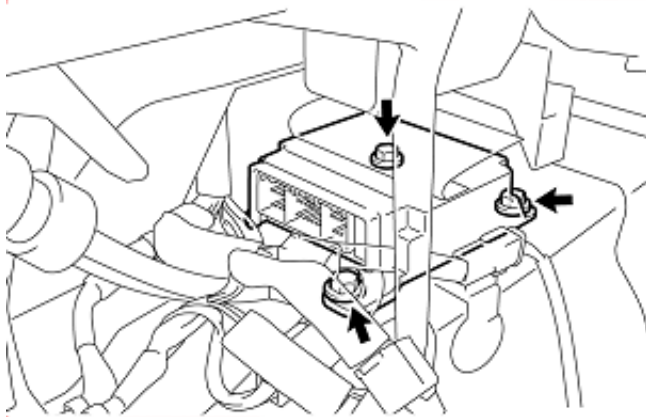
(Required IF Vehicle Exhibited Condition #1 Above)

- Remove the 3 bolts and the SDM.
- Install a NEW SDM, then continue to STEP 12.

TIGHTEN to 13ft. lb (17.5 N·m)
