Re: Toyota Safety Recall 13V-030 Dealer Notification - Remedy

Subject: Safety Recall DLA - **Remedy Available**
2006 Through Early 2012 Model Year IS 250 and IS 350,
2010 Through Early 2012 Model Year IS250C and IS 350C, and
2008 Through 2011 Model Year IS-F
Front Wiper Arm Nut

SAFETY RECALL DLA

FRONT WIPER ARM NUTS

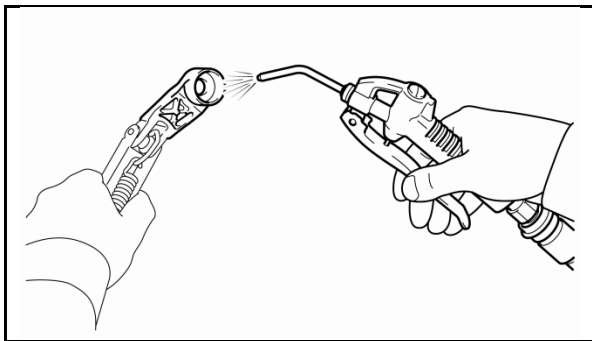
- Check the wiper arm pivot hole and determine the condition using the table below.

OK	NG
Condition Example		 	 
		ALL coloring and ALL serrations have been removed.	ALL coloring and ALL serrations HAVE NOT been removed.
Action Required		OK <ol style="list-style-type: none"> Proceed to step 4. CLEAN THE WIPER COMPONENTS 	NG <ol style="list-style-type: none"> Confirm condition by attempting to remove the serration pattern multiple times. Obtain a new replacement arm if the serration is still not fully removed. Proceed to step 4. CLEAN THE WIPER COMPONENTS

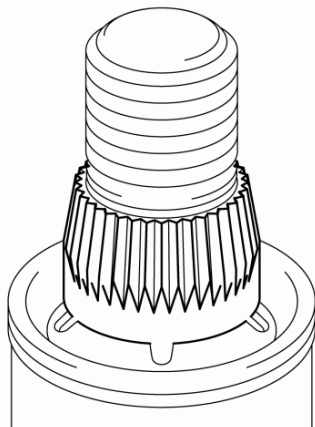
OK

The splines **MUST** be cleaned to prevent wiper arm slippage.

- Protect the cowl around the pivot shafts with tape or shop cloth.
- Using a wire brush, clean the splines of the pivot shafts to prevent wiper arm slippage.
- Use an air gun to remove any debris from the pivot shafts and surrounding area.

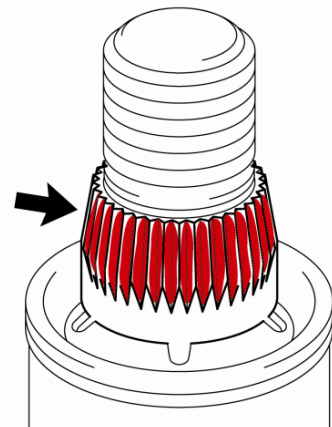
NG

Adhesion of
foreign
substances
