# RECALL CAMPAIGN BULLETIN

NTB13-034a

## VOLUNTARY SAFETY RECALL CAMPAIGN 2013 LEAF OCS SENSORS

**APPLIED VEHICLES:** 2013 Leaf (ZE0)

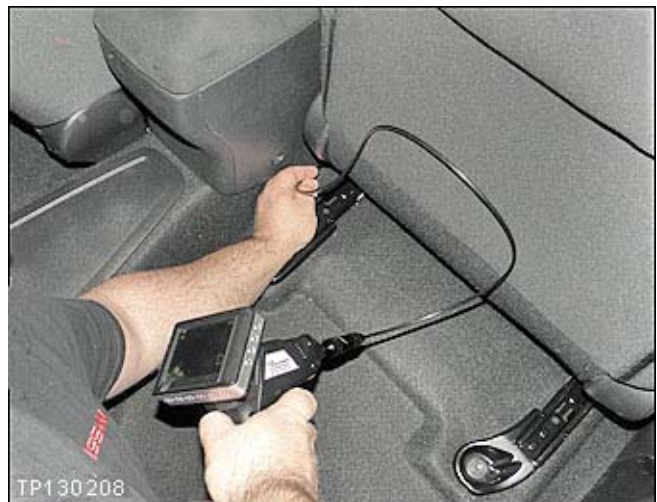
Figure A

2. Use borescope (J-50079 or equivalent) to read the lot code on the side of the inboard seat-track.

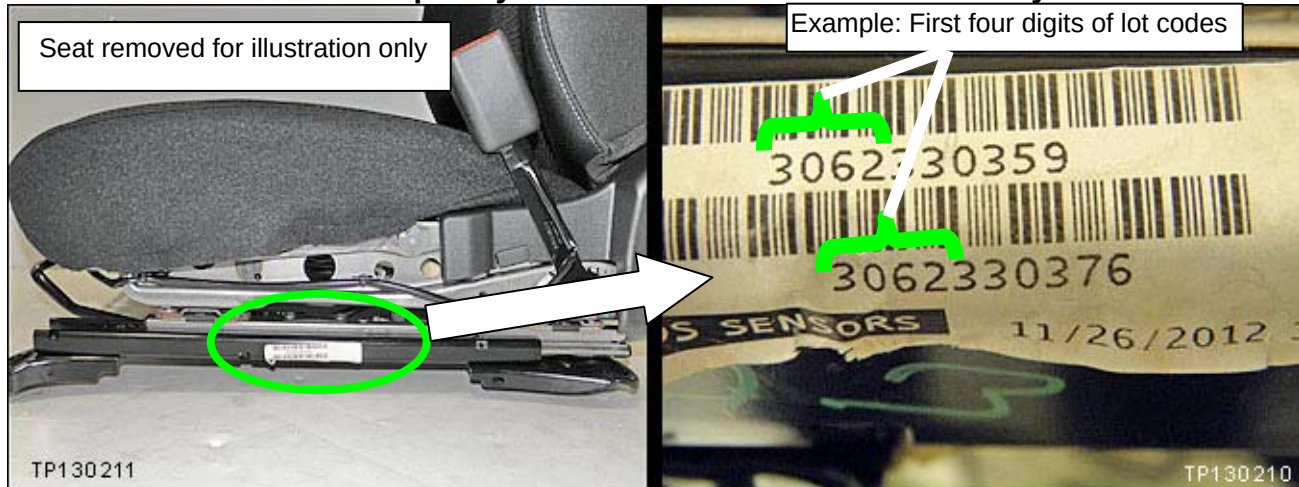
Figure B

**OCS sensor lot code example – your vehicles lot code numbers may be different.**

- In the **example** above, the first four digits are “3062” for both sensors.

**NG: Lot code is in this range: 2472 to 3102**

3. Write the first four digits of the lot code **for each sensor** on the repair order.

- If the first four digits of the lot code are 2472 to 3102, replace the sensor.
