RECALL CAMPAIGN BULLETIN

NTB13-032a

VOLUNTARY SAFETY RECALL CAMPAIGN 2013 SENTRA OCS SENSORS

CAMPAIGN ID #: PC213

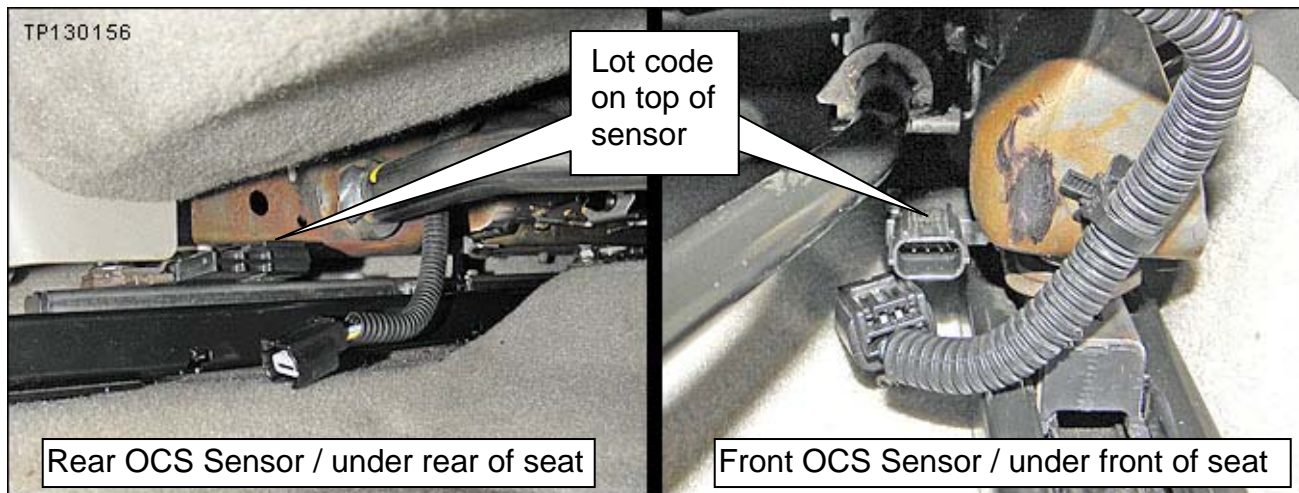
Figure A

2. From under the passenger front seat, disconnect the OCS electrical connectors (see Figure A).

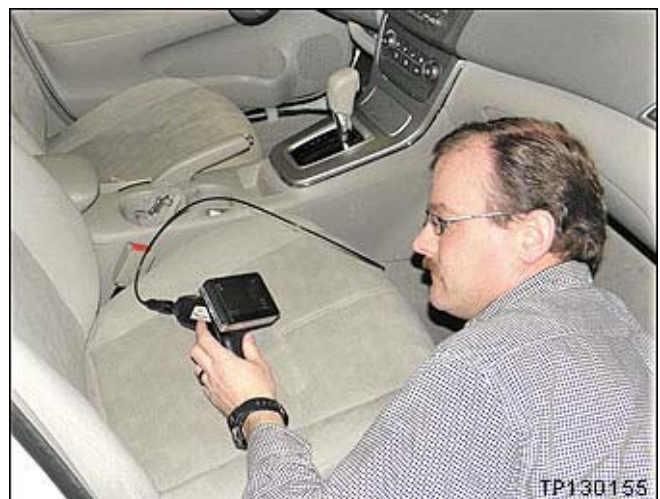
Figure B

3. Use borescope (J-50079 or equivalent) to read the lot code on top of each sensor.

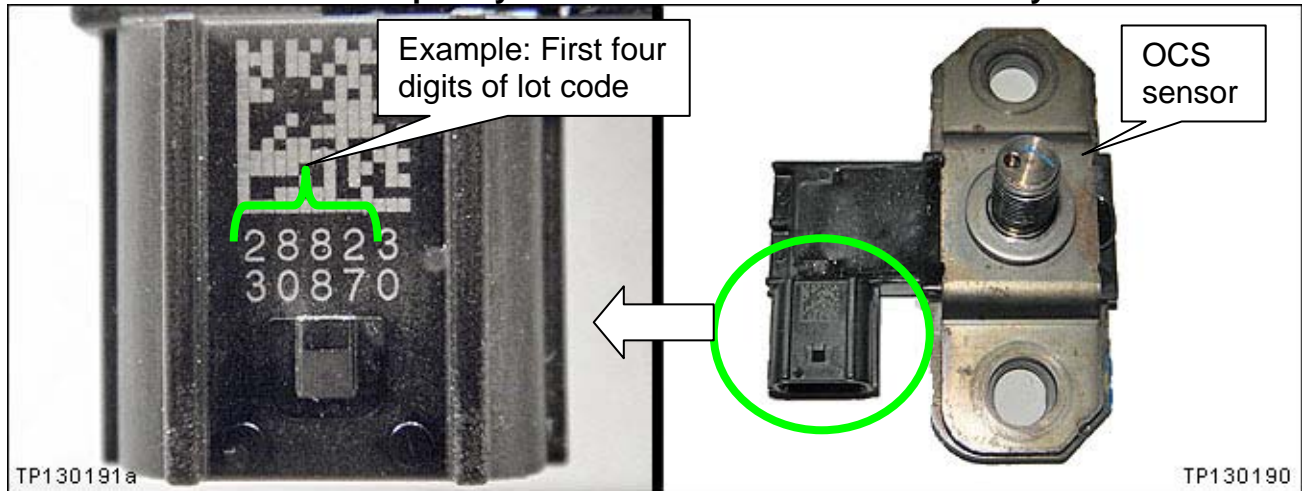
Figure C

OCS sensor lot code example – your vehicles lot code numbers may be different.

NG: Lot code is in this range: 2472 to 3102

- If the first four digits of the lot code are 2472 to 3102, replace the sensor.

4. Write the first four digits of the lot code **for each sensor** on the repair order.
 - In the **example** above, the first four digits are “2882”.
5. Reconnect the electrical connectors for both OCS sensors.
6. Determine if the OCS sensors are NG or OK.
