# RECALL CAMPAIGN BULLETIN

NTB13-035a

## VOLUNTARY SAFETY RECALL CAMPAIGN 2013 PATHFINDER OCS SENSORS

**APPLIED VEHICLES:** 2013 Pathfinder (R52)

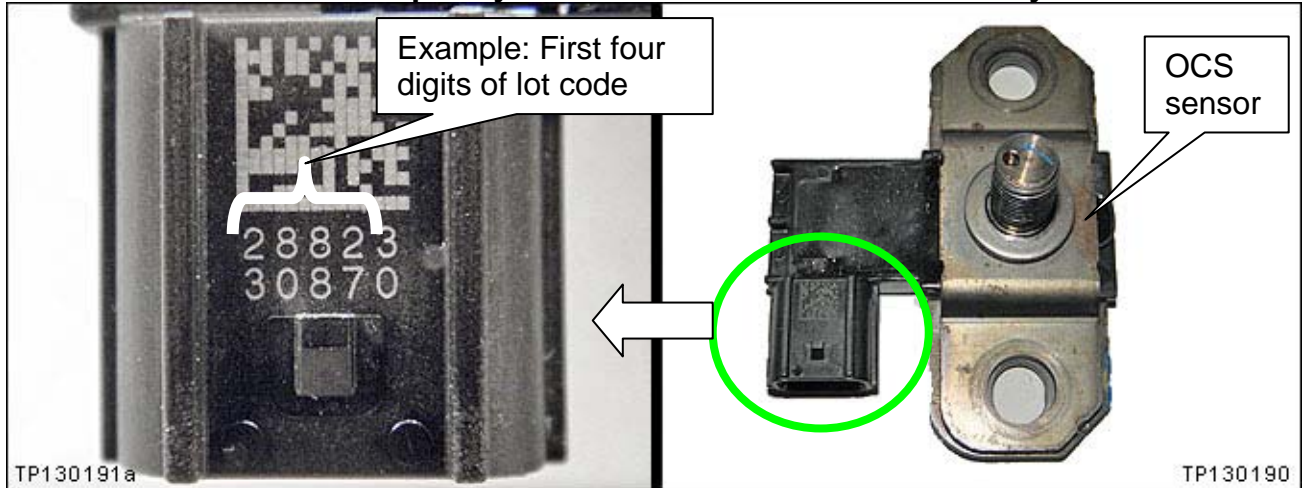
Figure 16

**OCS sensor lot code example – your vehicles lot code numbers may be different.**

**NG: Lot code is in this range - 2472 to 3102; replace the sensor**

- If the first four digits of the lot code are 2472 to 3102, replace the sensor.

- If the first four digits of the lot code are not in the range above, reinstall the original sensor.

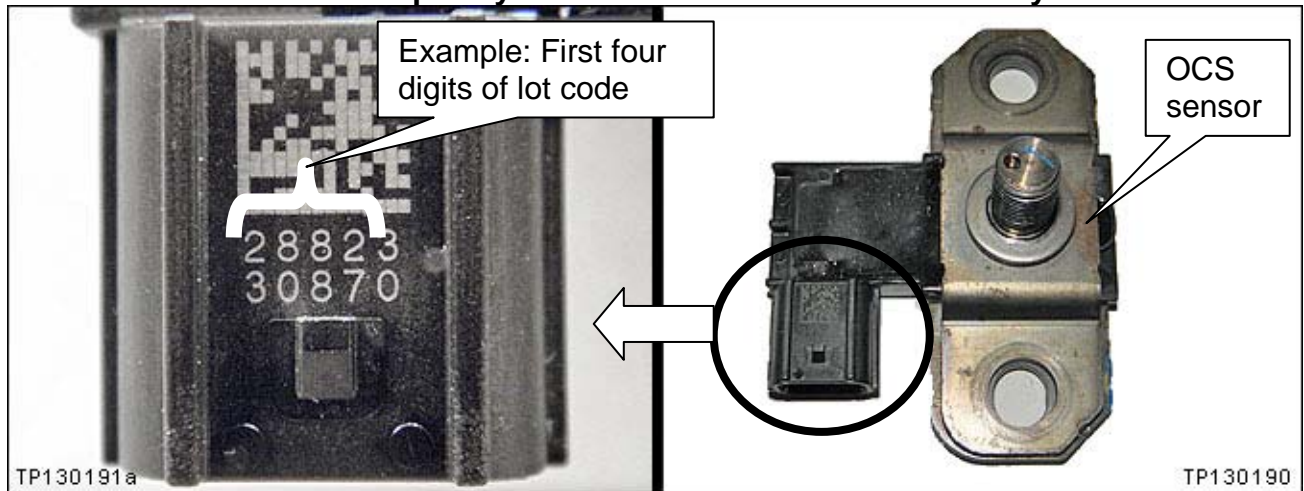
Figure 20

**OCS sensor lot code example – your vehicles lot code numbers may be different.**

**NG: Lot code is in this range - 2472 to 3102; replace the sensor**

- If the first four digits of the lot code are 2472 to 3102, replace the sensor.

- If the first four digits of the lot code are not in the range above, reinstall the original sensor.

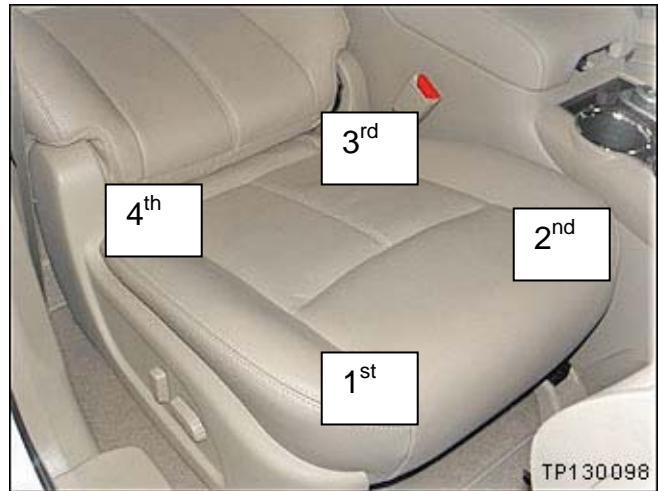
Figure 26

**NOTE:** DTC B1020 is an indication that the 14 mm nuts may be torqued incorrectly.

- In steps 18 and 19 you will be tightening the 14 mm nuts that hold the seat frame to the seat tracks.
- Torque the nuts in the order shown in Figure 26.

- **This is a critical torque specification.**
- **Make sure the torque wrench is properly calibrated.**
- **Make sure to torque these nuts as indicated.**

18. From under the front of the seat, torque the front 14 mm nuts:

- Torque nuts to:  
45 N•m (4.56 kg-m, **33 ft-lb**)

19. From the top of the seat cushion, torque the rear 14 mm nuts:
