## **Subject: SmartPlex Switch Hub Module**

**Models Affected: Specific Freightliner 108SD, 114SD, and Business Class M2 vehicles manufactured December 3, 2011, through December 12, 2012.**

# Recall Campaign

April 2013  
FL639A  
NHTSA #13V-074  
Transport Canada #13-088  
REVISED NOTICE

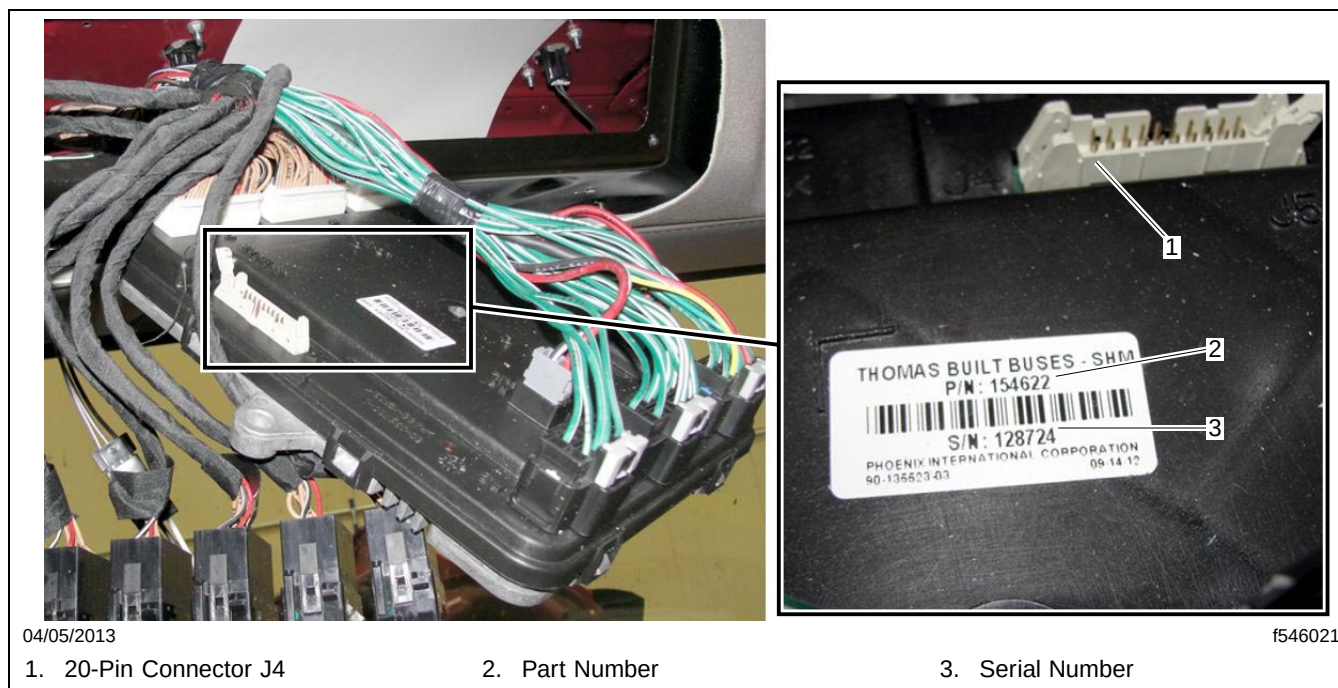
Fig. 2, SHM Label Inspection

If the serial number is 127176 or below, the SHM needs to be replaced. **Write down the SHM serial number to include on your payment claim**, then proceed to the step 6.

If the serial number is 127177 or higher, the SHM does not need to be replaced. Proceed to the Important statement just after step 6.

4. Gently lift the switch hub module from the mounting bracket, then remove it from the overhead console.
5. Inspect the label on the back of the SHM for the serial number. See Fig. 2.

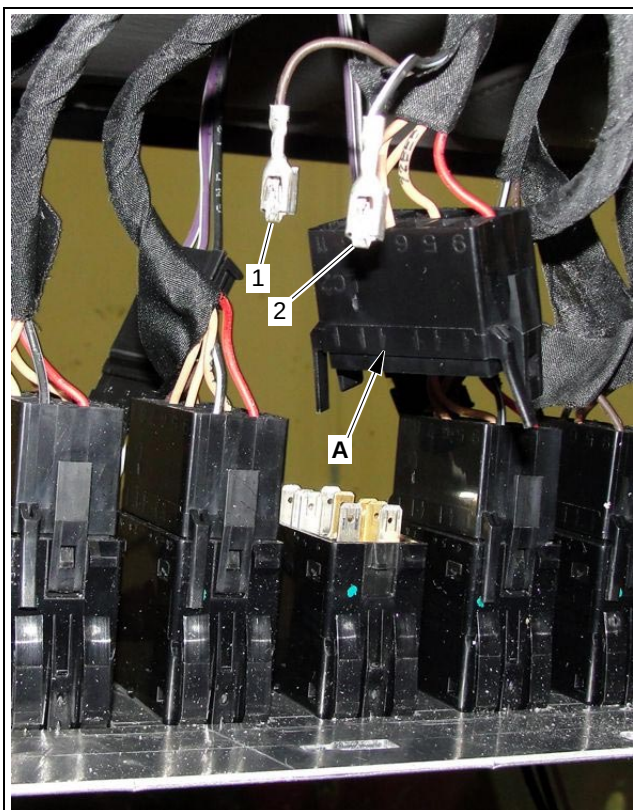
**Fig. 5, Switch Removed from the SHM Panel**

- 01/29/2013 f545999
- A. Any switch can be removed from the switch panel for this procedure.
1. Wire 29A (brown)
  2. Ground Wire (black with a white stripe)

8. Remove the switch ground wire from cavity 9, and switch wire 29A from cavity 11. The ground wire is black with a white stripe, and wire 29A is brown. See **Fig. 5**.
9. Connect switch wire 29A into cavity A of the free connector from the kit (new harness A06-89235-000), and the switch ground wire into cavity B. See **Fig. 6**.

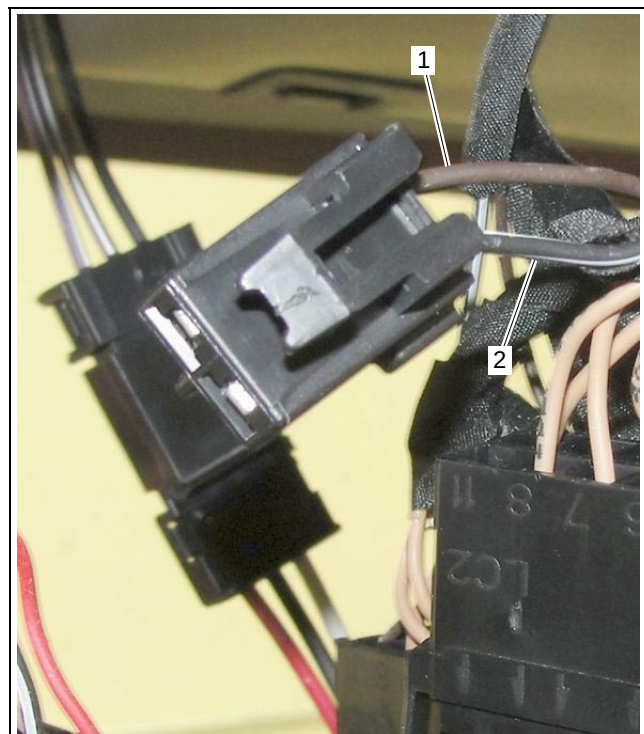
**Fig. 6, Wires Installed in the Free Connector**

- 01/29/2013 f546000
1. Wire 29A Connected to Cavity A
  2. Ground Wire Connected to Cavity B
