TMS-NTC-13112
May 13, 2013

Re: Toyota Safety Recall 13V-098 – Dealer Notification Remedy

Subject: Safety Recall – **Remedy Available**
2007 through Late 2013 Model Year FJ Cruiser Vehicles
Access Door Inner Panel

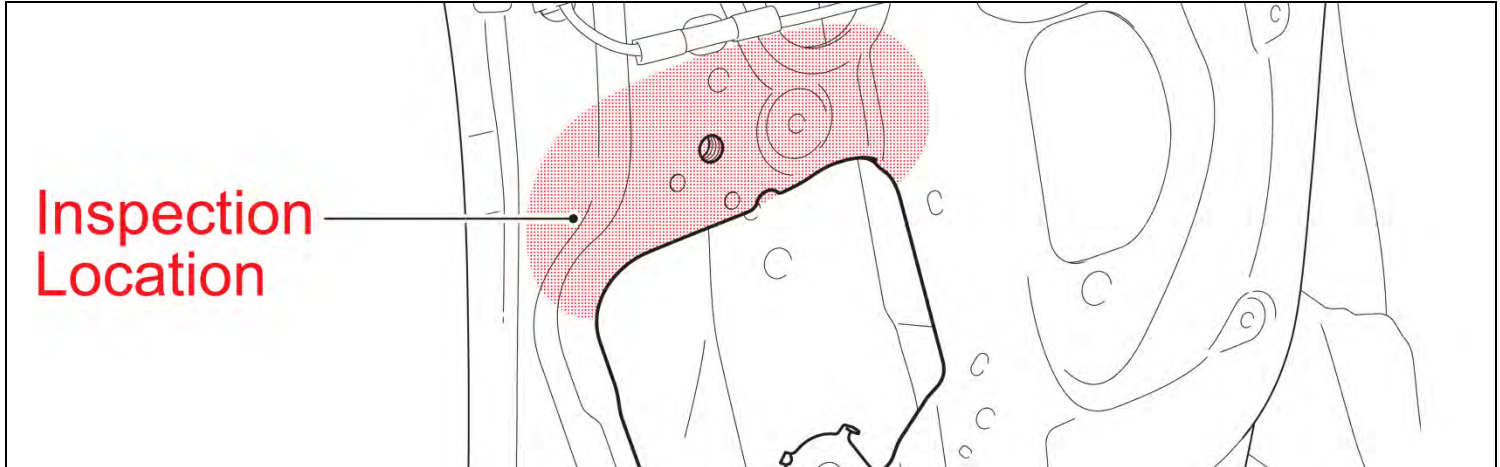
INSPECTION RESULT 1

- a) Visually inspect the inside of the door panel from the underside for a large retainer to determine if the vehicle has a newly designed door. The inspection can also be performed based on the amount of spot welds.

NOT newly designed door panel

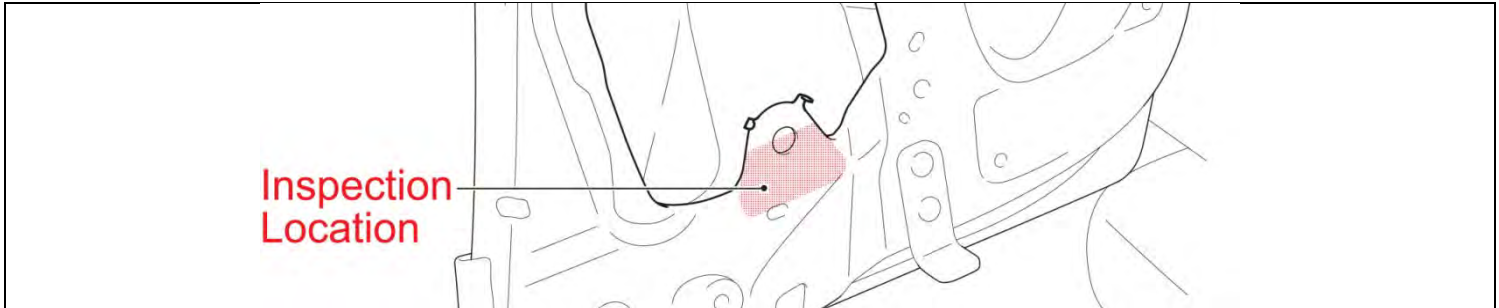
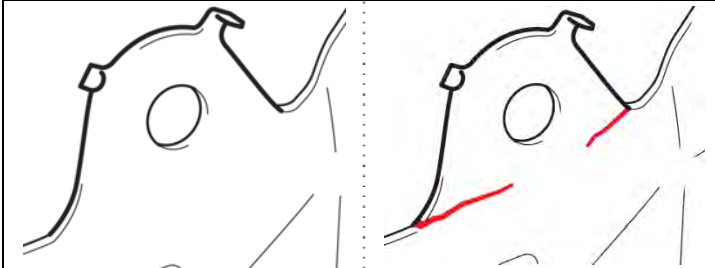
INSPECTION RESULT 3

No cracking or some cracking present
NO separation

If the anchor is cracking but not separated or there are no cracks present, additional inspection is required. Complete **STEP 2** below then proceed to **SECTION X**.

2. APPLY ANTI-RUST TREATMENT TO THE CRACK(S)

- Use Rust-Oleum 7779 or equivalent, touch-up paint.
- **ONLY** perform this step if inspection result 3 was identified.
- It is only necessary to apply paint if cracks are present.
- If the anchor separates during any of the remaining procedure, replace the door panel as outlined in inspection result 4.

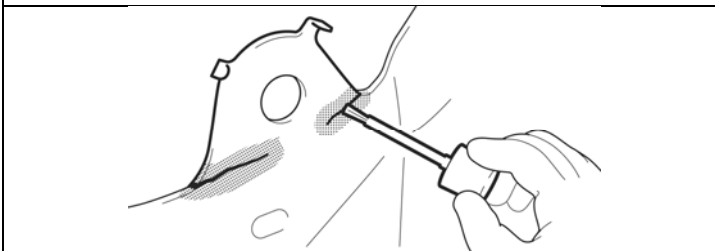
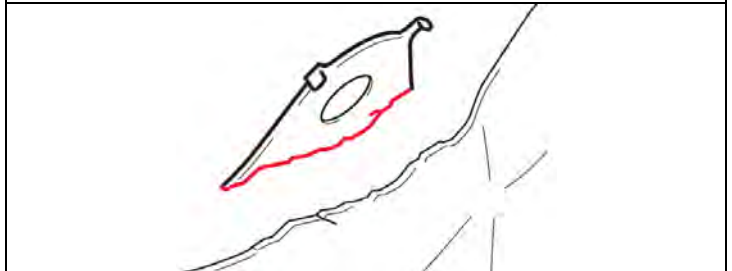
INSPECTION RESULT 4

Lower seatbelt anchor separation

It is necessary to replace the door panel and the seat outer belt assembly. A picture of the separation **MUST** be taken for MAC parts release. First, replace the door panel, refer to **SECTION XIII**. for details. Then complete **SECTION XII**.

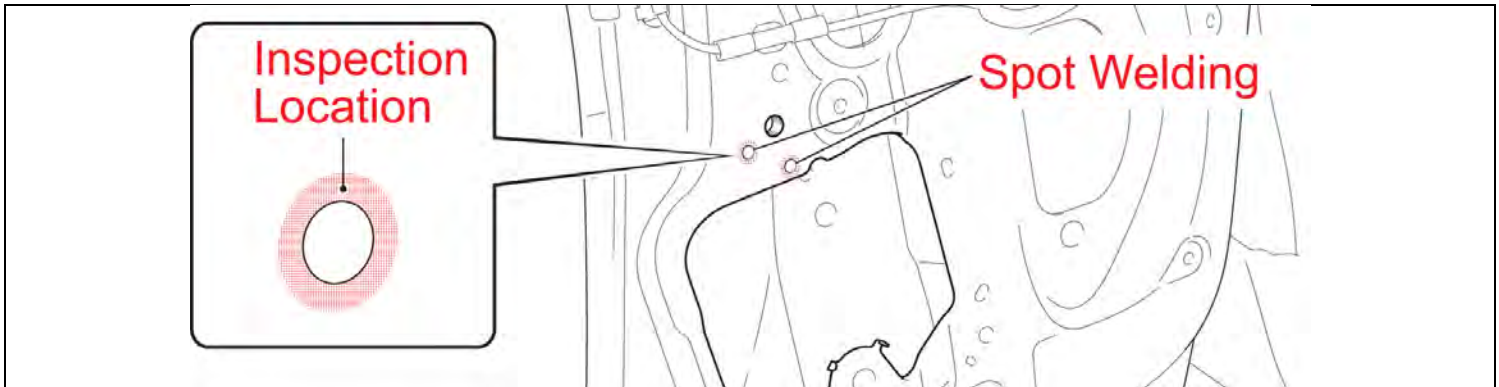
1. INSPECT THE REAR DOOR PANEL

Visually inspect the door panel around 2 welding points near the upper seatbelt anchor to determine if any cracking is found.

- a) Visually inspect the 2 welds near the upper seatbelt anchor for cracking.

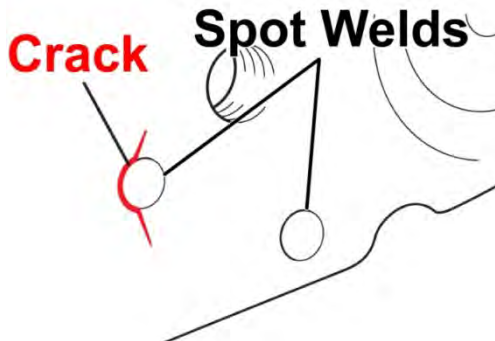
Cracking preset

It is necessary to install the access panel reinforcement and replace the seat outer belt assembly. Complete **STEP 2** below then proceed to **SECTION XI**.

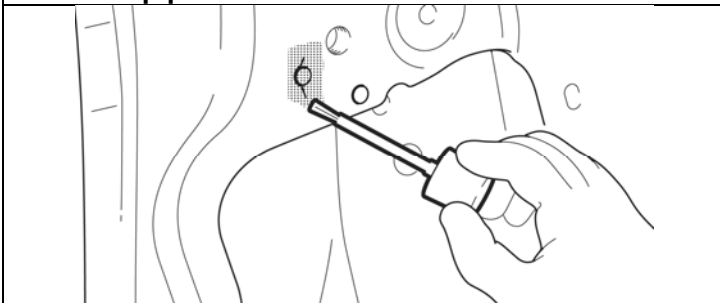
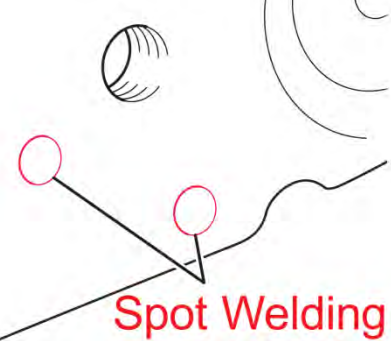
INSPECTION RESULT 6

NO cracking present

It is necessary to install the access panel reinforcement. Proceed to **SECTION XI**.

NOTE: If no cracking was found during inspections it is not necessary to replace the seat outer belt assembly.
