**SUBJECT:** 2003-2004 Mazda6 and 2004 RX-8 Passenger Air Bag Safety Recall 6913D

## 2003-2004 MAZDA6 AND 2004 RX-8 - PASSENGER-SIDE AIRBAG INFLATOR [RECALL 6913D]

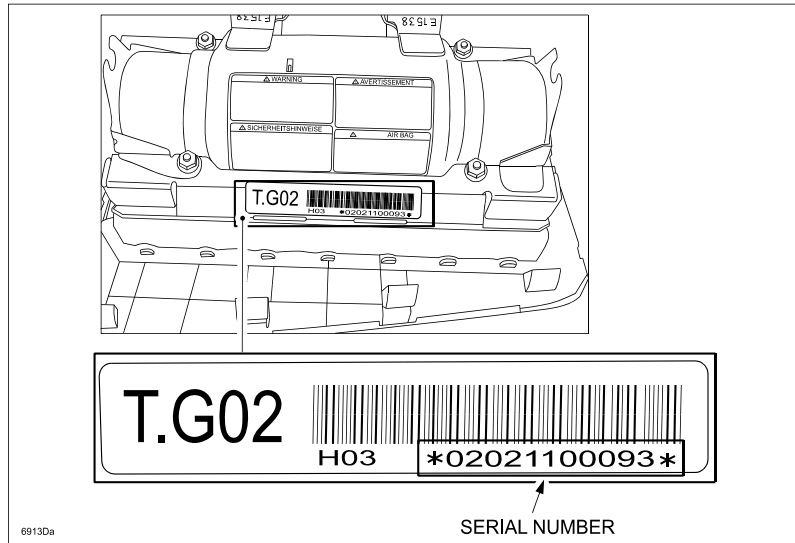
1. Remove the passenger-side air bag module assembly according to MS3 online or the Workshop Manual.
2. Read the eleven (11) digit serial number on the air bag module as shown below.
3. Contact the Mazda Dealer Assistance Group at (877) 727-6626, option 2 and provide the VIN and inflator serial number. DAG will confirm whether it is a defective inflator or not.

- If DAG confirms the inflator is not defective, reinstall the air bag module and return the vehicle to the customer.
- If DAG confirms the inflator is defective, replace the air bag module inflator with a modified part according to "C. REPAIR PROCEDURE."
