Federal Recall Information

13KWJ

Recall 13KWJ - ISL Alternator Wiring

8/2/2013

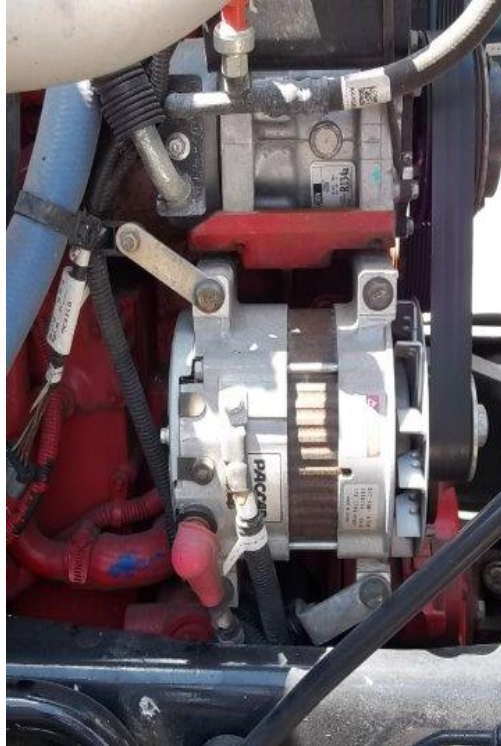
Figure 1 – Positive cable goes **DOWNWARD, OK**, no further action required

Inspect the routing of the alternator charging harness. If it is routed from the alternator in a **downward** direction (see Figure 1 below), **no further action is required**. File Quick Claim 13KWJ1, which will pay 0.3 hr labor to inspect.

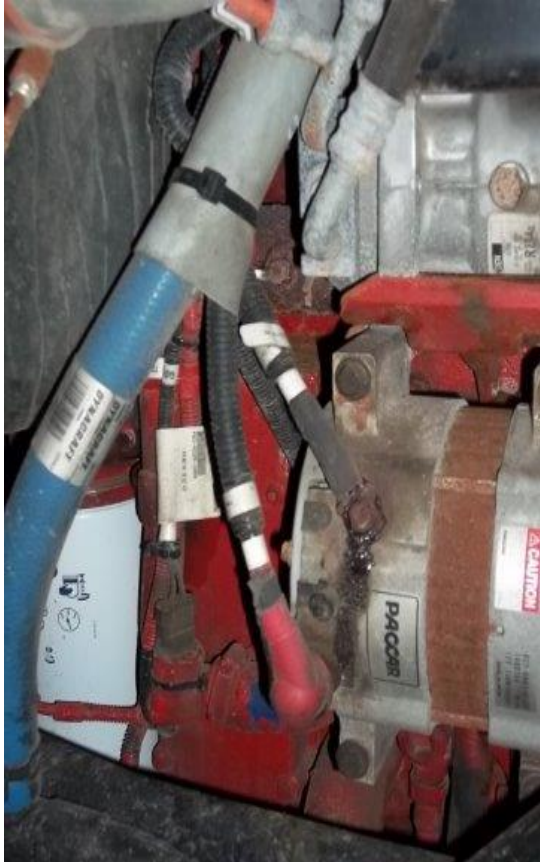
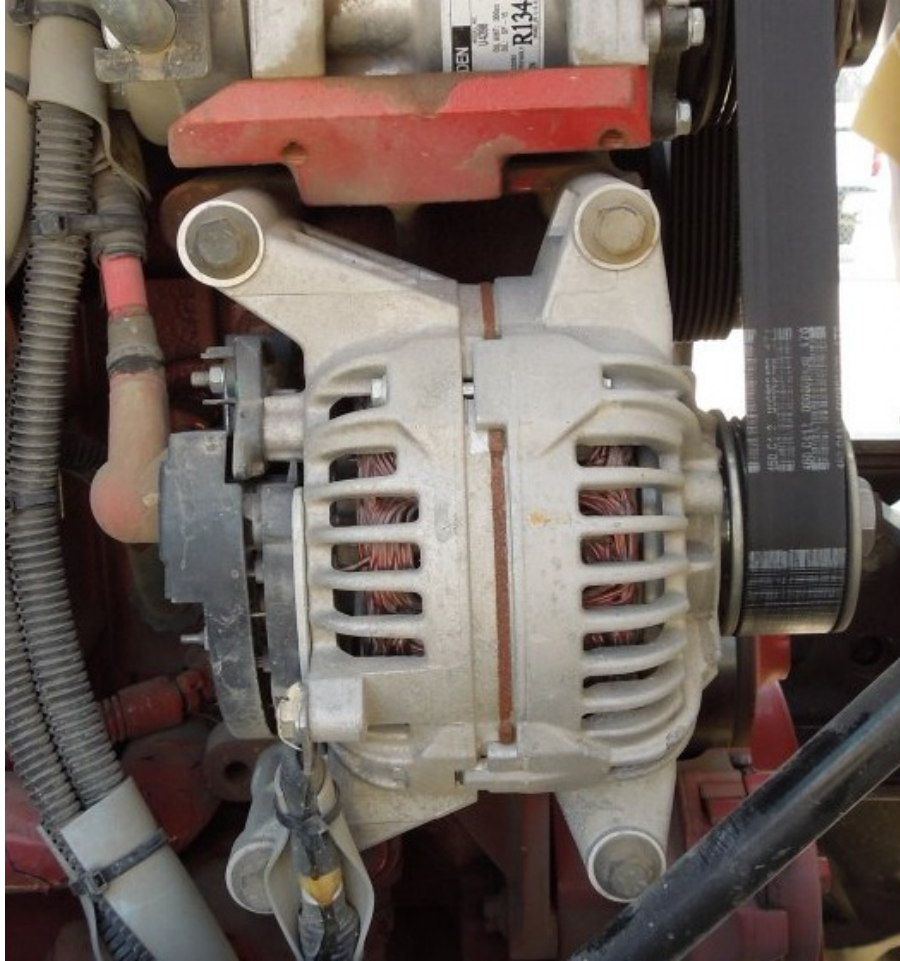
On certain T4 and W9 model series trucks equipped with ISL engines, an excess amount of electrical charge wiring may have been routed in a loop behind the alternator and near the exhaust manifold. Contact of the wiring with the exhaust manifold could result in damage to the wiring that could lead to a fire.

Figures 2 & 3 – Positive cable goes **UPWARD, NOT OK**, replace harness

If your inspection in Step 1 above reveals that the positive cable is routed in an **upward** direction (see Figures 2 & 3 below), **replace the harness** with the part number listed next to the chassis you are working on in the attached chassis list.

The routing of the new harness is the same as the old one, **EXCEPT** it must be routed downwards from the alternator (new harness is actually not long enough to route incorrectly in an upwards direction).
