**PRODUCT CAMPAIGN BULLETIN**

**APPLICABILITY:** 2013MY Tribeca & 2014MY Legacy/Outback

**NUMBER:** WQJ-46

**SUBJECT:** 5-Speed Automatic Transmission (5EAT)  
Parking Rod

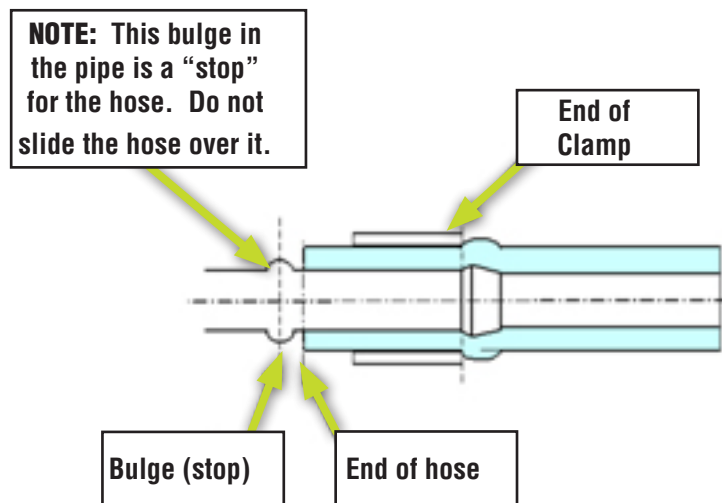
The illustration below shows the proper positioning of the new ATF cooler hoses on the fluid pipes.

The Service Procedure for this campaign will involve the replacement of the 5EAT transmission assembly along with the 2 Automatic Transmission Fluid (ATF) inlet and outlet hoses. Transmission units replaced as part of WQJ-46 are NEW, not re-manufactured.
