PRODUCT CAMPAIGN BULLETIN

APPLICABILITY: 2013MY Tribeca & 2014MY Legacy/Outback

NUMBER: WQJ-46

SUBJECT: 5-Speed Automatic Transmission (5EAT)
 Parking Rod

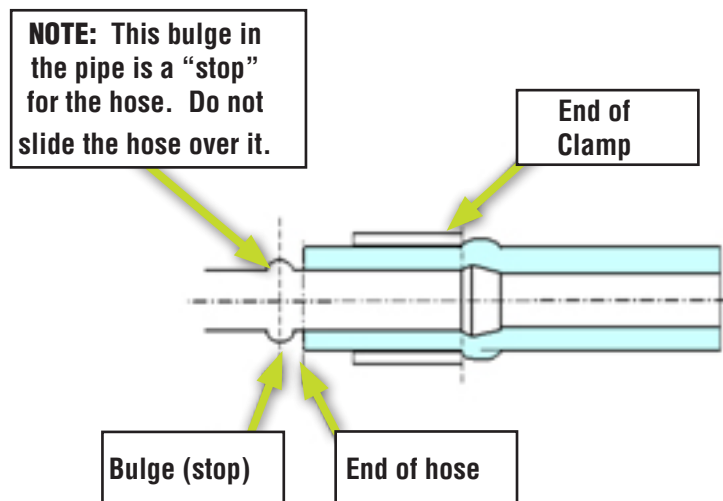
The illustration below shows the proper positioning of the new ATF cooler hoses on the fluid pipes.

The Service Procedure for this campaign will involve the replacement of the 5EAT transmission assembly along with the 2 Automatic Transmission Fluid (ATF) inlet and outlet hoses. Transmission units replaced as part of WQJ-46 are NEW, not re-manufactured.
