Michael A. Berardi
Director
Service Engineering Operations
Ford Customer Service Division

September 16, 2014

SUBJECT: **Safety Recall 13S08 – Supplement #3**
Certain 2005 through 2011 Model Year Crown Victoria, Grand Marquis, and Town Car
Vehicles Originally Sold or Currently Registered in Corrosion States
Steering Column Shaft

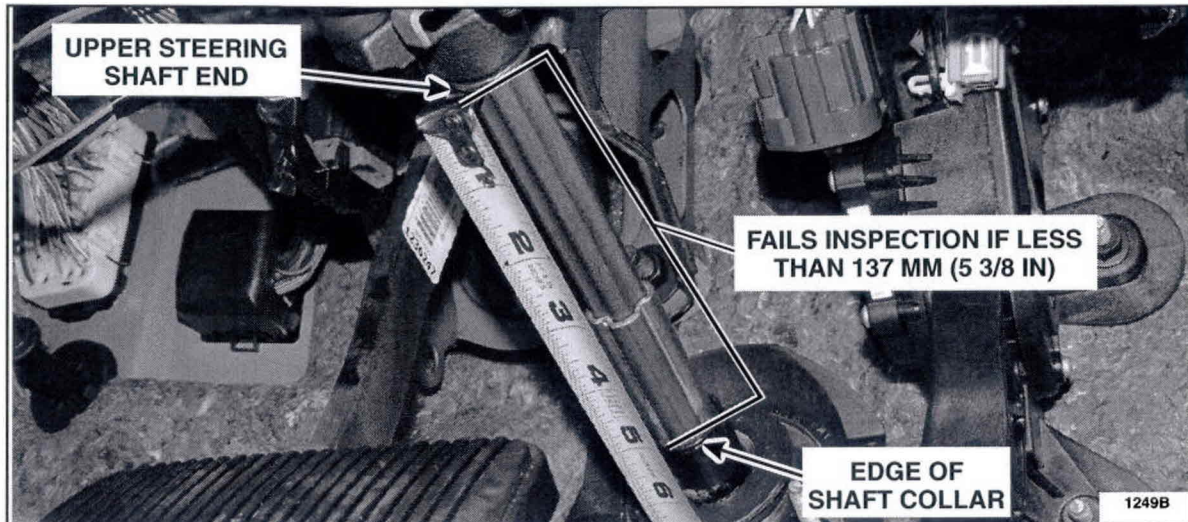
FIGURE 1

1. Measure the distance between upper steering shaft end and the edge of the shaft collar.
See Figures 1 and 2.
 - If the upper steering shaft measurement is less than 137 mm (5 3/8 in), it fails inspection.

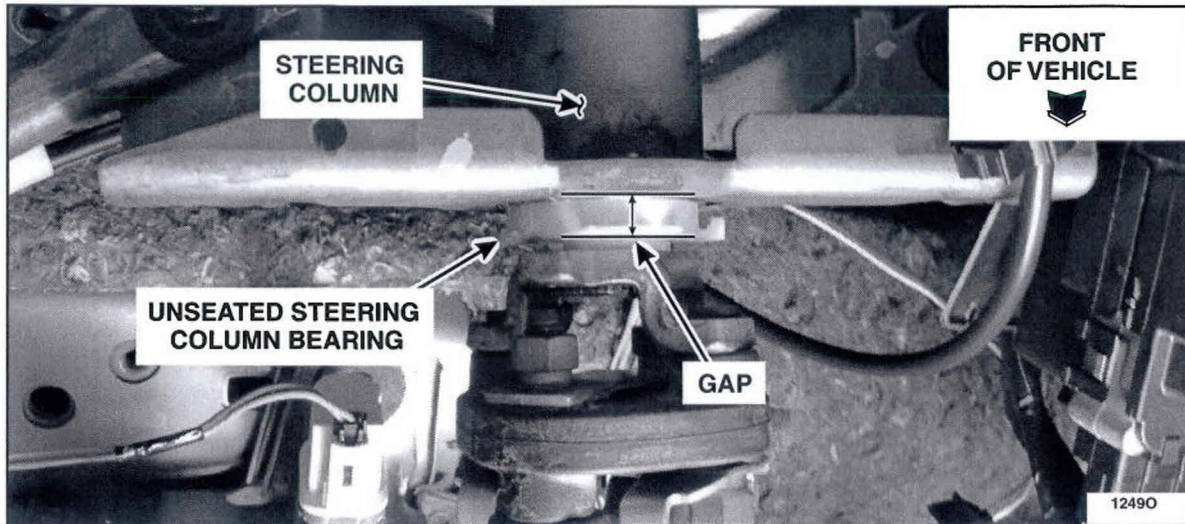
FIGURE 3

1. Inspect the steering column for an unseated steering column bearing. See Figures 3 and 4.

- If the steering column bearing is unseated, it fails inspection.

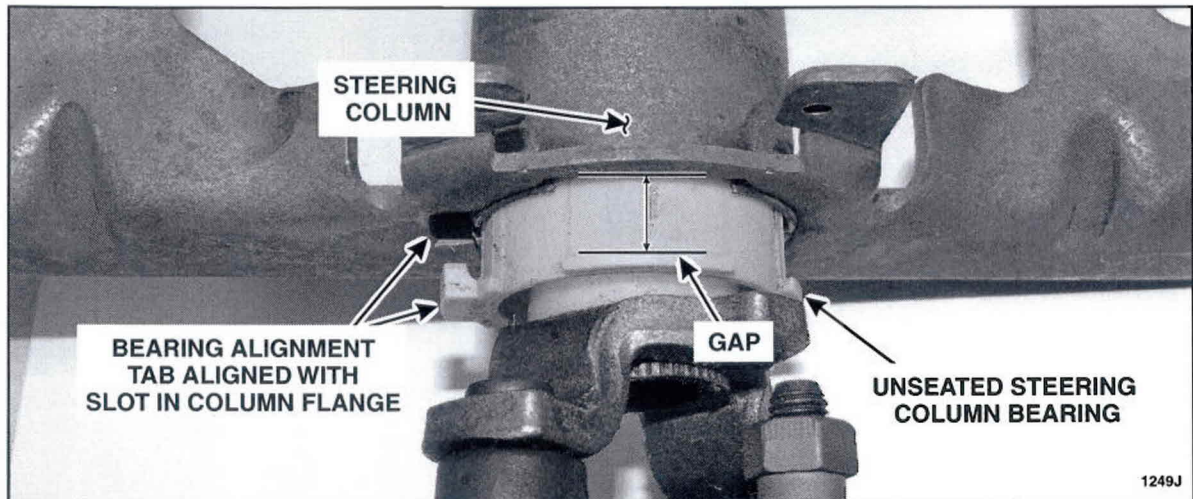
FIGURE 5

NOTE: In some instances the steering column bearing orientation tab may have broken off. If the tab has broken off, the bearing is still usable and can be seated within the steering column in any orientation.

2. Align the bearing alignment tab with the slot in the column flange. See Figure 5.
