**SUBJECT: Safety Recall 13S08**

Certain 2005 Through 2011 Model Year Crown Victoria, Grand Marquis, and Town Car  
Vehicles Originally Sold or Currently Registered in Corrosion States  
Steering Column Shaft

**Safety Recall 13S08**

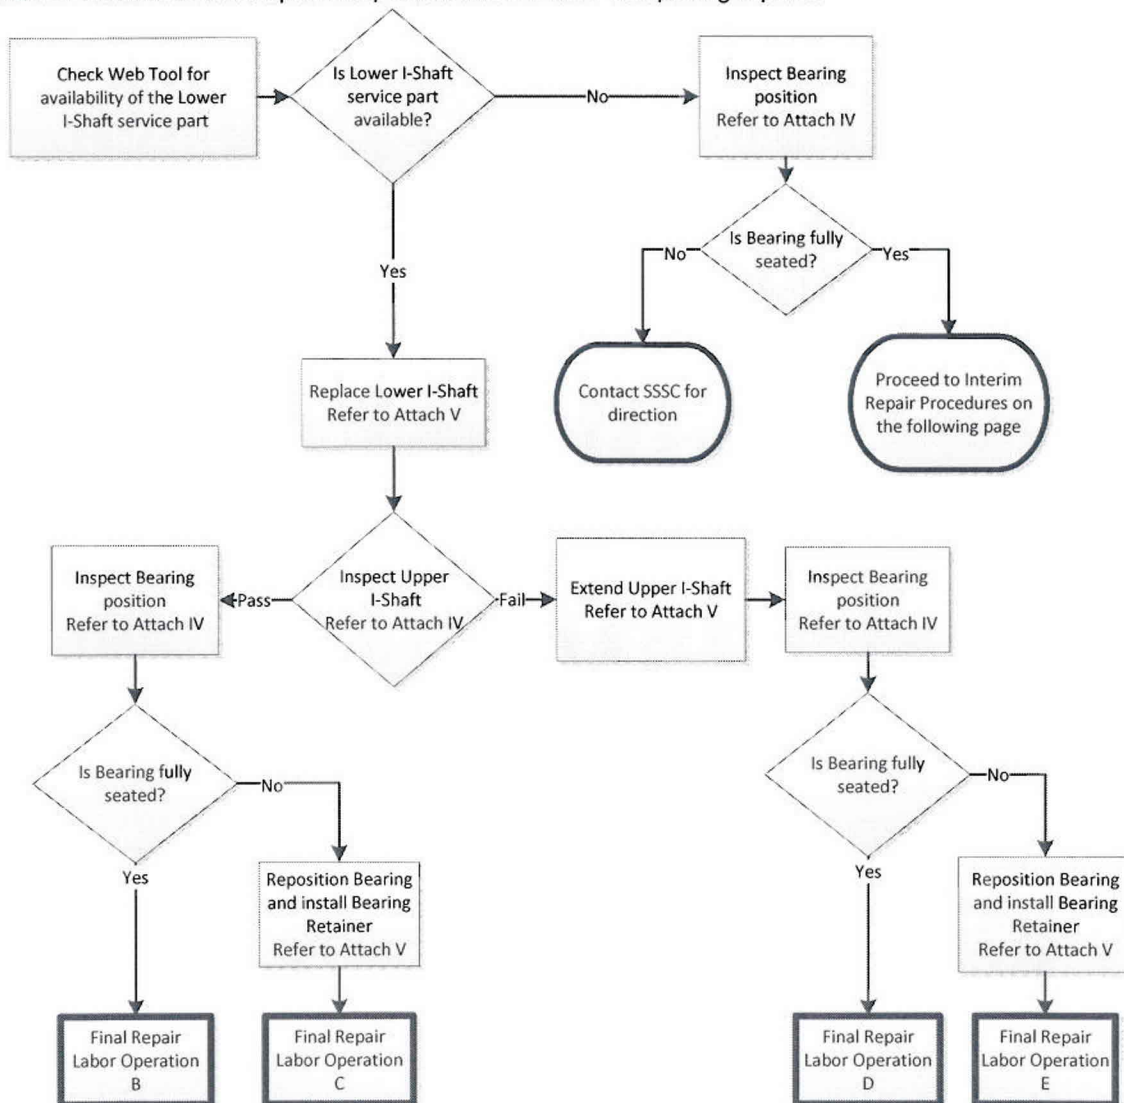
Refer to the following flow chart for inspection and repair criteria:

**NOTE:** Review all subsequent inspection areas before completing repairs.

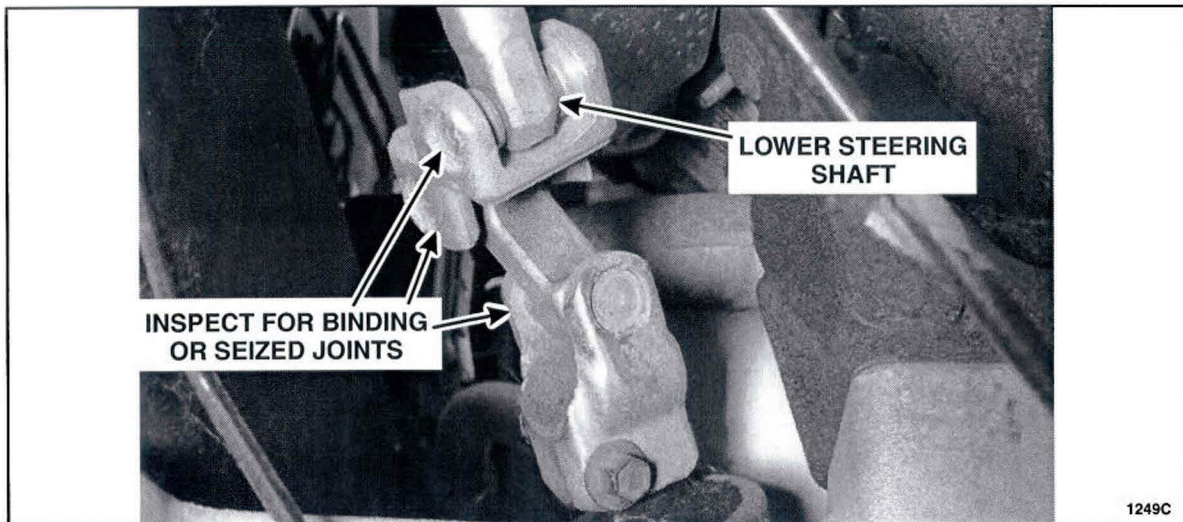
FIGURE 2

3. Inspect the lower steering shaft joints for binding or seizure. See Figure 2.

- Exercise the upper portion of the lower steering shaft throughout its range of motion.
- If the lower steering shaft does not move freely and without binding, it fails inspection.
- Reconnect the lower intermediate shaft using a *new* upper steering shaft to lower steering shaft bolt, after all subsequent inspections are complete.
  - Tighten the *new* bolt to 48 Nm (35 lb-ft).

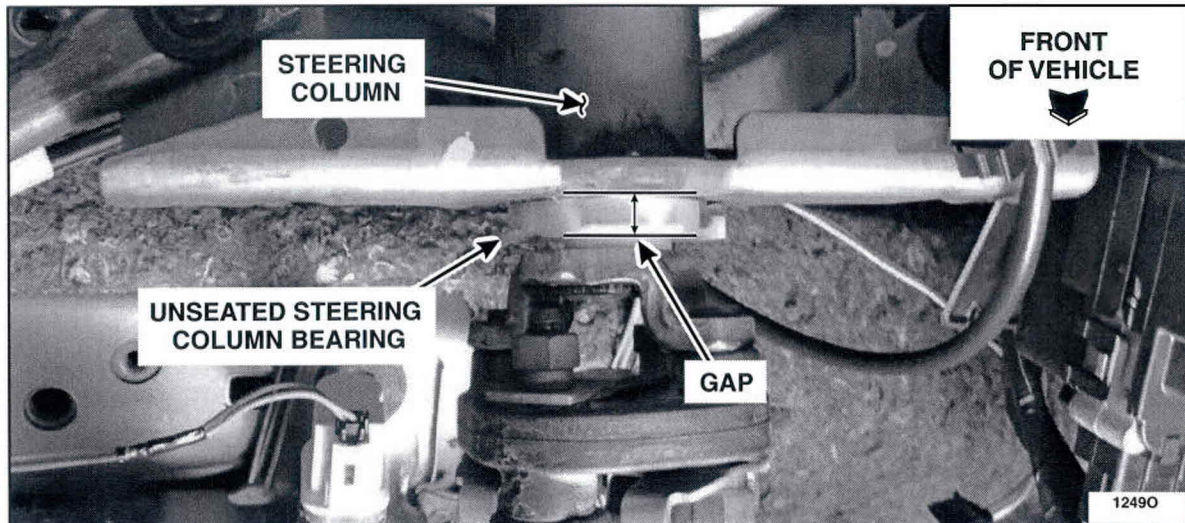
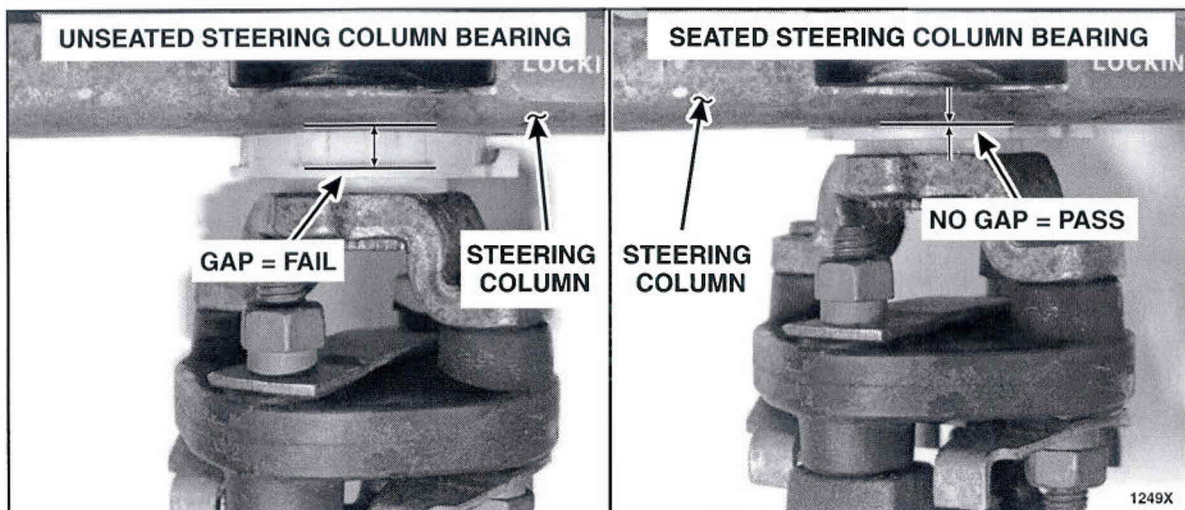
1. Inspect the steering column for an unseated steering column bearing. See Figures 3 and 4.

- If the steering column bearing is unseated, it fails inspection.

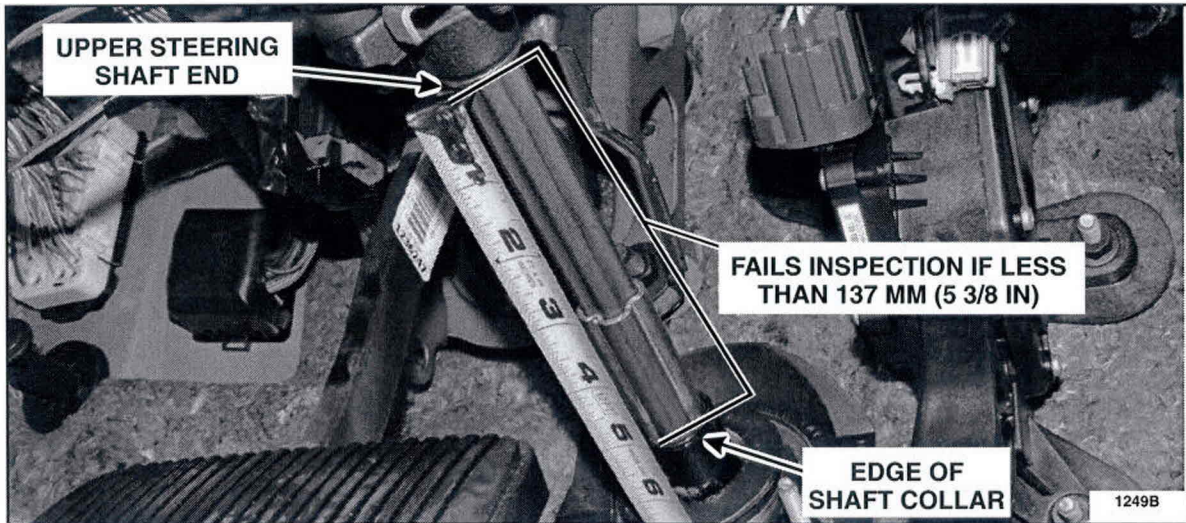
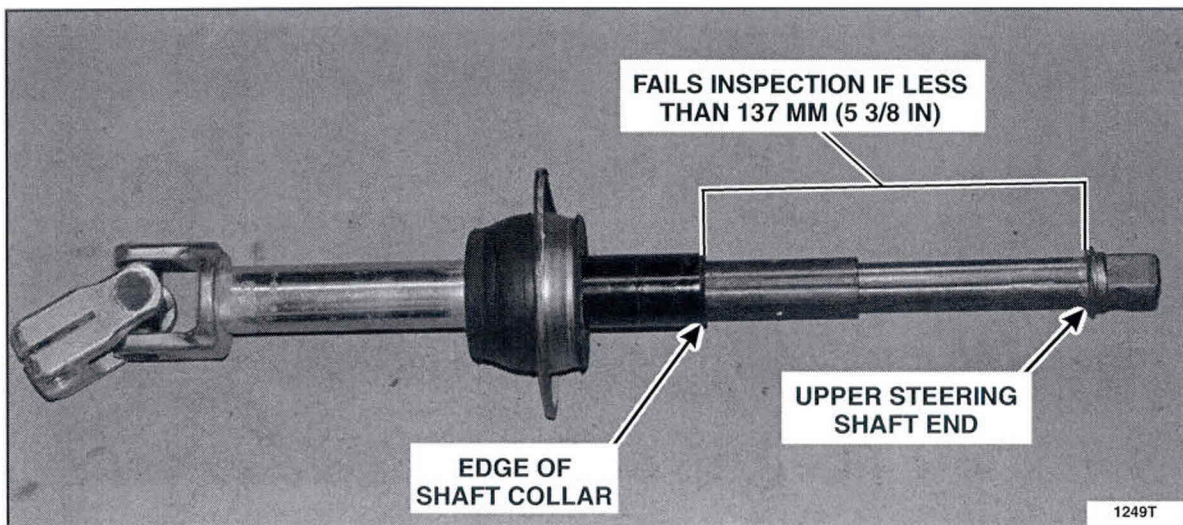
1. Measure the distance between upper steering shaft end and the edge of the shaft collar.  
See Figures 5 and 6.

- If the upper steering shaft measurement is less than 137 mm (5 3/8 in), it fails inspection.

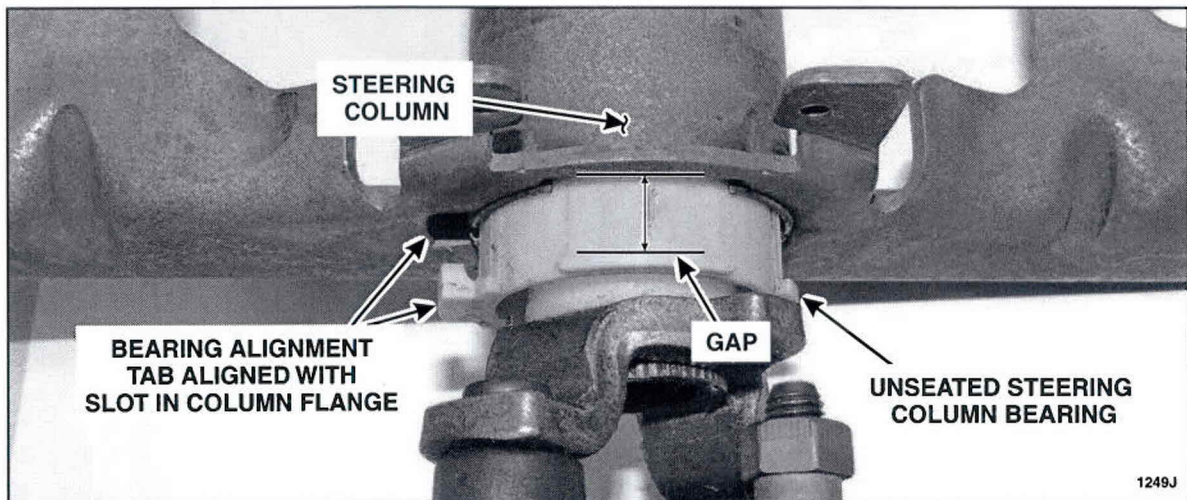
FIGURE 8

**NOTE:** In some instances the steering column bearing orientation tab may have broken off. If the tab has broken off, the bearing is still usable and can be seated within the steering column in any orientation.

2. Align the bearing alignment tab with the slot in the column flange. See Figure 8.
